The Interactive Window System was a sterling effort by Colt International, aimed at developing an integrated and modular product for use in naturally ventilated buildings. Milton Park Ltd piloted the system in a passive solar building completed for Marston Book Services. How well has the building performed?

PROBE

16: Marston Book Services

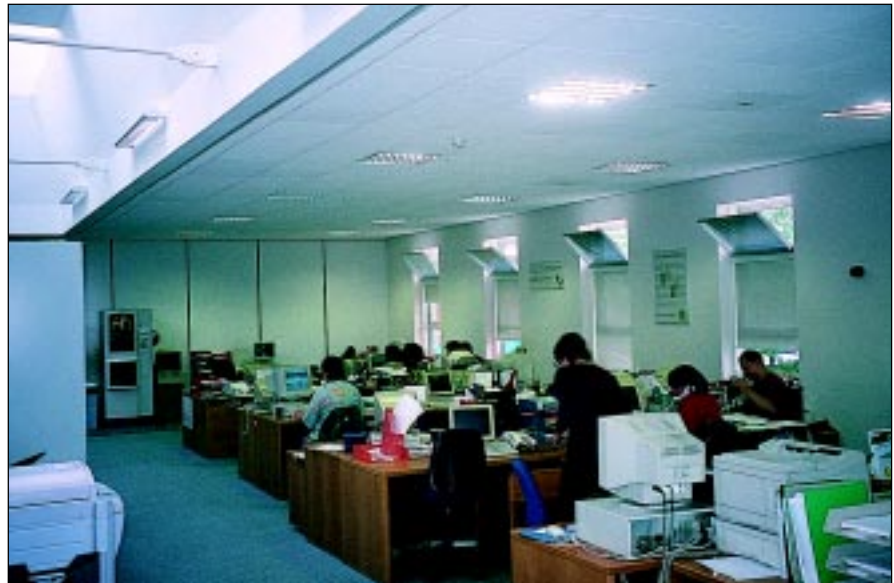
The glare from sun and sky is disappointing in view of the care devoted to the window system. This is due to diagonal sunshine coming past the ends of the light shelves, and bright spots on the blinds in bright sunshine.

The reported glare from sun and sky is disappointing in view of the care devoted to the window system. This seems to be due to diagonal sunshine coming past the ends of the light shelves and bright spots on the translucent blinds in bright sunshine. There are no blinds on the north facade, but bright skies can still cause problems with contrast glare and reflections in computer screens.

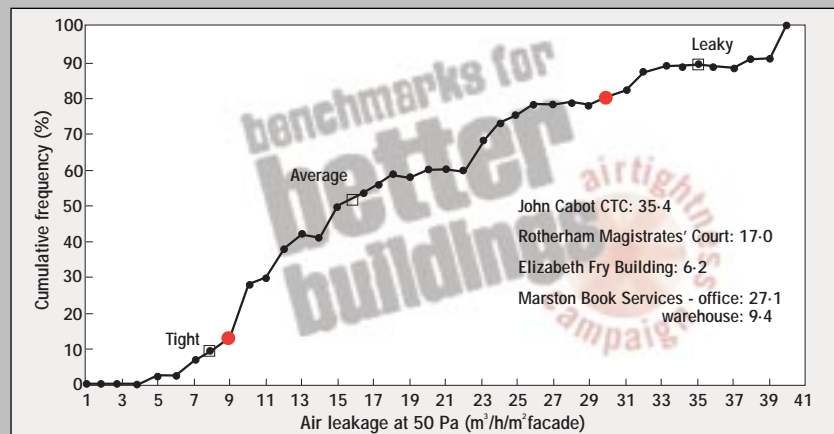
FIGURE 4: The air leakage data for Marston Book Services, plotted on the BRE/BSRIA rolling database.

The Q-value (Q_{50}/S) for the offices was calculated to be $27.1 \text{ m}^3/\text{h}/\text{m}^2$ of envelope area (calculated at 1366 m^2). This puts the building near the 'leaky' group on the BRE/BSRIA database (figure 4).

This indicated significant air leakage through the roof structure of the office building, and at the junction between the office brickwork and the warehouse cladding, which occurs at the smoking room. In depressurisation mode, a ceiling tile was lifted manually, and a severe downward draught of air was detected from the office roof space.

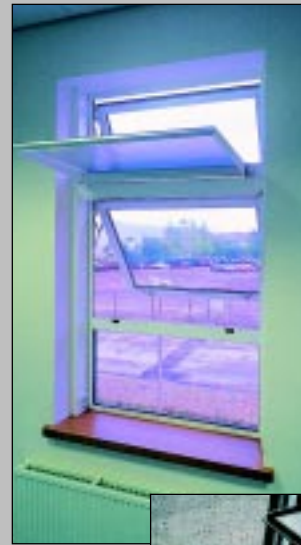
So how has the Interactive Window System performed? Occupants regarded the windows as successful in the main for ventilation, and particularly liked the performance of the upper motorised window, although some whistling occurred in high winds. However, the central window element performed poorly, as only a small wind was required to blow it shut.

The window hinges do not have sufficient resistance, and there is no slit-catch position.

Consequently, people sitting by the windows cannot control the draught, and feel that too much of the air goes over their heads.

Occupants liked the upper motorised window, but the central window elements close under only a small wind, leading to...
