Barclaycard headquarters

One of the greenest corporate headquarters of the 1990s has been subject to a rigorous PROBE investigation. How has the building performed and has it lived up to its environmental qualifications?

BY THE PROBE TEAM

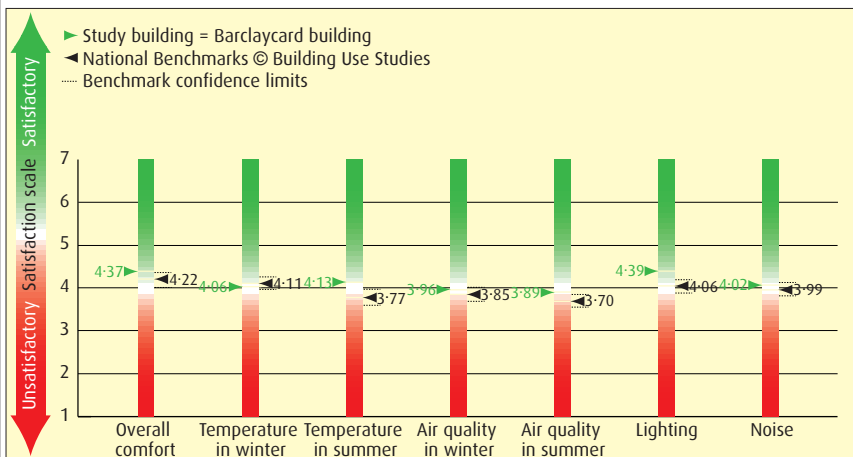
On comfort, Barclaycard scores consistently better than the benchmarks, with summer temperature and air quality, and lighting all being significantly better. Negative observations include lack of temperature stability (which some respondents said affected productivity), lower floors too cool while upper floors are too warm, and the seeming indifference of system settings to weather conditions.

Figure 3: Overall satisfaction with comfort conditions at the Barclaycard head office.

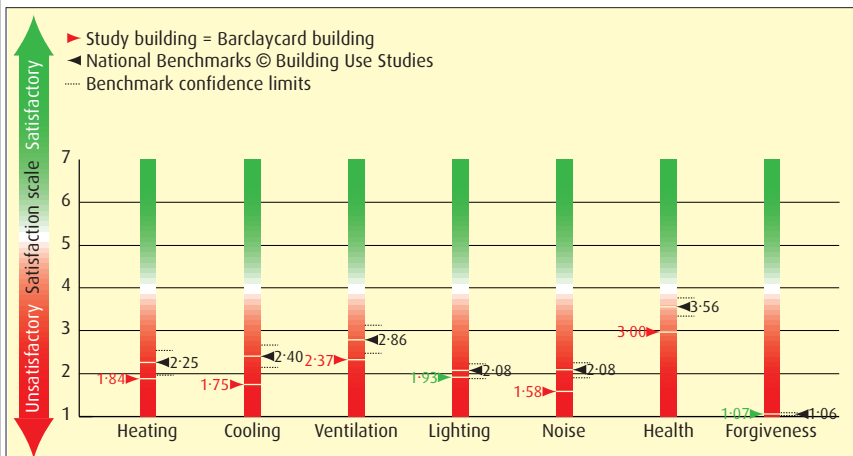
Scores for perceived control are all significantly lower than the benchmark figures, which themselves are well below the scale mid-point (figure 4, left). This is balanced by good scores for quickness of response, with that for cooling being significantly better than the benchmark.

Figure 4: Overall satisfaction with health and perceived control over the environment.

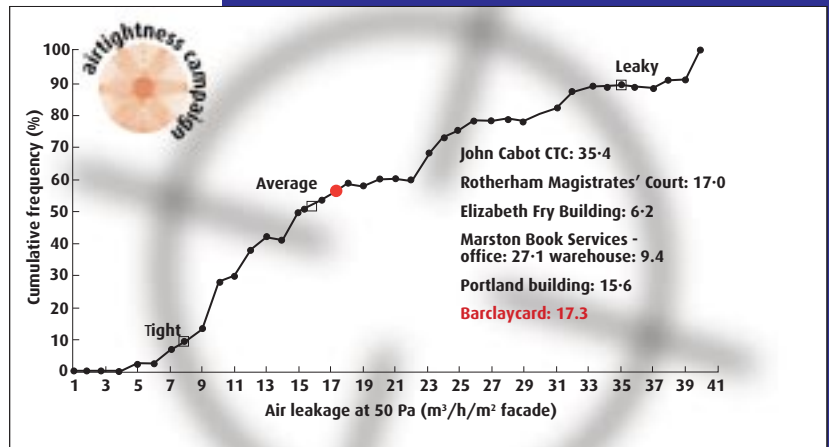
FIGURE 5: The air leakage data for the Barclaycard head office, plotted on the BRE/BSRIA database. The cumulative distribution represents a sample of three building types: those designed to be airtight, buildings designed without airtightness as a design criteria, and some older buildings.

The results of the test gave an air leakage index for the building of 17.8 m³/h/m² at a pressure differential of 50 Pa. As plotted on the BRE/BSRIA database, the building is classified as just above the average benchmark value (figure 5, above).
