PROBE 9

benchmarks for
better
buildings

BY BILL BORDASS, ROBERT COHEN AND MARK STANDEVEN

THE NON-OFFICE BUILDINGS

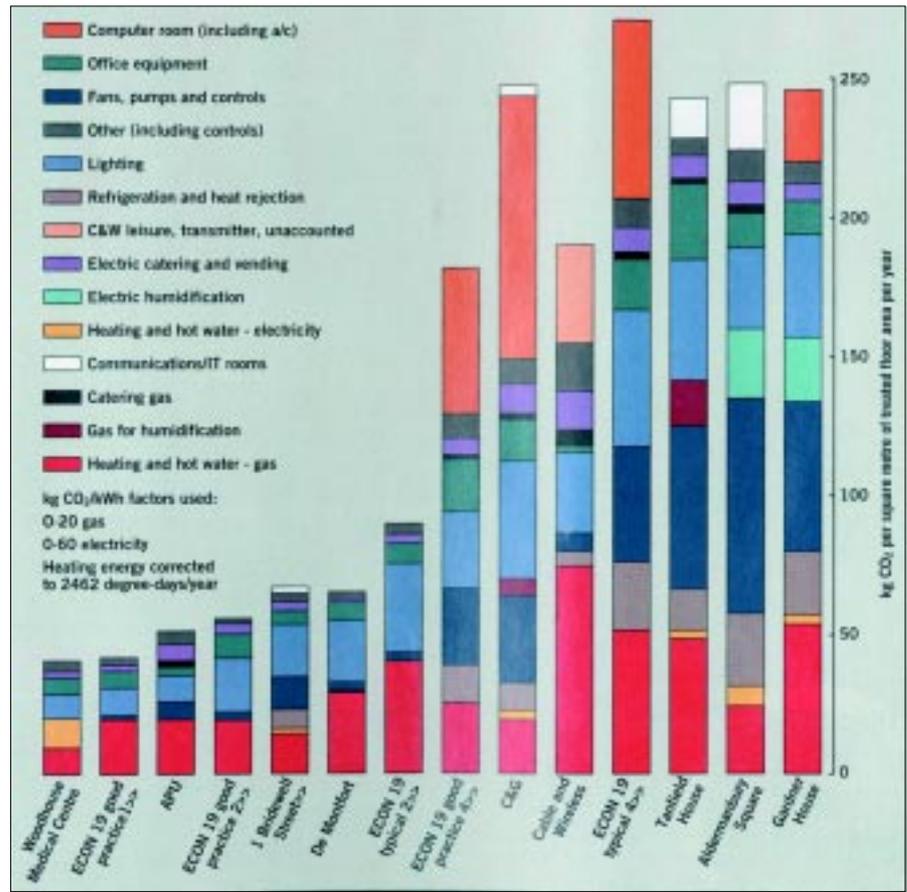
FIGURE 1: Annual CO₂ emissions for the PROBE buildings measured against ECON 19 benchmarks.

Figure 1 shows annual CO₂ emissions for all the buildings, using conversion factors of 0.20 kg/kWh for gas, and 0.60 for electricity. The data is bracketed between *ECON 19* "good practice" and "typical", and includes one of the best air conditioned offices surveyed under the EEO's Best Practice programme: 1 Bridewell Street. The electricity factor represents a typical level for the years in which the consumption data was collected – the current industry value is lower.

C&G is near the good practice level, while the others are just above typical. Energy consumption at Gardner House is anomalously high (by at least 20%) due to the extended plant run times, necessary until airtightness problems are sorted out. Gas/electricity consumption is currently 20% higher.

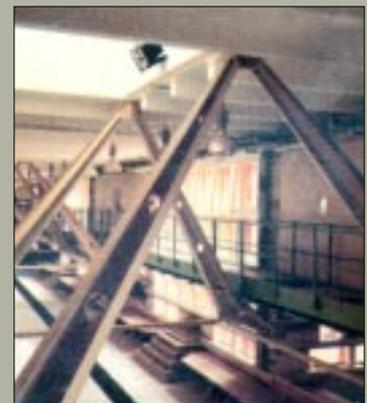
At Tanfield House the heat is rejected into office exhaust air handling units (ahus), avoiding the need for separate condenser units. However, the resultant coupling between office ventilation and heat rejection has led to problems with the full fresh air system, such as the need to operate the office exhaust fans whenever heat needs rejecting, for example outside normal occupancy hours.

Increased pressure drops and higher exhaust fan energy consumption has also resulted. Averaged over annual operating hours only about 7% of the design cooling load is being rejected whereas the coil resistance exists for 100% of the time.

Heat recovery means constant system pressure drops at Tanfield House.
