RENOLD

Troubleshooter

INTRODUCTION

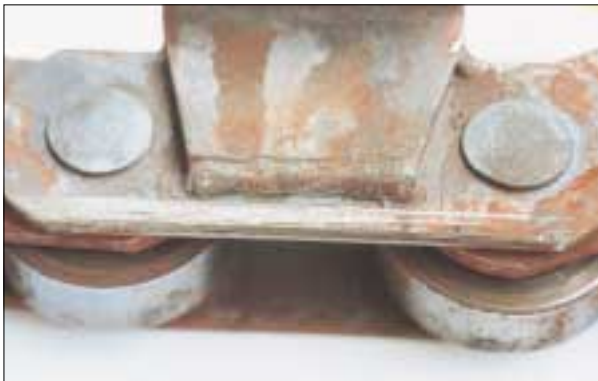
Figure 1

FIGURE 1 MODE OF FAILURE - ABRASION

APPLICATION	134,000 N breaking load chain operating on a slat conveyor with slats bolted across the K attachments.
FAILURE MODE	Side plates showed severe rubbing marks along one edge.
DIAGNOSIS	The side plate edges have been rubbing against some fixed point on the conveyor structure, probably the edge of the guide tracks. The effect of this would be to wear away the side plate and to increase the drive power and chain tension.
SOLUTION	Determine the point of contact and realign the chain to prevent rubbing. It may be necessary to check and adjust the track to ensure levels are correct across the two strands.

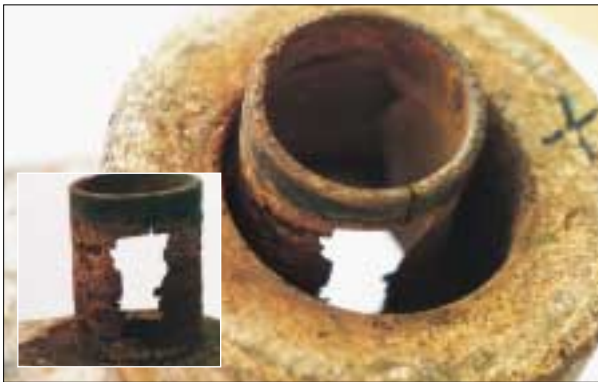
Figure 2

FIGURE 2 MODE OF FAILURE - ABRASION

APPLICATION	Conveyor chain used in handling wet china clay.
FAILURE MODE	Severe wear between the chain bush and roller in a china clay extraction plant.
DIAGNOSIS	Abrasive residues (Quartz) in the clay from the original granite material causing wear to the surfaces.
SOLUTION	Specify Renold Chain with extra hard surface materials to be included in the manufacture of chain round parts.

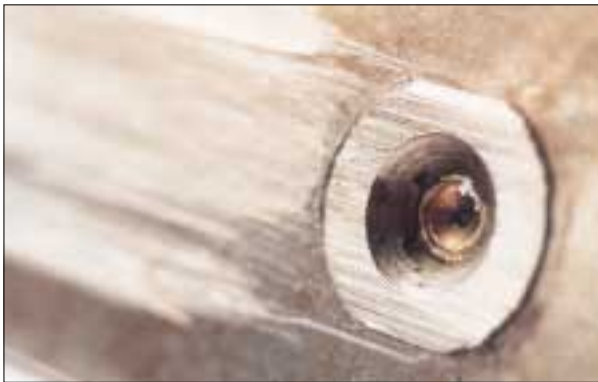
Figure 3

FIGURE 3 MODE OF FAILURE - ALIGNMENT

APPLICATION	Can steriliser chain.
FAILURE MODE	Wear to the pin ends has removed the rivet security and the outer plate has become detached.
DIAGNOSIS	Differential wear to the chains has caused the vertical strands to move to the side and contact the guides. The guides are of similar hardness to the pin ends and the pin ends have worn away releasing the outer side plate.
SOLUTION	Fit side guides that are softer than the pin ends. Also consider fitting a rubbing block at intervals along the chain to protect the pin end.

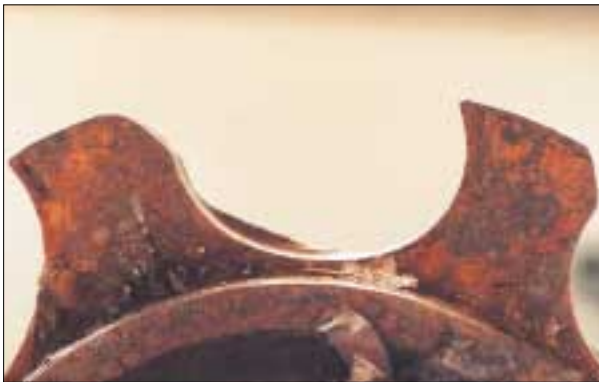
Figure 4

FIGURE 4 MODE OF FAILURE - ALIGNMENT

APPLICATION	Cast iron sprockets fitted to chain scraper conveyors used for cleaning the primary screens at a sewage treatment plant.
FAILURE MODE	Sprocket teeth suffered severe wear over a six month period and several teeth were so weakened that they fractured across the thinnest section.
DIAGNOSIS	The teeth were machined to a thinner section to accommodate flanged rollers on the chain and the chain was allowed to run out of line which resulted in only part contact on the sprockets. The resulting high pressure caused the rapid wear shown on the photograph.
SOLUTION	Replace the sprockets and realign the chain to ensure full contact between the chain roller and the sprocket teeth.

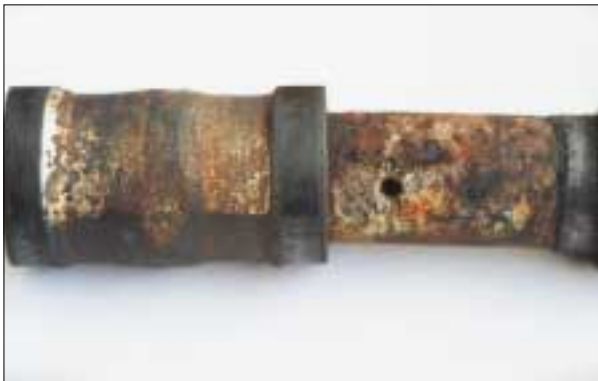
Figure 5

FIGURE 5 MODE OF FAILURE - CORROSION / EROSION

APPLICATION	Heavy duty chain used on a slat conveyor carrying cut sugar cane into a sugar factory.
FAILURE MODE	Severe corrosion and wear of pin and bush surfaces.
DIAGNOSIS	Chain pin and bush were supplied drilled for grease gun lubrication. No lubrication has been applied and the surfaces have been subjected to unprotected corrosion / erosion by acidic sugar juice and sand contamination.
SOLUTION	Replace the chain and ensure that the grease gun lubrication feature is regularly used.

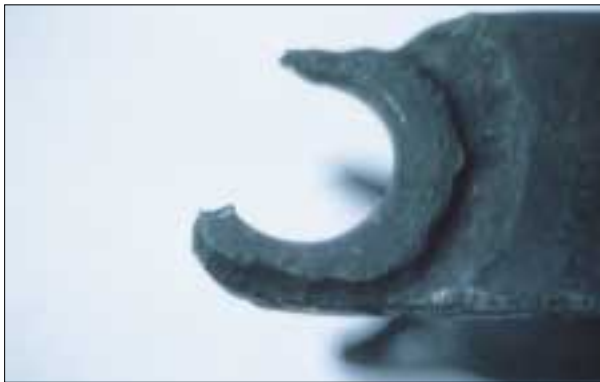
Figure 6

FIGURE 6 MODE OF FAILURE - CORROSION / EROSION

APPLICATION	Threading chain for passing finished steel strip through the final washing and finishing process.
FAILURE MODE	Severe erosion of material from areas of the chain leading to weakening and tensile failure.
DIAGNOSIS	Sequence of environments between caustic, water and air at high pressure caused erosion / corrosion of the side plates which reduced the section side plates leading to tensile failure.
SOLUTION	Protection of the chain by either zinc plating or shielding to prevent the erosion.

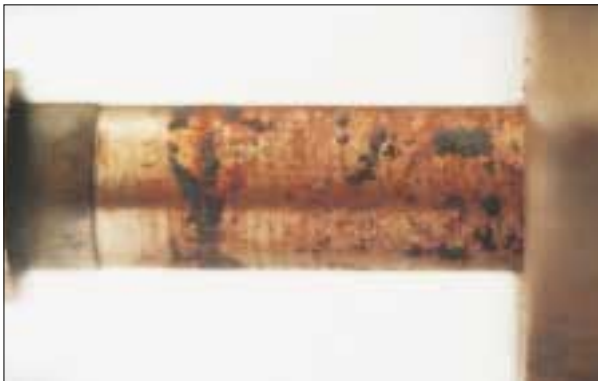
Figure 7

FIGURE 7 MODE OF FAILURE - FRETTING

APPLICATION	Tilt tray sorter chain used in baggage handling in the baggage hall of a major airport.
FAILURE MODE	Chain pins and bi-planar block show scoring and heavy red deposit indicating fretting corrosion.
DIAGNOSIS	Fretting corrosion caused by marginal lubrication, where the lubricant present is insufficient to prevent the asperities on each component rubbing together.
SOLUTION	Every pin should be removed and all traces of abrasive red oxide removed. The chain should then be operated in an improved lubrication regime.

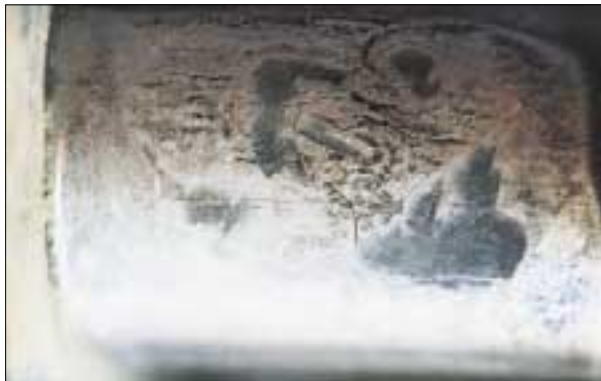
Figure 8

FIGURE 8 MODE OF FAILURE - IMPACT & ALIGNMENT

APPLICATION	Gravity bucket conveyor handling hot cement in a cement works.
FAILURE MODE	Heavy surface cracking on the surface of the bushes and abrasion of the inner faces of the side plates.
DIAGNOSIS	This problem appears to be caused by heavy impact on the bushes. The abrasion on the side plates suggests that the chain is riding up onto the top of the sprocket teeth and then dropping into engagement.
SOLUTION	Initially the alignment between the chain and the sprockets should be checked. If this is correct then the remaining alignments should be checked, i.e. sprocket centres, levels, chain centres, etc.

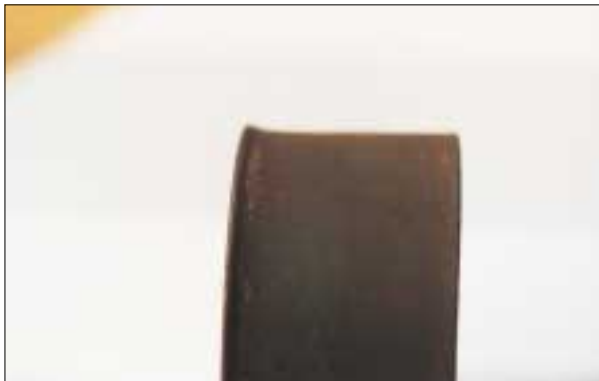
Figure 9

FIGURE 9 MODE OF FAILURE - MISALIGNMENT

APPLICATION	Conveyor chain roller profile after use on a twin strand slat conveyor.
FAILURE MODE	Eccentric wear across the face of the roller has caused a lip on one side.
DIAGNOSIS	The chain has run to one side to the degree where the roller edge has been over the edge of the chain track. The effect of this type of situation is to increase the roller face wear rate by only using part of the face width to carry the loads.
SOLUTION	Re-align the chain to run correctly on the chain tracks. In the failure shown the chain could be re-used with the lip ground off, providing the roller is a sintered through hardened type. Otherwise the chain should be replaced.

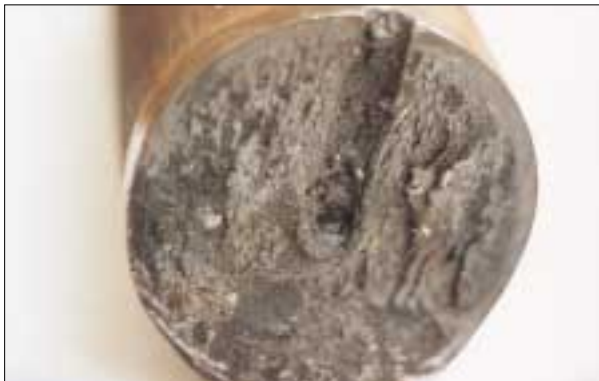
Figure 10

FIGURE 10 MODE OF FAILURE - MISALIGNMENT

APPLICATION	Heavy duty gravity bucket conveyor chain operating in a cement works.
FAILURE MODE	The extended bearing pin has failed across the hole which was drilled to allow lubricant into the outboard roller.
DIAGNOSIS	The chain has moved sideways until one of the rollers has fouled the conveyor structure causing the extended pin to fail. The cross section is interesting in that the fine grained hardened case and the coarse grained ductile core can clearly be seen.
SOLUTION	The circuit of the conveyor should be checked to find the contact point. The conveyor should be checked to find and correct the reason for the movement to the side.

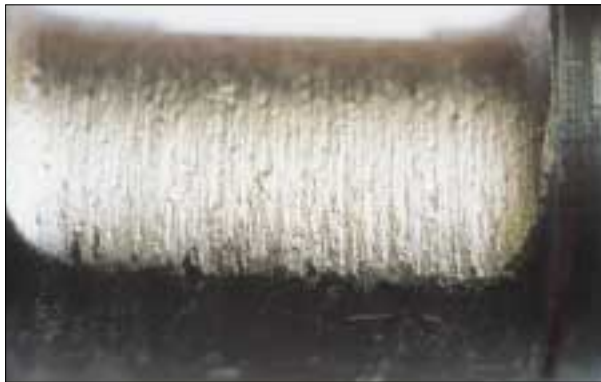
Figure 12

FIGURE 12 MODE OF FAILURE - OVERHEATING

APPLICATION	Stainless steel chain renewed in an oven operating at a high temperature.
FAILURE MODE	The replacement chain wore severely after a short time resulting in the removal for examination.
DIAGNOSIS	At the same time as replacing the chain, heat trap doors had been fitted which saved heat loss but increased the oven temperature to a level above the acceptable working value for the chain.
SOLUTION	Return to the previous method of working or accept a much reduced chain life. Heat resisting steels are a possibility.

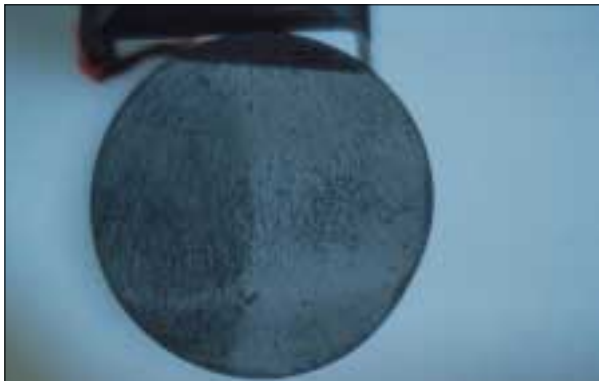
Figure 13

FIGURE 13 MODE OF FAILURE - OVERLOAD

APPLICATION	Extended pin fitted to chain to carry an outboard roller.
FAILURE MODE	Sudden shock overload has caused the pin to fail.
DIAGNOSIS	The extended pin has failed due to overload or shock loading. The failure has initiated at the corner of the flat on the pin. The "river markings" flowing away from the crack initial point can be clearly seen.
SOLUTION	Determine the reason for the shock / overload and either remove the cause or redesign the pin to carry the load.

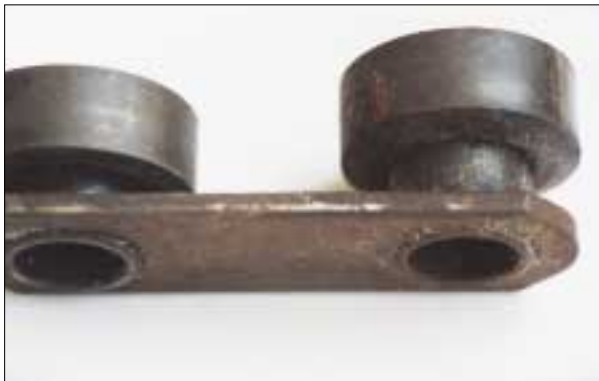
Figure 14

FIGURE 14 MODE OF FAILURE - ROLLER SEIZURE

APPLICATION	Chain used in an oven conveying system.
FAILURE MODE	Rollers seized on bushes producing flats on roller outside diameters.
DIAGNOSIS	The grease lubrication used on the chain was not suitable for the oven temperature and during operation the grease 'carbonised' causing seizure of the rollers.
SOLUTION	Apply a light flushing oil to the chain to clean out the residue of carbon. If this is not successful then the chain must be replaced and lubricated with an oil compatible with the oven operating temperature.

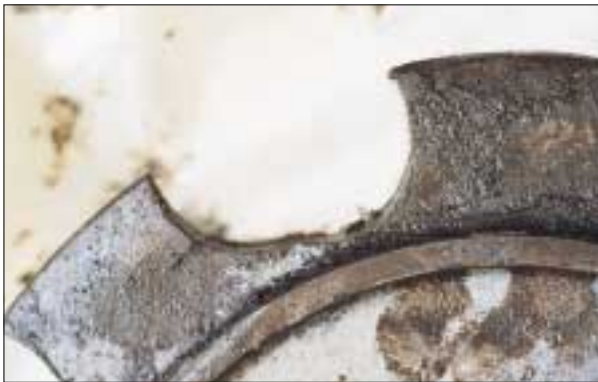
Figure 15

FIGURE 15 MODE OF FAILURE - SPROCKET TOOTH WEAR

APPLICATION	Sprockets fitted at the end of a conveyor.
FAILURE MODE	Severe hooking wear of the sprocket teeth has been compounded with a second phase of hooked wear.
DIAGNOSIS	The original chain and sprockets have followed normal wear patterns with hooked wear of the sprocket teeth and pitch elongation of the chain. A new chain has then been fitted to the old wheels which have a worn tooth form incompatible with the pitch of the new chain. The result is severe secondary wear of the sprocket teeth and probably very rapid chain pitch extension.
SOLUTION	Always check the condition of the existing sprocket teeth before fitting a new chain to any system. In this case the sprockets must be renewed and the chain checked for damage.

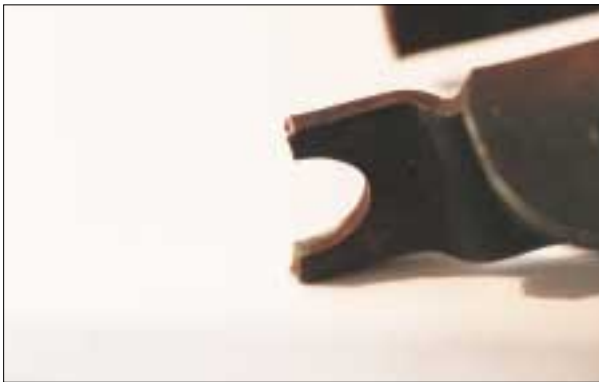
Figure 16

FIGURE 16 MODE OF FAILURE - TENSILE OVERLOAD

APPLICATION	Bottle washer chain used for washing returned milk bottles in a caustic environment.
FAILURE MODE	The chain cranked link has failed in tensile mode.
DIAGNOSIS	The outer link has been crudely modified which was thinner than the normal inner link.
SOLUTION	Obtain a properly designed cranked link from Renold.

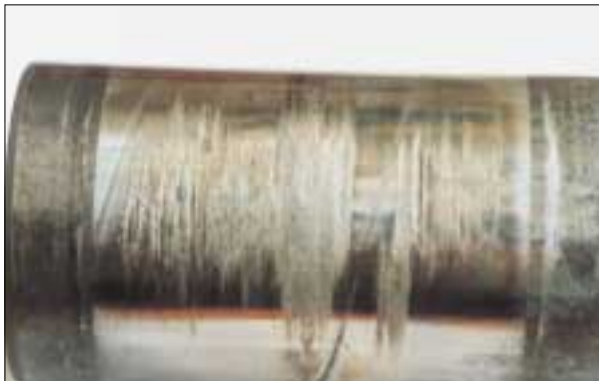
Figure 17

FIGURE 17 MODE OF FAILURE - GALLING

APPLICATION	Hollow pin (step pin) used in a high rise escalator.
FAILURE MODE	The pin pressure faces have suffered from severe galling where the surfaces have articulated and fused together.
DIAGNOSIS	The very high pressures experienced by these high rise escalators have led to squeeze-out and failure of the lubricant allowing the surfaces to touch and gall when the chain articulated.
SOLUTION	Use high quality, high pressure lubricants and ensure that the lubricant regime is such that the film of lubricant is constantly maintained between the surfaces.

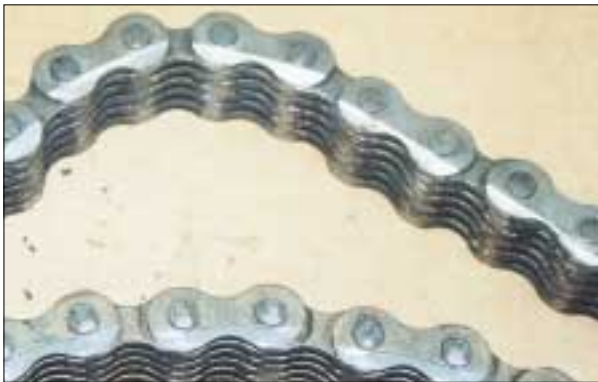
Figure 18A

FIGURE 18A MODE OF FAILURE - ALIGNMENT

APPLICATION	1" P 5 x 6 leaf chain used in a counterbalance mechanism for the drivers cab in an overhead crane.
FAILURE MODE	Excessive judder noticed by the crane driver.
DIAGNOSIS	Inspection of the counterbalance arrangement showed that the pulley had worn excessively on one side. This was reflected on one side of the chain. The pulley was found to be out of line with the line of action of the chain attachment points.
SOLUTION	Renew chain and pulley and realign.

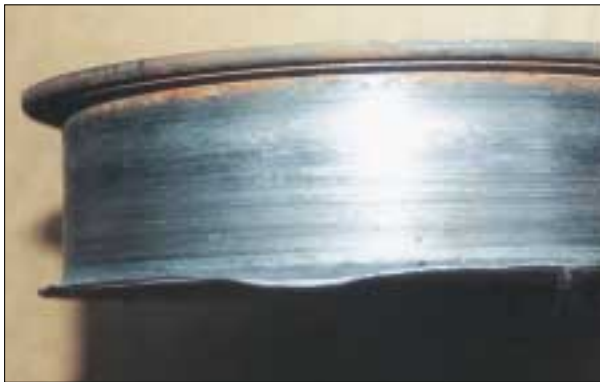
Figure 18B

FIGURE 18B MODE OF FAILURE - ALIGNMENT

APPLICATION	1" P 5 x 6 leaf chain used in a counterbalance mechanism for the drivers cab in an overhead crane.
FAILURE MODE	Excessive judder noticed by the crane driver.
DIAGNOSIS	Inspection of the counterbalance arrangement showed that the pulley had worn excessively on one side. This was reflected on one side of the chain. The pulley was found to be out of line with the line of action of the chain attachment points.
SOLUTION	Renew chain and pulley and realign.

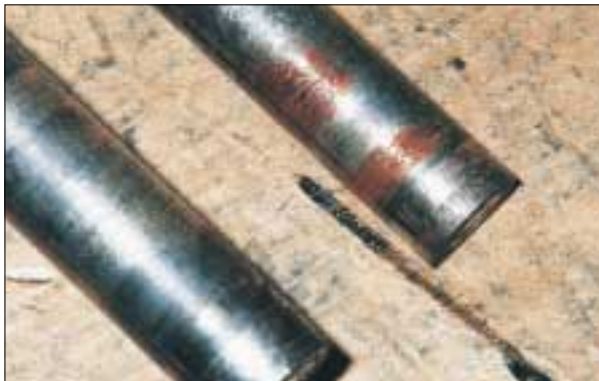
Figure 19

FIGURE 19 MODE OF FAILURE - GALLING & FRETTING CORROSION

APPLICATION	Chain used for a lifting application.
FAILURE MODE	Galling and fretting corrosion.
DIAGNOSIS	The chain being under constant loading at high bearing pressure has resulted in the lubricant being squeezed out between the pin and bush bore. This created a metal to metal contact resulting in a slight galling of the surfaces and the oxidization of the microscopic particles, giving the red oxide deposit. A typical example of fretting corrosion.
SOLUTION	More frequent lubrication schedule to be introduced.

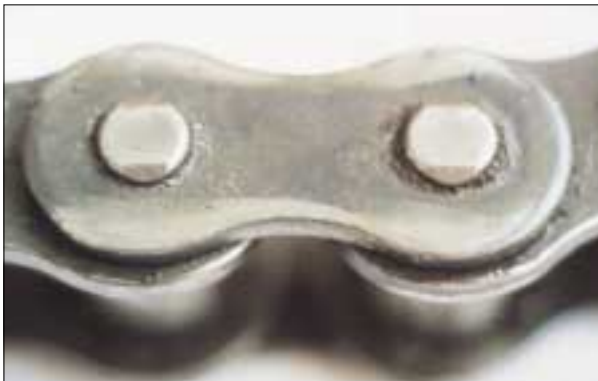
Figure 20

FIGURE 20 MODE OF FAILURE - ABRASION

APPLICATION	Simple transmission chain drive.
FAILURE MODE	Rubbing wear on the face of the side plates, the end of the side plates and the pin end.
DIAGNOSIS	The chain has been rubbing against some fixed point on the circuit. From the wear pattern it seems likely that the chain has worn a groove in the fixture, probably initiated by the harder pin ends.
SOLUTION	Realign the chain drive before the damage to the chain becomes too serious and the chain has to be scrapped.

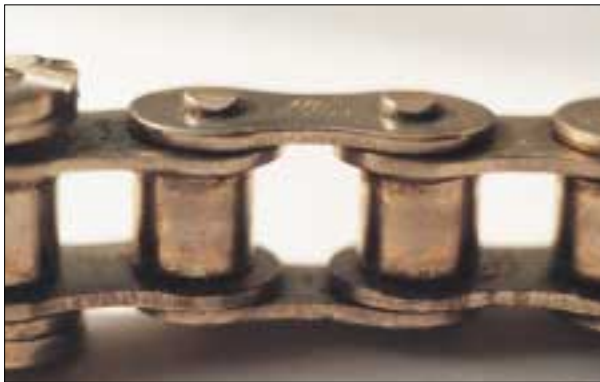
Figure 21

FIGURE 21 MODE OF FAILURE - ABRASION

APPLICATION	Stainless steel transmission chain used to remove produce from the cooking oil in an automatic fryer.
FAILURE MODE	The chain suffered rapid pin/bush wear and pitch extension.
DIAGNOSIS	When the oil at the delivery end of the fryer was examined, it was found to contain product residue that had been degraded to form very hard burnt particles, that were abrading the chain round parts.
SOLUTION	Fit replacement chain and introduce a filtration system to the cooking oil to remove the abrasive residue.

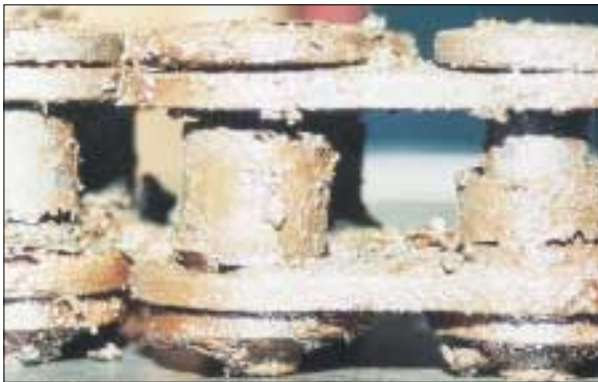
Figure 22A - Before Cleaning

FIGURE 22A MODE OF FAILURE - CORROSION	
APPLICATION	1 3/4" ANSI simple detachable chain used on a table roll drive in a steel mill.
FAILURE MODE	Heavy corrosion and erosion of all parts.
DIAGNOSIS	Bush and rollers have corroded / worn to a wafer thin condition with corresponding wear on the pins. Plates have a great deal of side wear and are heavily pitted. This chain has been used in an extremely hostile environment subject to high temperatures and water spray.
SOLUTION	Improve lubrication methods. Replace chain more frequently.

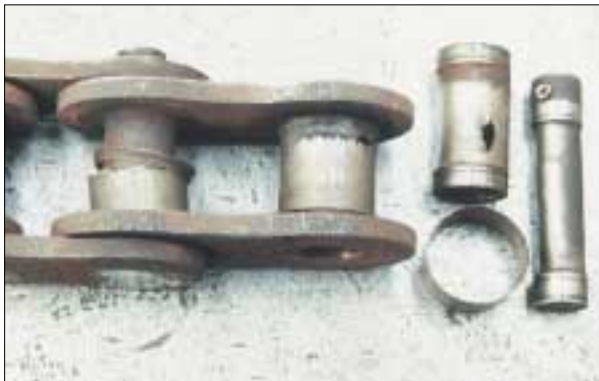
Figure 22B - After Cleaning

FIGURE 22B MODE OF FAILURE - CORROSION

APPLICATION	1 3/4" ANSI simple detachable chain used on a table roll drive in a steel mill.
FAILURE MODE	Heavy corrosion and erosion of all parts.
DIAGNOSIS	Bush and rollers have corroded / worn to a wafer thin condition with corresponding wear on the pins. Plates have a great deal of side wear and are heavily pitted. This chain has been used in an extremely hostile environment subject to high temperatures and water spray.
SOLUTION	Improve lubrication methods. Replace chain more frequently.

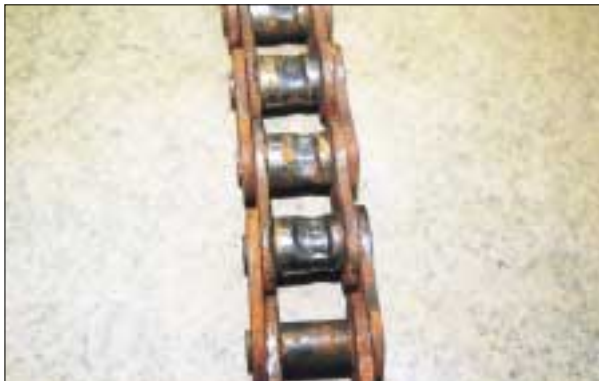
Figure 23

FIGURE 23 MODE OF FAILURE - CORROSION	
APPLICATION	Chain drive used on a barrelling machine.
FAILURE MODE	Corrosion.
DIAGNOSIS	This chain has been used in an environment with water contamination. The chain has not been regularly lubricated and external parts have gradually corroded until the rollers seized. The chain has then proceeded to wear heavily on the rollers.
SOLUTION	Protect from water if possible. Increase degree of maintenance lubrication.

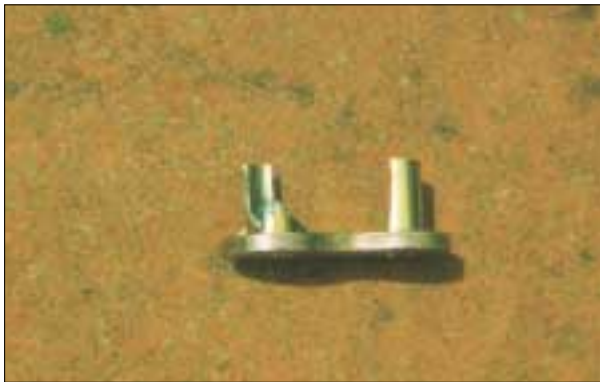
Figure 24

FIGURE 24 MODE OF FAILURE - FRACTURE

APPLICATION	1.25" P BS zinc plated chain used in a water environment.
FAILURE MODE	Bushes fractured on assembly
DIAGNOSIS	Customer supplied zinc plated bushes for assembly. When assembled the bushes broke into several fragments due to hydrogen embrittlement as they had not been de-embrittled after plating.
SOLUTION	Ensure correct de-embrittlement treatment is carried out immediately after plating.

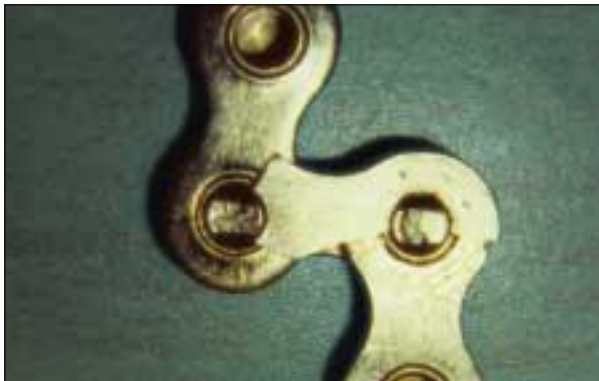
Figure 25

FIGURE 25 MODE OF FAILURE - FRACTURE

APPLICATION	1.0" P BS chain.
FAILURE MODE	Plates fractured when chain working load was applied.
DIAGNOSIS	Chain had been zinc plated by customer without carrying out any de-embrittlement treatment which resulted in chain failure due to hydrogen embrittlement.
SOLUTION	Chain should be initially zinc plated before assembly by Renold.

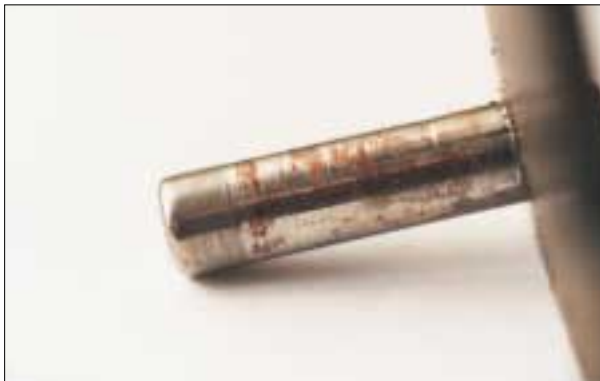
Figure 26

FIGURE 26 MODE OF FAILURE - FRETTING CORROSION

APPLICATION	Transmission chain with pushers at intervals to control the conveying of boxes of breakfast cereal.
FAILURE MODE	Severe wear of one pin of the pusher attachment and red deposit indicating fretting corrosion.
DIAGNOSIS	The pusher attachment was designed 50.8mm pitch to fit on a chain of 25.4mm pitch and operate on sprockets designed for 25.4mm pitch chains. This obviously caused very high pressure on one pin of the attachment link which squeezed out most of the lubricant. This resulted in the marginal lubrication situation required to produce fretting corrosion.
SOLUTION	<ol style="list-style-type: none"> 1. Use specially designed sprocket teeth with relieved tooth pocket at the attachment position. 2. Employ a high performance lubricant with solid residue to prevent squeeze-out.

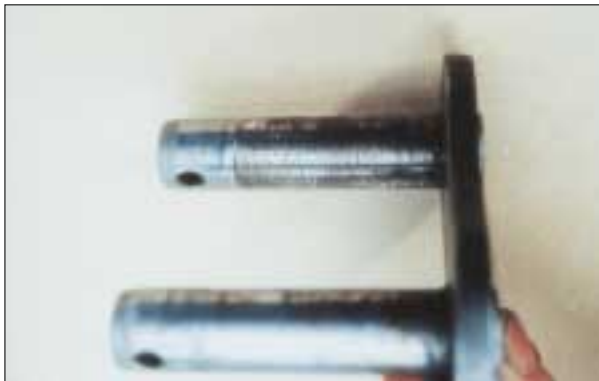
Figure 27

FIGURE 27 MODE OF FAILURE - GALLING

APPLICATION	2.5" P ANSI chain used on a lifting application.
FAILURE MODE	The bearing areas have suffered galling where the surfaces have articulated and then fused together.
DIAGNOSIS	Very high bearing pressures had been experienced in this lifting application. The effect being that the lubricant had failed and galling had occurred on articulation.
SOLUTION	Use a high quality, high pressure lubricant and ensure that a film of lubricant is maintained between mating surfaces.

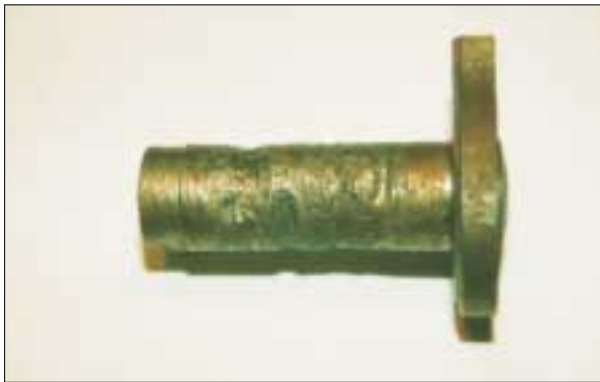
Figure 28

FIGURE 28 MODE OF FAILURE - GALLING

APPLICATION	3.5" P BS chain used on a marine diesel engine.
FAILURE MODE	Severe galling due to high bearing pressures and lack of lubrication between articulating surfaces resulting in surfaces fusing together.
DIAGNOSIS	Lubrication pump failure resulted in surfaces fusing together under high bearing pressure. This galling process is also referred to as 'micro welding'.
SOLUTION	Ensure adequate means of lubrication.

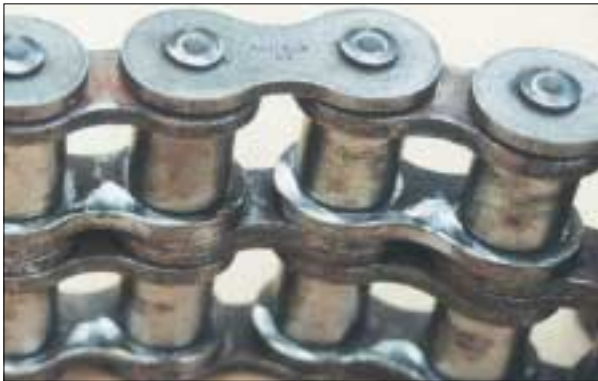
Figure 29A

FIGURE 29A MODE OF FAILURE - LUBRICATION & ALIGNMENT

APPLICATION	1" P BS duplex chain driving a flywheel on a 400 Tonne press.
FAILURE MODE	Excessive wear. Chain jumping teeth causing tooth rounding.
DIAGNOSIS	Examination of the chain showed no lubrication had been applied in the 6 months service life. The loads involved require a minimum of oil sump lubrication. In addition to this the centre distance was higher than recommended and the sprockets were out of line.
SOLUTION	Improve the lubrication method. Consider hardening the driver teeth. Correct the drive alignment.

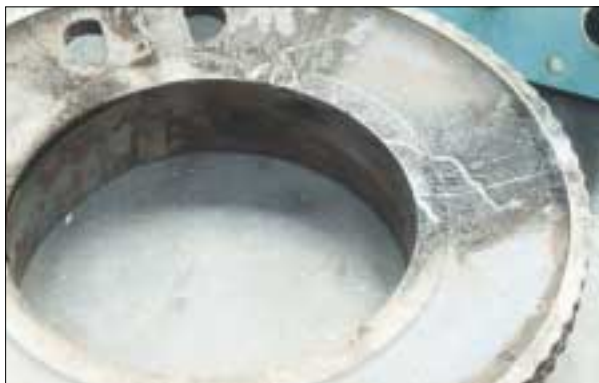
Figure 29B

FIGURE 29B MODE OF FAILURE - LUBRICATION & ALIGNMENT

APPLICATION	1" P BS duplex chain driving a flywheel on a 400 Tonne press.
FAILURE MODE	Excessive wear. Chain jumping teeth causing tooth rounding.
DIAGNOSIS	Examination of the chain showed no lubrication had been applied in the 6 months service life. The loads involved require a minimum of oil sump lubrication. In addition to this the centre distance was higher than recommended and the sprockets were out of line.
SOLUTION	Improve the lubrication method. Consider hardening the driver teeth. Correct the drive alignment.

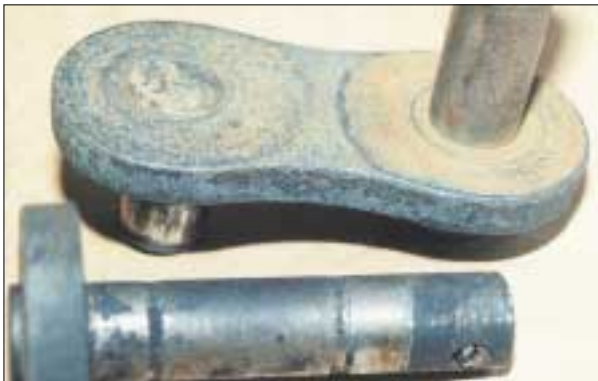
Figure 30

FIGURE 30 MODE OF FAILURE - LUBRICATION & INSTALLATION

APPLICATION	Special 2 1/2" P ANSI simple chain used for conveying in a mine.
FAILURE MODE	No 58 pin suffered a fatigue failure.
DIAGNOSIS	The joint was extremely dry and showed no signs of lubrication. The joint showed heavy galling with the presence of surface corrosion products. Subsequent investigation revealed that the chain had been running in water, but more significantly that the user had opened out the holes on the loose plate of the No 58 joint to make assembly easier. This caused the fatigue failure experienced.
SOLUTION	Provide a better lead in on the pin to enable the user to assemble more easily. Reconsider lubrication regime.

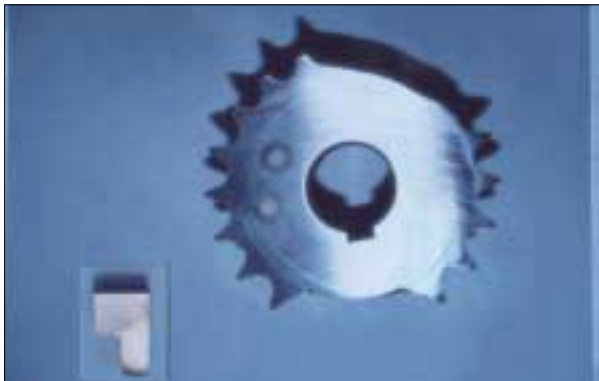
Figure 31

FIGURE 31 MODE OF FAILURE - MATERIAL CRACKING BELOW TEETH

APPLICATION	0.5" P BS 20 tooth sprocket.
FAILURE MODE	Material cracking below teeth.
DIAGNOSIS	Customer had flame hardened the teeth incorrectly. Due to the differential rate of cooling resulting from the sprocket section, cracking occurred.
SOLUTION	Sprockets to be supplied with teeth already flame hardened by Renold.

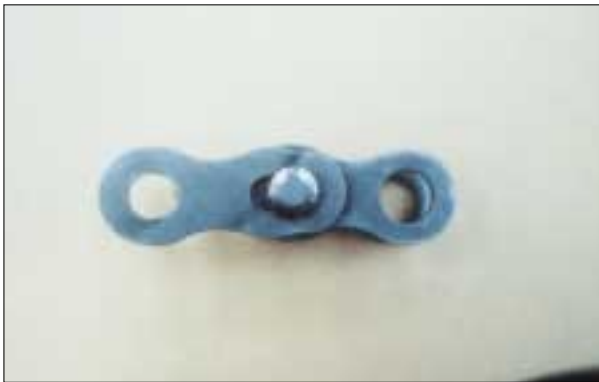
Figure 32

FIGURE 32 MODE OF FAILURE - OVERLOAD

APPLICATION	1.5" P BS chain test sample.
FAILURE MODE	Outer plates have been permanently stretched due to the high load.
DIAGNOSIS	Good example of overload.
SOLUTION	Correctly size the chain for the application.

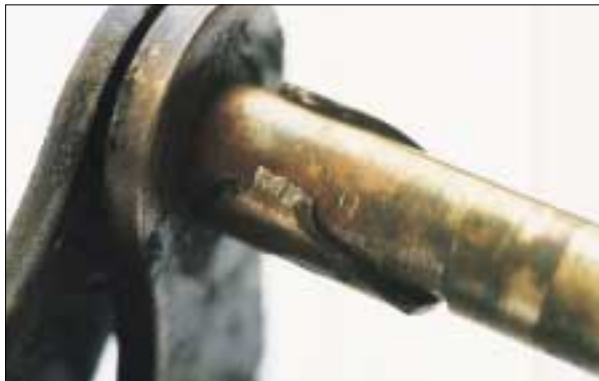
Figure 33

FIGURE 33 MODE OF FAILURE - OVERLOAD

APPLICATION	Duplex transmission chain used in severe overload situation.
FAILURE MODE	Severe damage to transmission chain pin and collapse of the chain bush.
DIAGNOSIS	Excessive overload on the chain led to the collapse of the bush and damage to the pin.
SOLUTION	Correctly size the chain for the application.

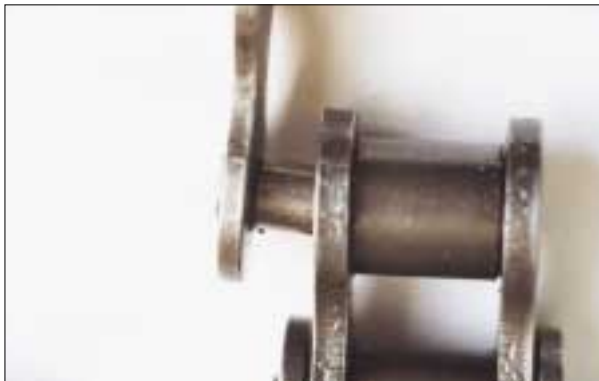
Figure 34

FIGURE 34 MODE OF FAILURE - RIVETING FAILURE

APPLICATION	Simple transmission chain drive to a machine.
FAILURE MODE	One outer link has become detached and the pin bent.
DIAGNOSIS	The loose side plate of a No 107 connecting link has become detached due to inadequate riveting on site. The pin has moved out and jammed in position allowing the chain to continue working until the failure was noticed.
SOLUTION	Replace the No 107 link and ensure that the pins are adequately riveted.

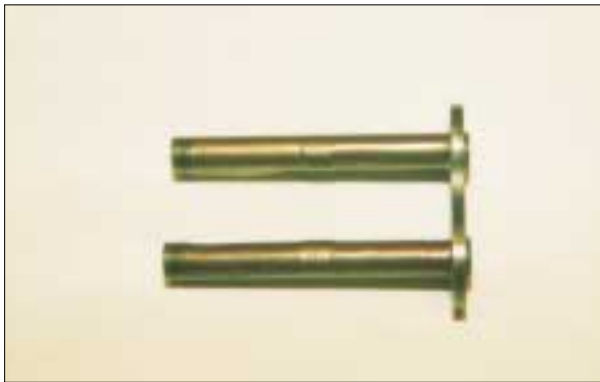
Figure 35

FIGURE 35 MODE OF FAILURE - WEAR

APPLICATION	1.5" P BS duplex chain.
FAILURE MODE	Pin bearing areas worn. Note position of intermediate plates is clearly visible.
DIAGNOSIS	Over a long period of time the pins have gradually worn until the chain elongation has reached 2%
SOLUTION	Monitor chain extension regularly.

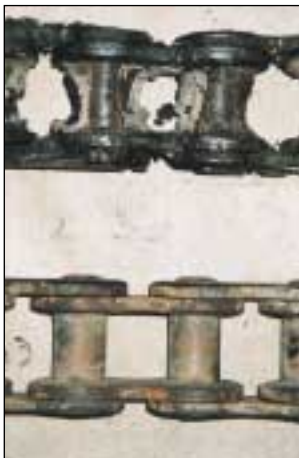
Despite working in a wet environment for over 60 years, the end of life inspection revealed this Renold chain to still be in good condition.

This can mainly be attributed to the maintenance schedule undertaken by the customer.
