RE: Mitchell Park Horticultural Conservatory
Structural Condition Study

MITCHELL PARK DOMES

INTRODUCTION

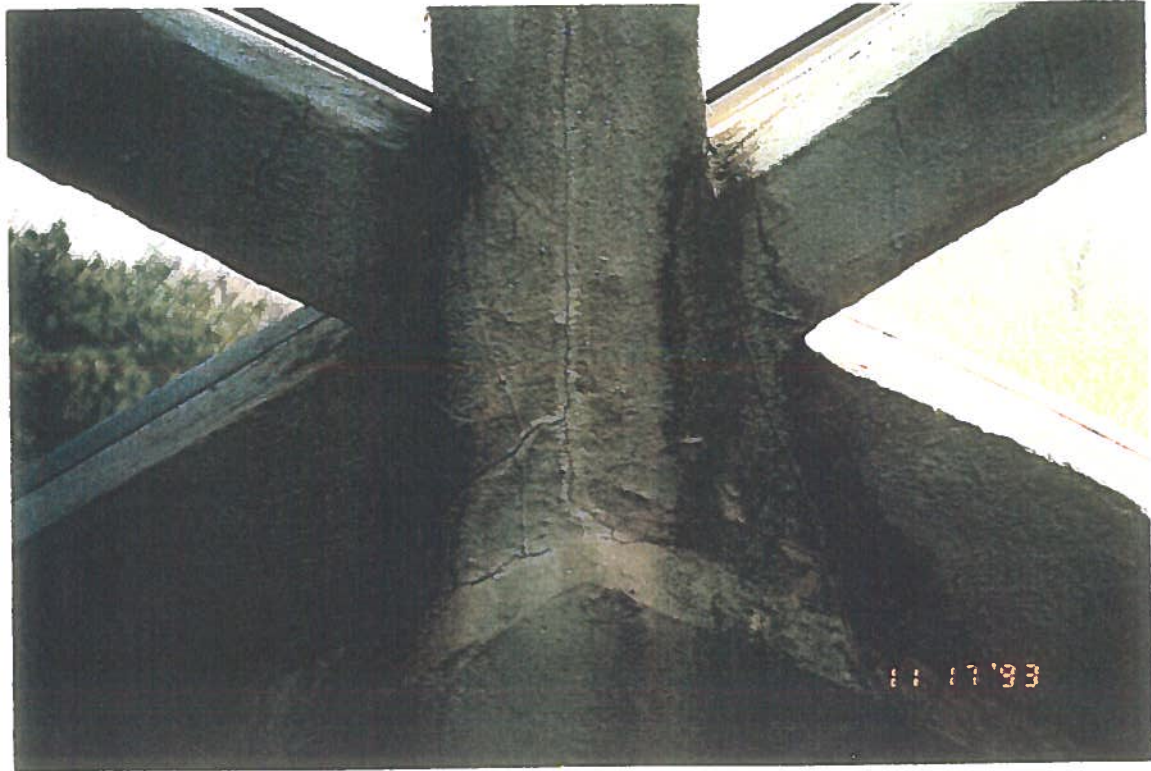
Photo No. 1
Arid Dome - East Face

A pattern of concrete cracks appear in each of the domes. These cracks appear typically where two separate precast pieces were connected during construction (Appendix A, Photo No. 1). There is also visible cracking between the concrete base and the precast frame members (Appendix A, Photo No. 2). The cracks, although unsightly, appear to be only superficial in nature. The cracks, however, give access points for moisture to come in contact with the steel reinforcing and connections. This may lead to deterioration of the concrete frame. To eliminate the cracks, the areas should be routed and caulked. The caulk should be troweled flat and must be compatible with the concrete and the paint.

Cracks and staining on concrete frame

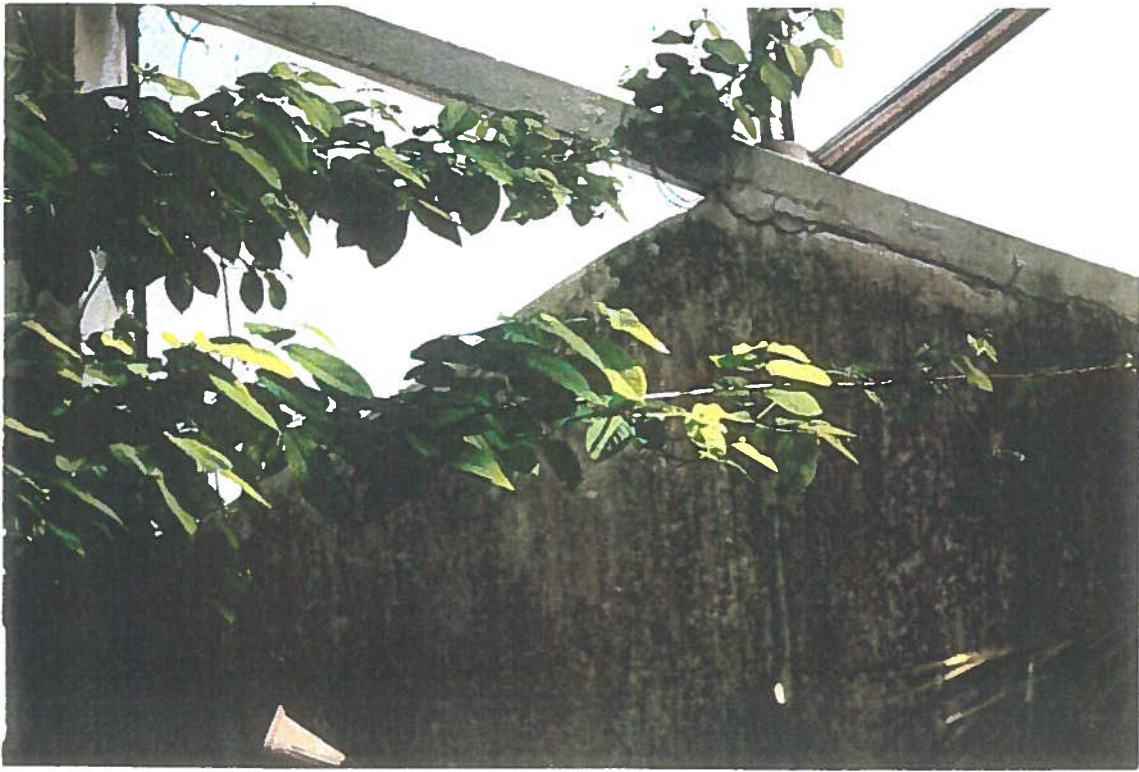
Photo No. 2
Tropical Dome - Above East Service Door

Cracking between concrete members.
Visible plant growth on paint.

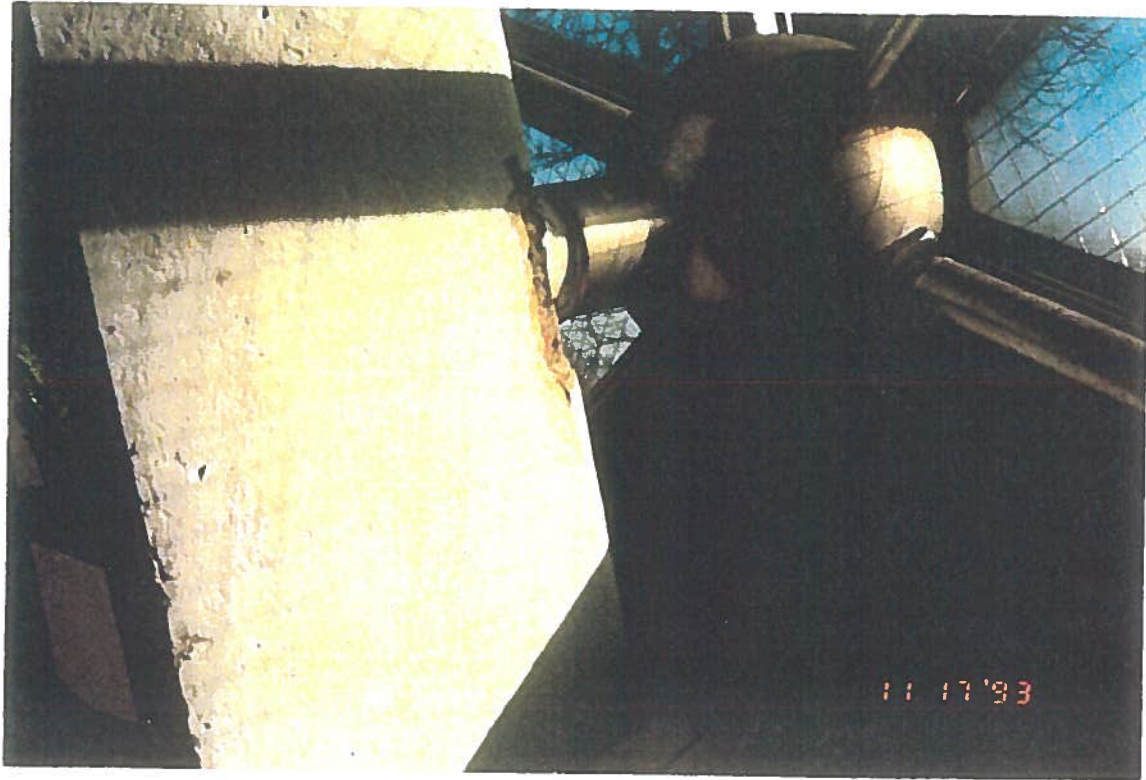
Photo No. 3
Arid Dome - East Face

There are an average of 12 small spalls per dome. A spall is a form of concrete deterioration, most often caused by corrosion of embedded steel. As the steel corrodes, the corrosion products take up more volume than the original steel, causing outward pressure against the concrete. This cracks the concrete between the steel and the surface, causing a spall. The spalls typically occur at the embedded plate for the attachment of the hub assembly to the concrete frame and are visible from the catwalk around the base of the domes (Appendix A, Photo Nos. 3 and 4).

Concrete spall which has exposed embedded steel plate.
Steel plate is rusting.

The exposed rusting steel at the spall locations should be, in general, cleaned to the base metal with a needle gun and then a power wire brush. The bare steel should then be touched up with two coats of corrosion resistant paint. The spalls are not typically visible to visitors, they need only be painted to match the surrounding concrete frame. Patching with grout is not necessary as the grout may shrink and crack or fall off causing further problems.

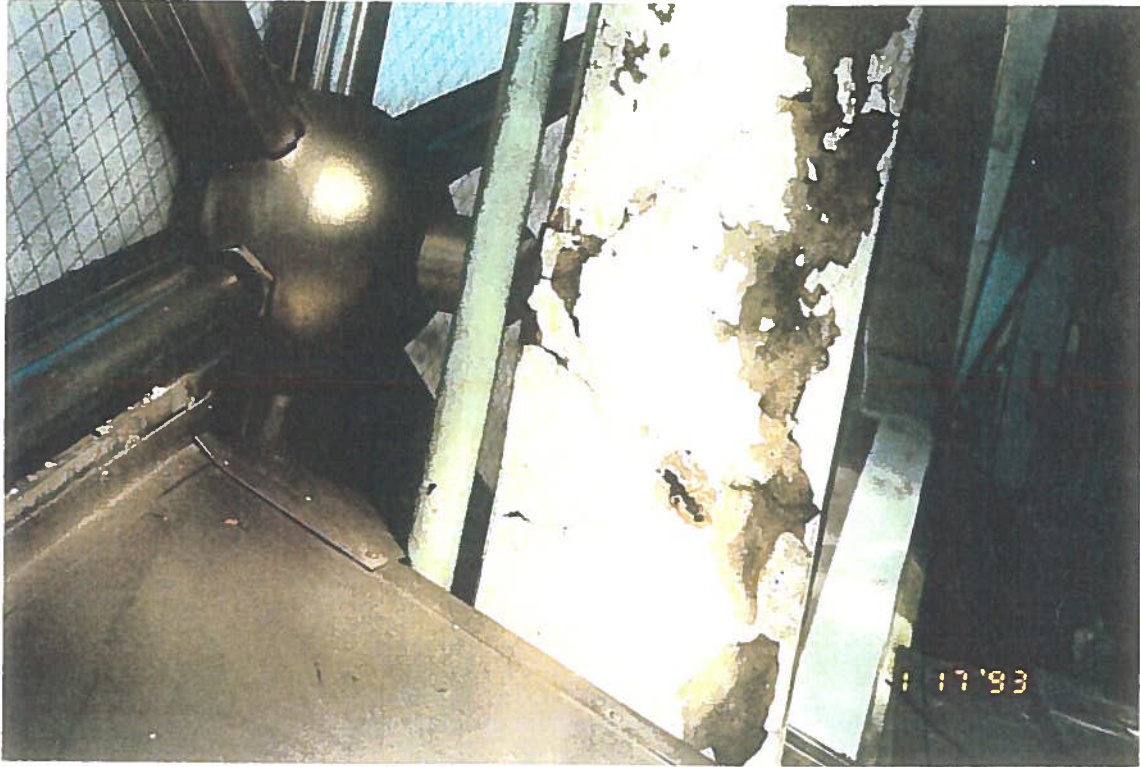
Photo No. 4
Tropical Dome - West Face

Peeling paint and exposed, corroding reinforcing steel

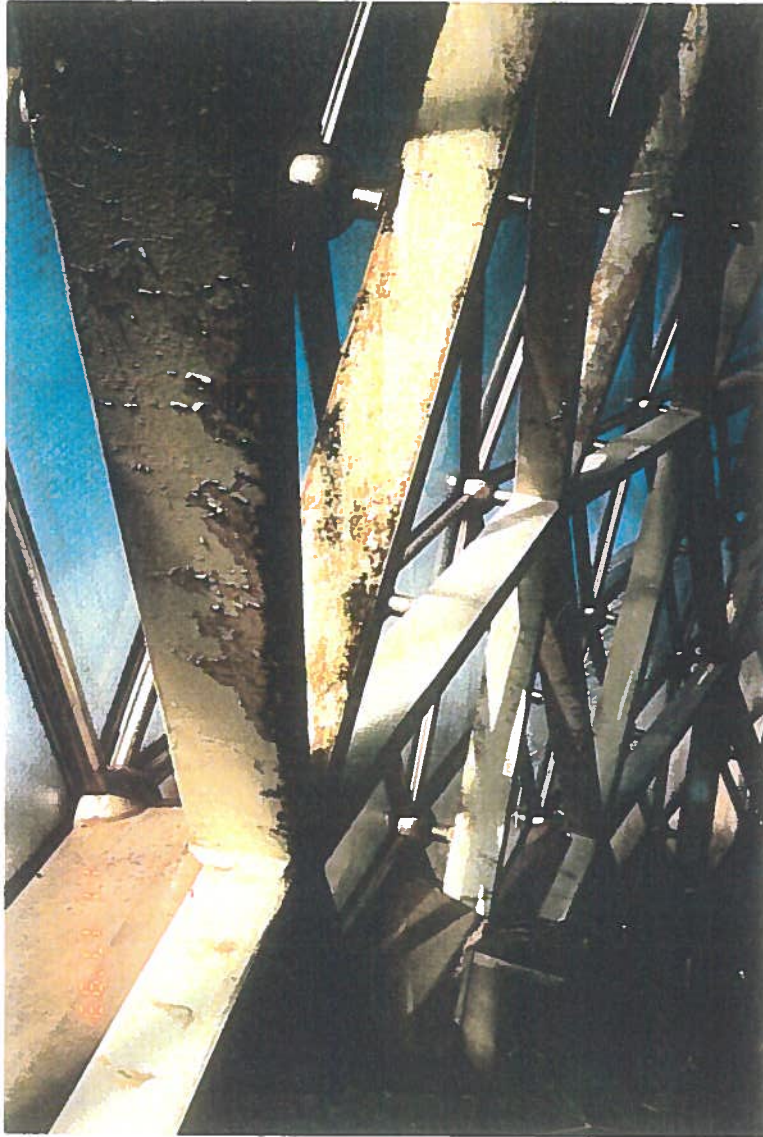
Photo No. 5
Tropical Dome - West Face
Peeling Paint and Plant Growth

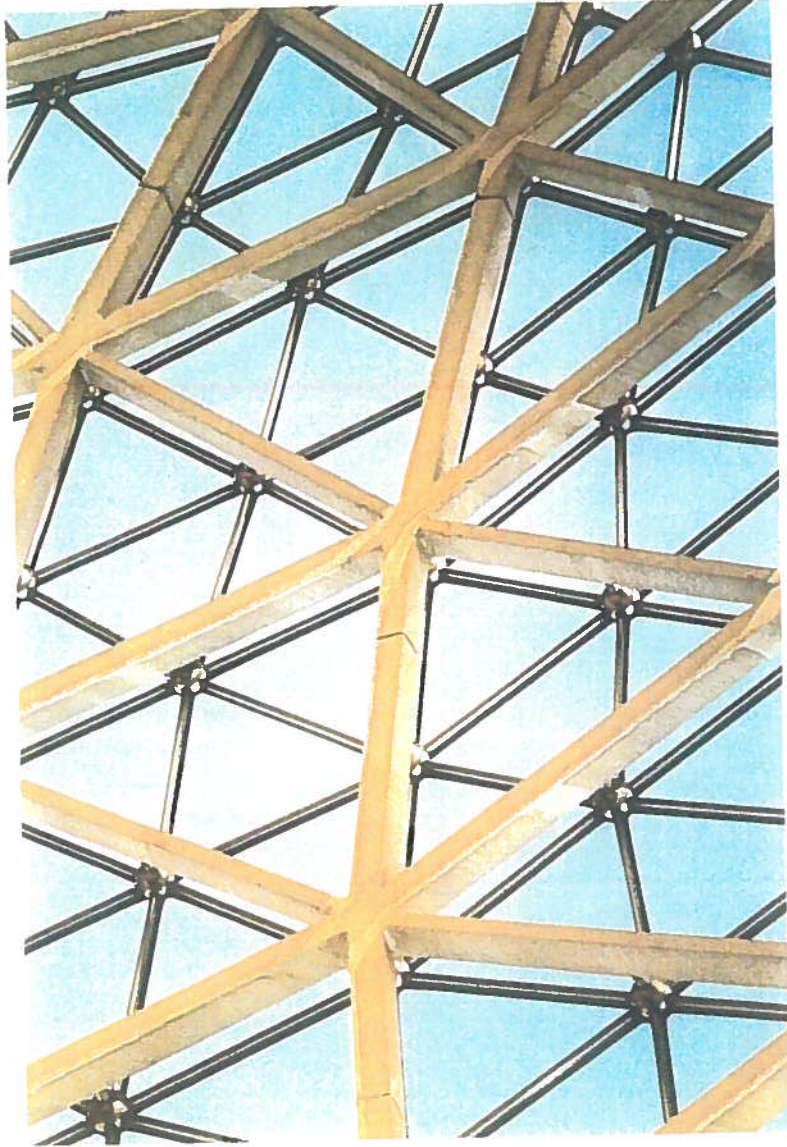
Photo No. 6
Arid Dome

Typical dirt/dust streaking on concrete frame.

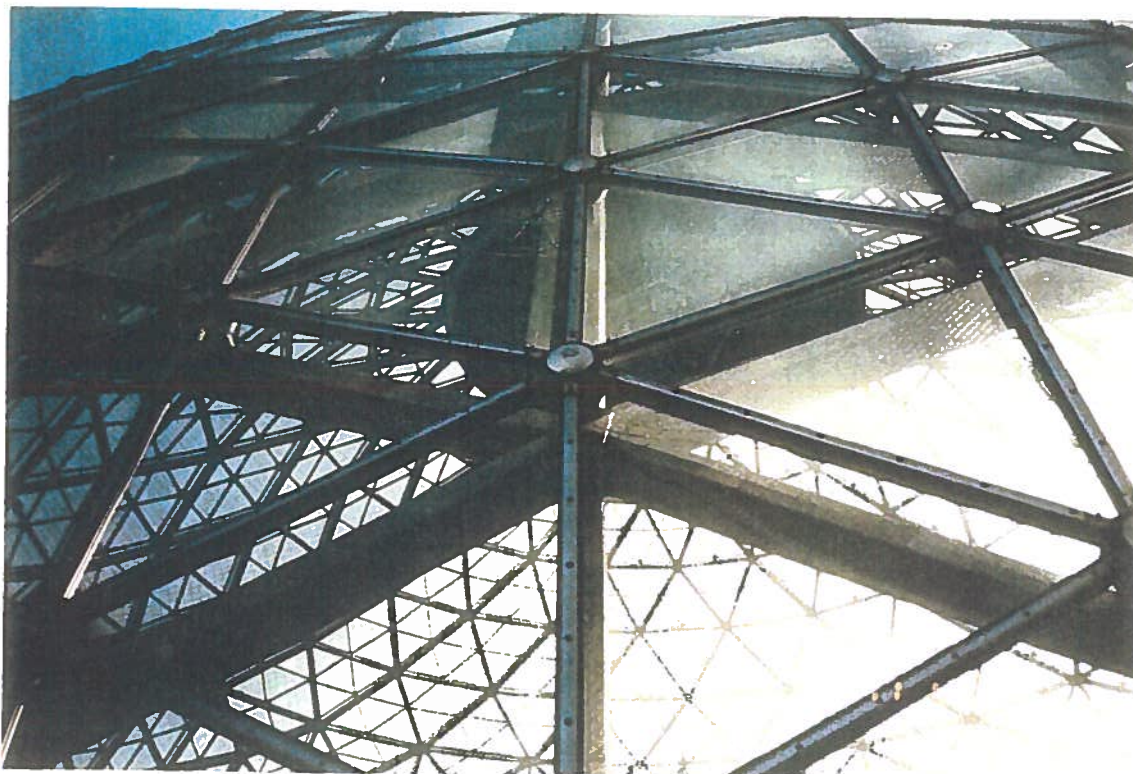
Photo No. 7
Arid Dome - North Face

The majority of glass breakage in the upper one-third of each dome is thought to be caused by the brittle nature of the 1/4-inch wire glass (Appendix A, Photo No. 7). Most of this type of breakage is believed to have occurred during the first few years of the Domes' existence. The breakage in the lower two-thirds is a combination of the brittle nature of the glass and vandalism. Some breakage may have been caused by the shifting of the aluminum frame. Some breakage may have been caused when a cart was used as a platform for the window washers to clean the exterior of the glass.

Typical Broken Glass

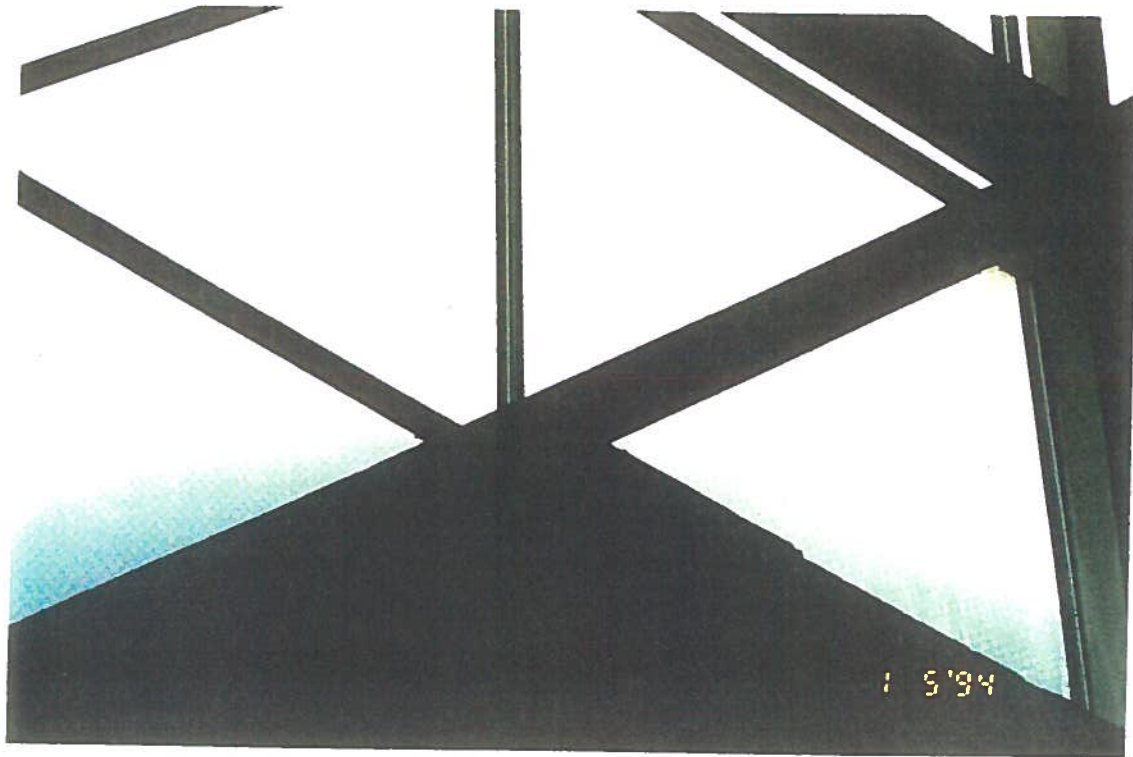
Photo No. 8
Arid Dome

Vandals have used stones, hammers, and guns to break the glass. In some cases, entire lites have been broken to gain access to the structure. This type of damage is typically seen on the east side of the domes which is not visible from the street and occurred when the domes were closed to the public. Some of the vandalism has resulted in large holes in the glass which could not be repaired (Appendix A, Photo No. 8). The holes, as well as some of the cracks, allow moisture to enter the domes. Conservatory Management feels that vandalism is a major security issue. There is concern for the safety of individuals and property in the Domes.

Typical glass breakage caused by vandalism

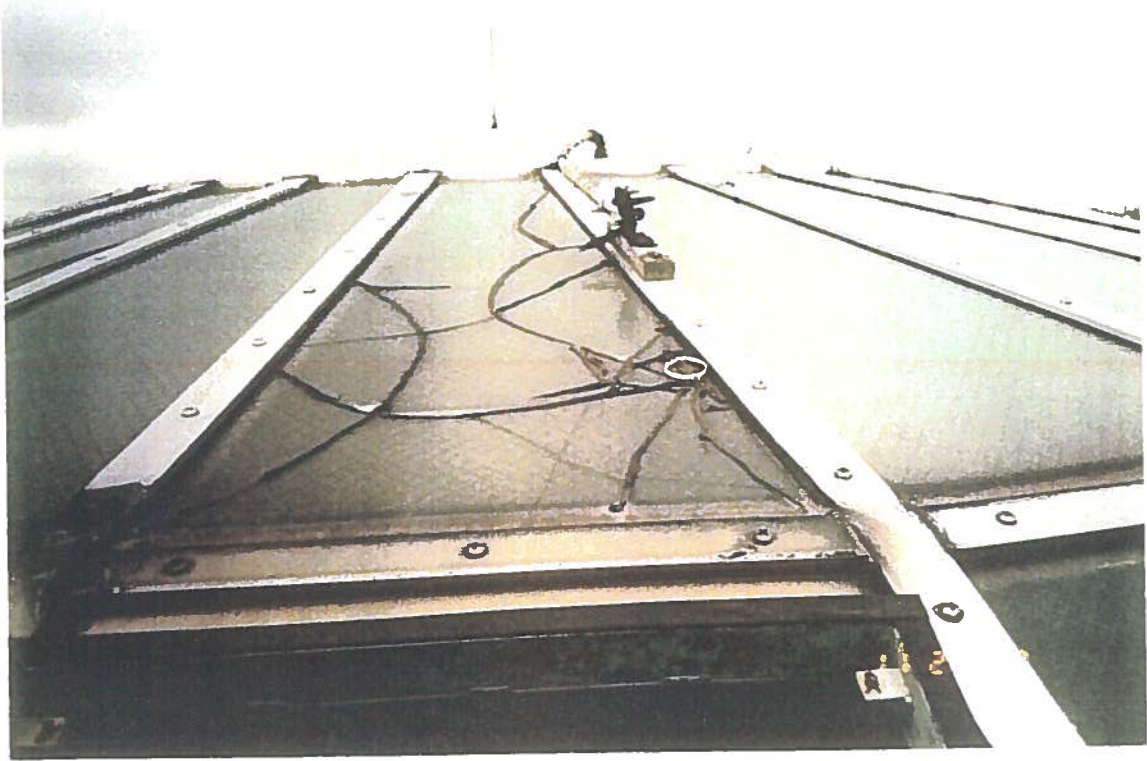
Photo No. 9
Arid Dome - South Face

In the Arid Dome, there are two pieces of cracked glass over the apex (Appendix A, Photo No. 9). The glass has been caulked to stop leakage onto the mechanical equipment. It is estimated that the Tropical and Show Domes each have similar quantities of broken glass in this area.

Broken Glass At Apex

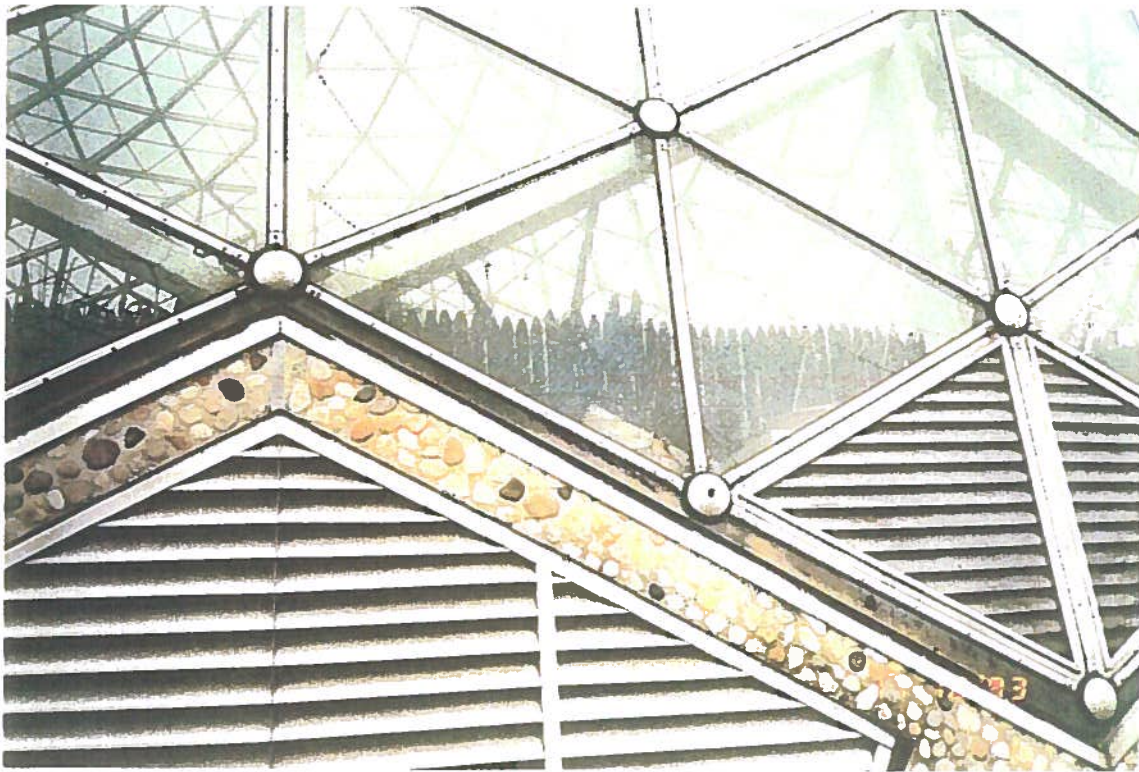
Photo No. 10
Arid Dome - East Face

There have been a small number of lites of glass replaced or repaired. Two lites in the Tropical Dome and one lite in the Arid Dome were replaced with a polycarbonate material. There have also been lites replaced with 1/4-inch wire glass, but these are not visibly detectable. Repair work has included caulking small holes in the glass and using boards to close off larger holes (Appendix A, Photo No. 10).

Board used to close off large hole.
Also, missing hub center cap.

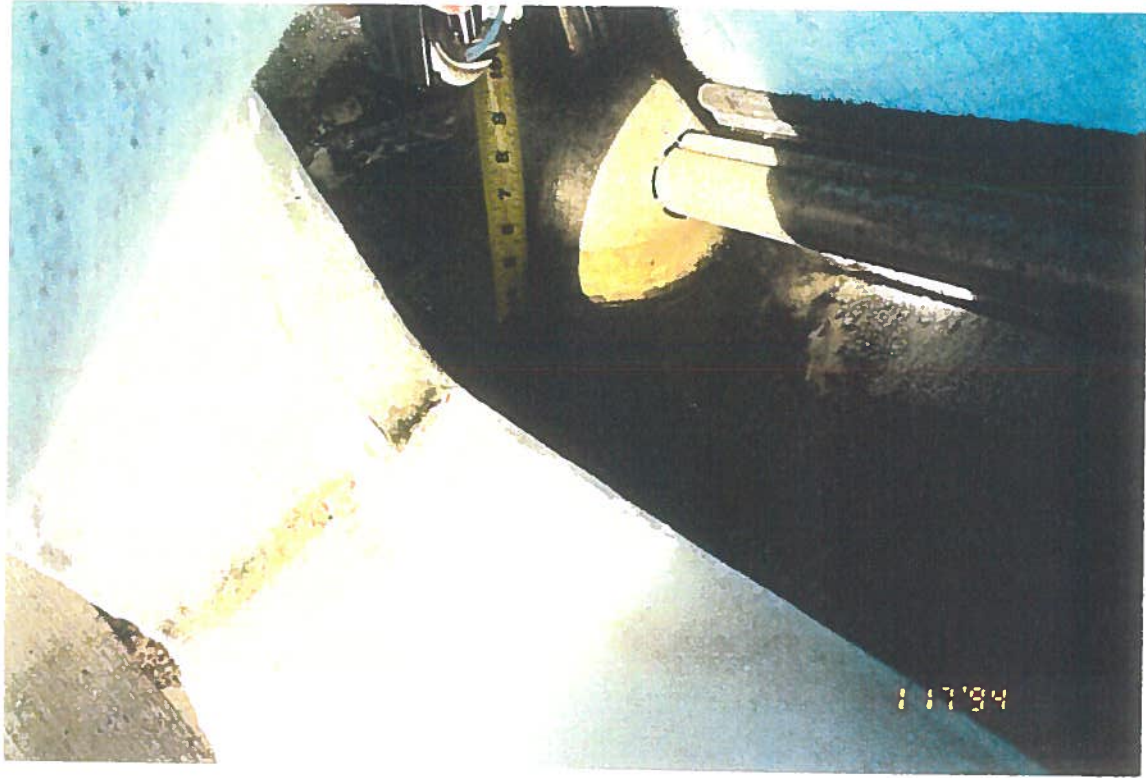
Photo No. 11
Arid Dome - Above Service Door

Standing water in low point above service door

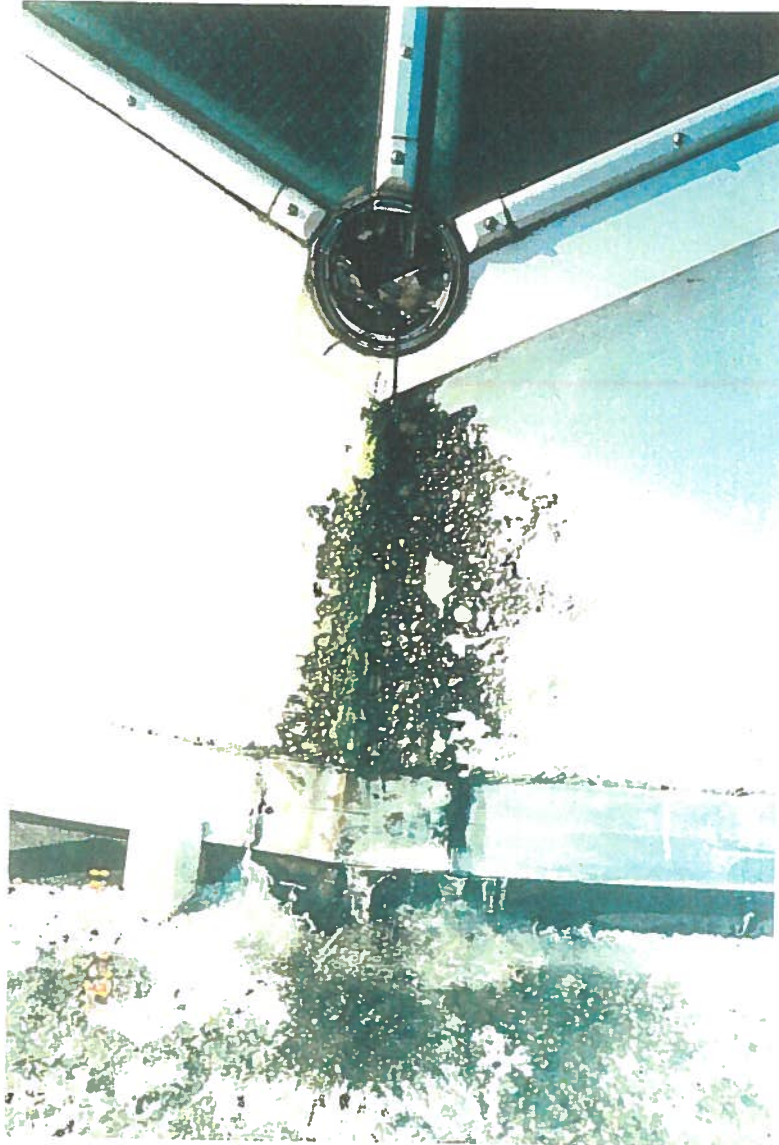
Photo No. 12
Tropical Dome - East Face

On the exterior of the Tropical Dome, above the service door, water from the inside has found its way through the base flashing. The water runs down the exterior face of the dome onto the roof above the door. There is deterioration of the exterior concrete wall (Appendix A, Photo No. 12). This flashing should be replaced and the concrete wall repaired. The water at the low points needs to be redirected to eliminate dripping at the doorways.

The hub above the service door, which has caused water to leak onto the concrete wall. Paint has peeled, plant growth is evident, and ice has formed.

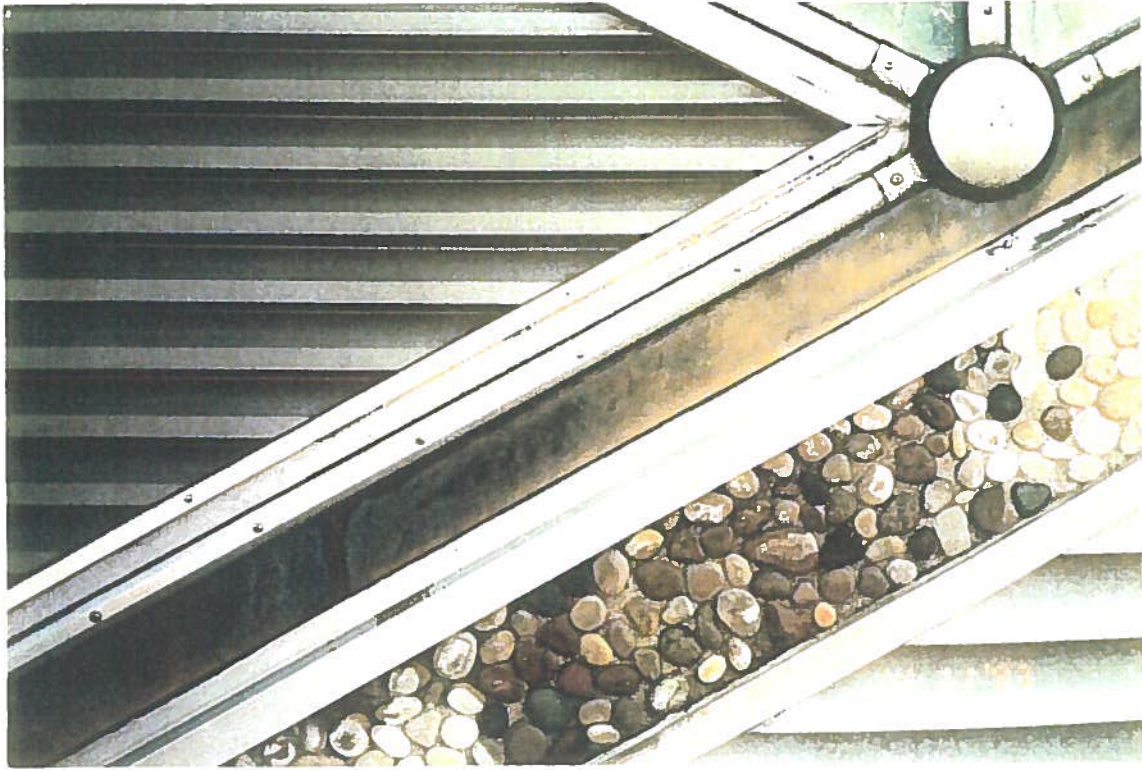
Photo No. 13
Tropical Dome - West Face

There is water leakage beneath the base flashing in at least two locations on the northwest face of the Tropical Dome (Appendix A, Photo No. 13). The base flashing should be removed and replaced to eliminate the water leakage. Approximately 10 percent of the base flashing should be replaced during reglazing. The remaining 90 percent of the flashing should be cleaned of plant growth and dirt.

Water leakage through glazing system frame

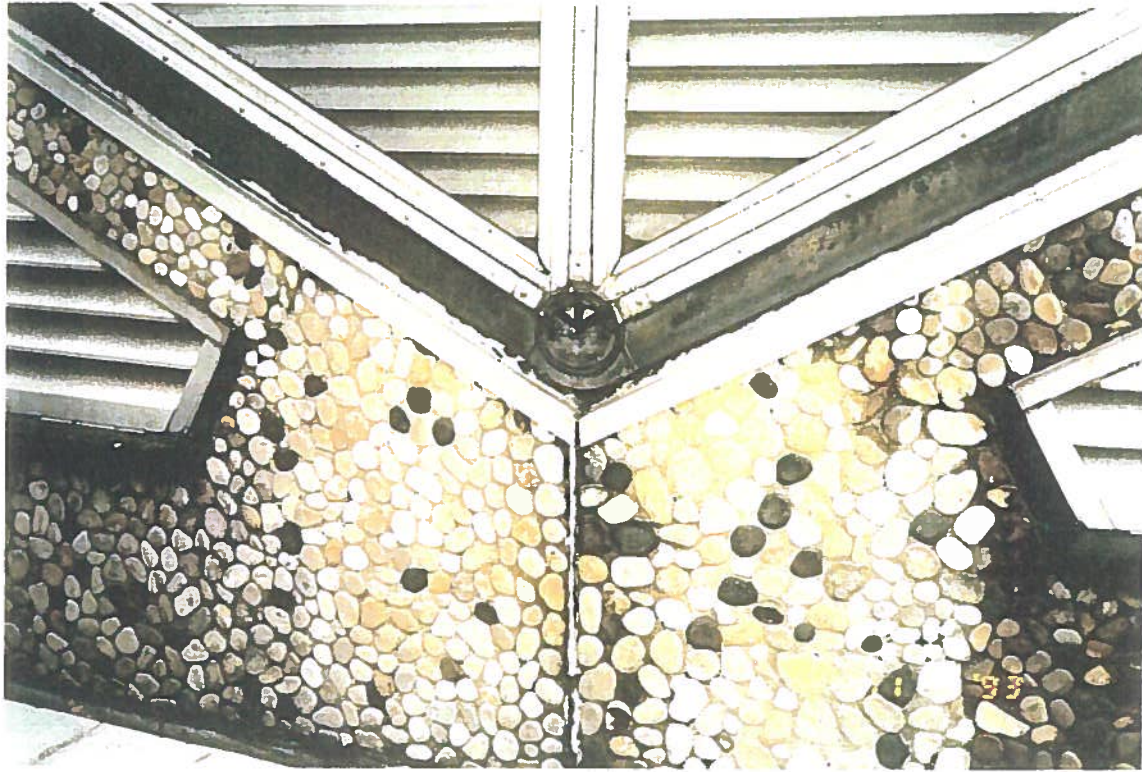
Photo No. 14
Tropical Dome

There are at least five missing hub cap assemblies (Appendix A, Photo No. 14). Most missing hub cap assemblies are low on the structure and easily accessible. There are also at least three missing hub center caps. Where the center cap is missing, the hole has typically been filled with caulk. The missing hub cap assemblies detract from the aesthetics of the domes. The opening allows moisture and bugs to enter the drainage system, while heat escapes the building in the winter. It was noted during an inspection that ice had formed in an open hub. The ice blocks the channeling of moisture in the drainage system. The missing hub cap assemblies should be replaced during reglazing.

Typical missing hub

As the glazing is replaced, the gasket material and seals could be replaced with new silicone based gasket material and silicone sealant. The missing hub cap assemblies should also be replaced during reglazing.

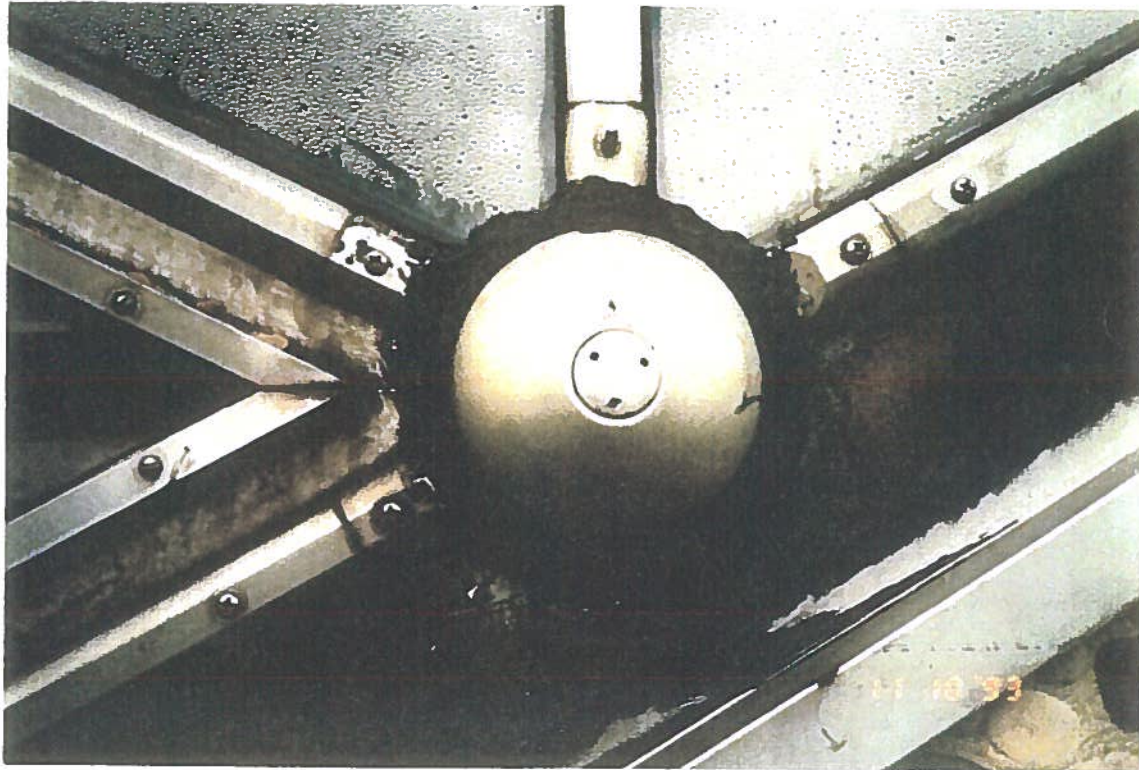
Photo No. 15
Tropical Dome - East Face

There are numerous locations where the perimeter of the hub cap assembly was caulked to prevent moisture from entering the internal drainage system (Appendix A, Photo No. 15). These seals may not be fully effective and are unsightly. The affected hub caps should be removed and resealed during reglazing.

Typical hub cover that has been caulked.
Note polycarbonate glazing above hub.

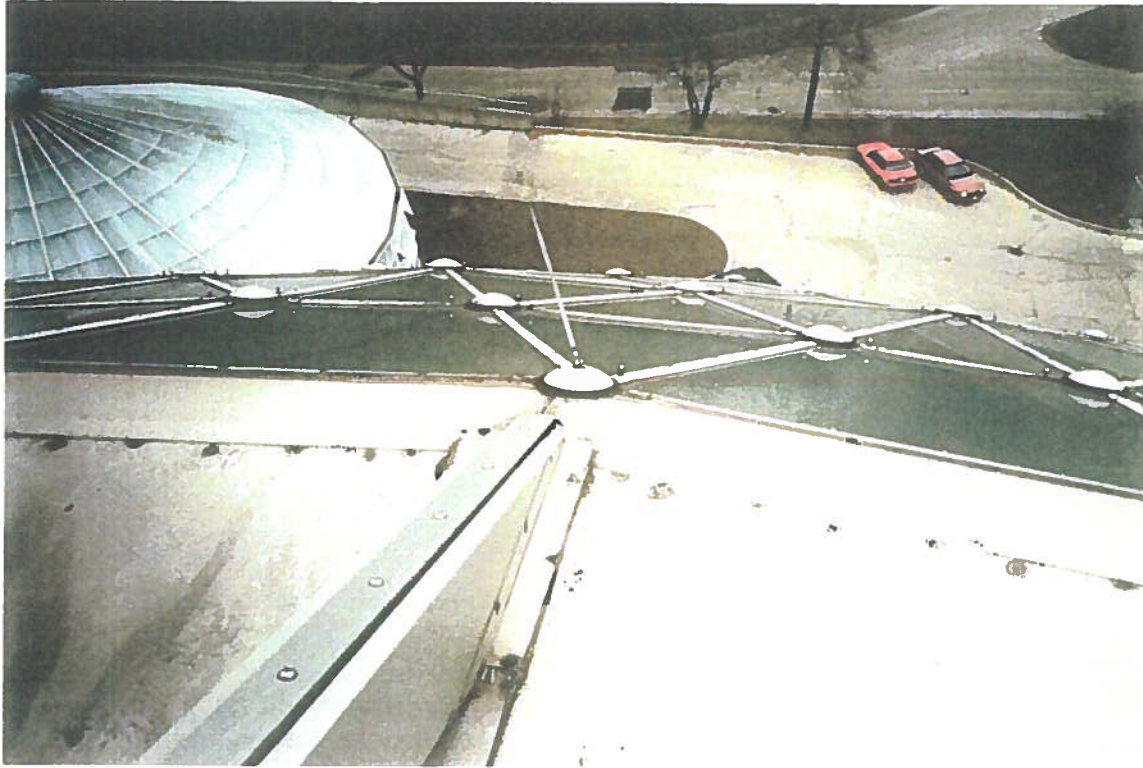
Photo No. 16
Arid Dome - North Face

There are at least three lightning rods that are not properly attached to the hub assembly as visible from the ground. The connection between the hub and the lightning rod has been broken, and the rods no longer stand perpendicular to the hub cap. The lightning rod may not be functioning properly and the appearance is unsightly (Appendix A, Photo No. 16). The lightning rods should be repaired at the same time reglazing is done, while equipment and manpower are available on-site.

Broken lightning rod

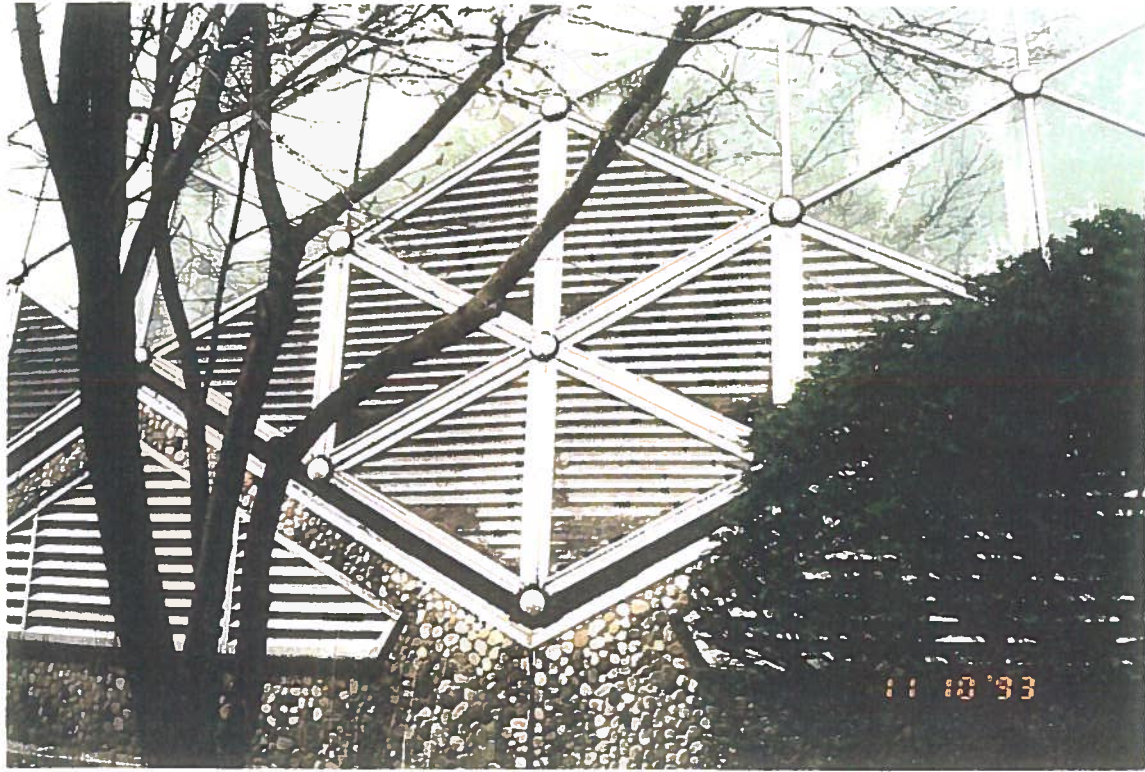
There are approximately 45 screens in the three domes in need of repair or cleaning; 25 are ripped, and 20 have debris trapped between the screen and louver. This debris includes old leaves and plant growth (Appendix A, Photo No. 17). The ripped screens allow bugs and animals access to the domes. The debris prevents the louvers from drawing in the required air intake which causes the air handling system to run inefficiently. The ripped screens should be removed and repaired. The debris between the screen and louver should be removed and the screens replaced.

Photo No. 17
Tropical Dome - East Face
Debris between screen and louver

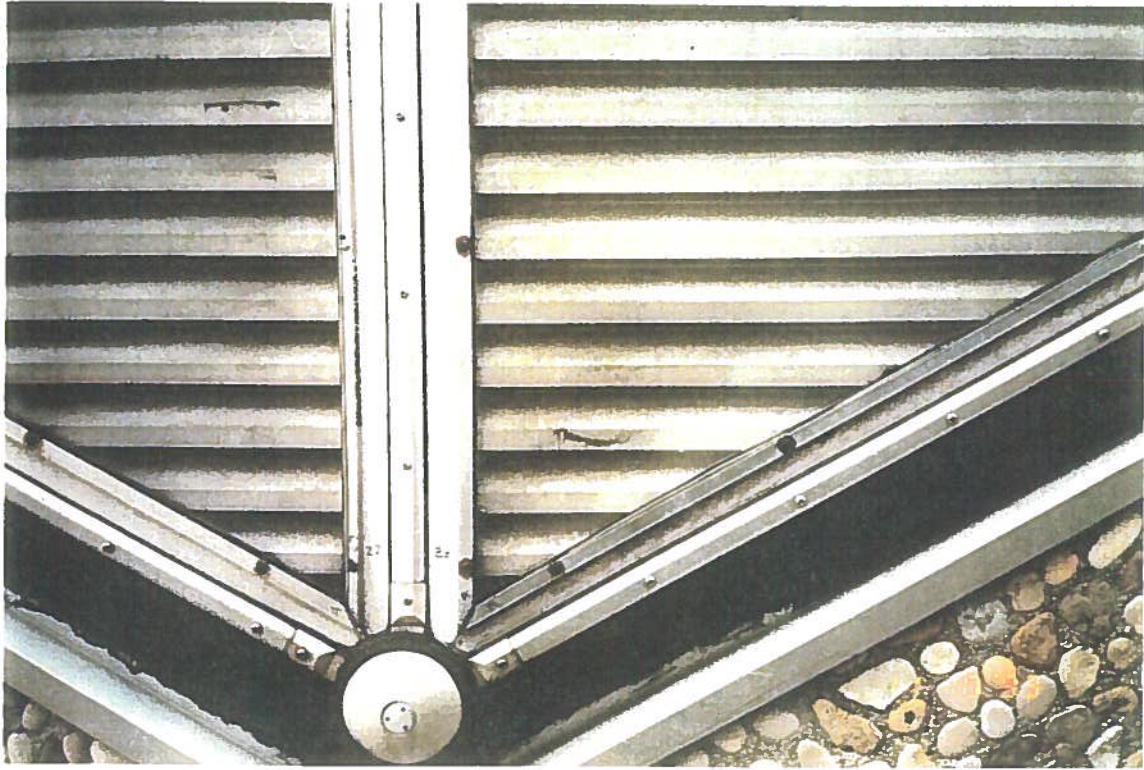
Photo No. 18
Show Dome

Stainless steel screws were originally used to attach the screens and caps to the structure. Over time, an estimated 1,000 screws were replaced. At these locations, stainless steel screws were not used and the replacement screws have corroded (Appendix A, Photo No. 18). The replacement fasteners have had a galvanic reaction with the aluminum which causes discoloration and loss of material. The corroded fasteners should be replaced with stainless steel fasteners and any deterioration of the screen frame should be cleaned. Some of the corroded screws are on screens that need to be removed and repaired or cleaned. This cost is included in the screen replacement cost.

Replacement screws that have corroded

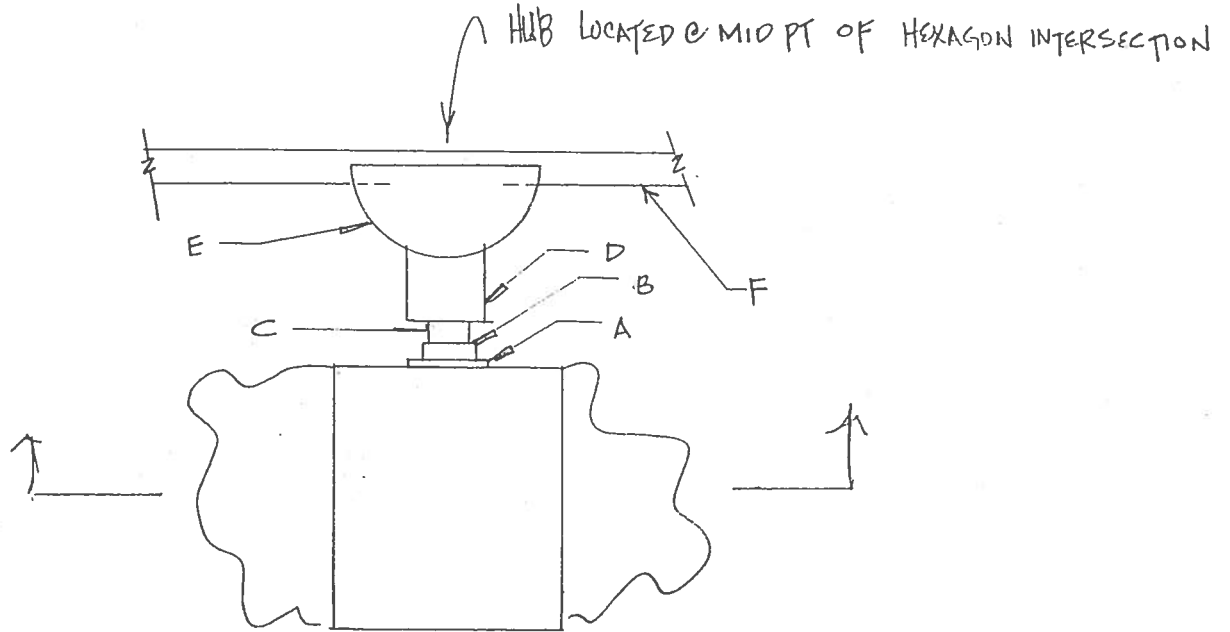
A notch was filed on #A & used as a base pt.

Good continuity exists btwn pt A and pts B, C, D, & E.

Continuity does not exist between pt A & pt F.

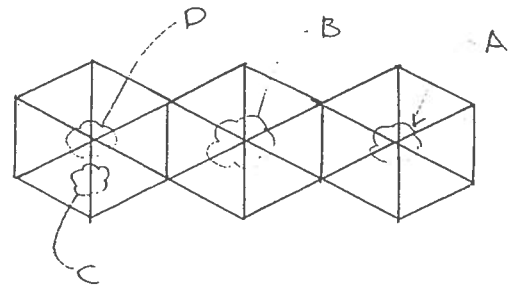
Attachment to hub $\#$ @ Location "A"
(Base)

Hub assembly @ "B" not continuous w/ rebar grid
(Both $\#$'s knocked out of position) (See attached typewritten report).

Hub $\#$ @ midpoint @ "C" continuous w/ rebar grid (concrete spall @ $\#$)
