**Milwaukee County  
Mitchell Park Horticultural Conservatory  
"The Domes"**

**Show Dome Facade Study  
and  
Lower Level Facade Study**

**October 10, 2008**

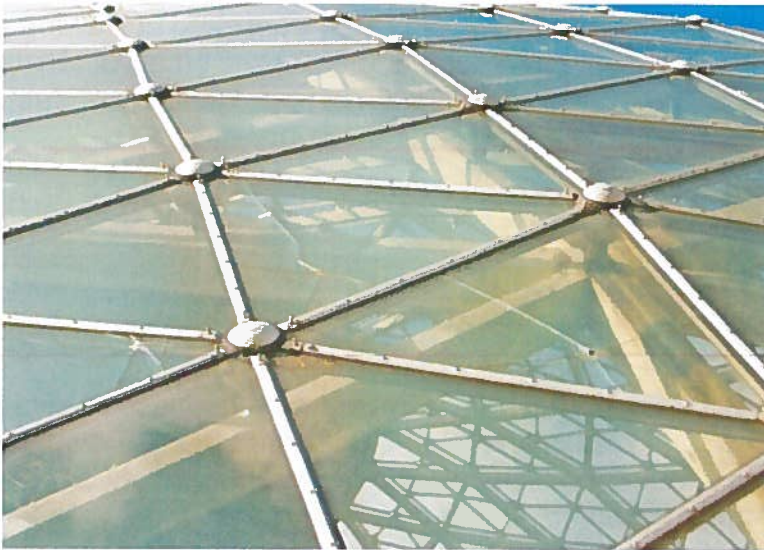
**Figure 2:** Typical Glass Panel Breakage

There are numerous reasons for the damaged glass panels. The obvious projectile damaged glass appears to be mostly due to vandalism, but may also include some minimal damage from wind blown debris or hail. The majority of the cracked glass appears to be caused by the brittle nature of the ¼" wire glass, and the result of differential thermal expansion and contraction movement between the glass and the aluminum framing. Also, some breakage may have occurred as the result of built-up stresses due to fastening of the glass to the framing via the rafter caps and screws. There is also some suspicion that previous maintenance equipment, which rolled on the outside of the dome, may have cracked some of the glass, and it has never been replaced. Most of the breakage from maintenance equipment may have occurred during the first few years of the domes' existence.

Many of the water leaks within the Show Dome are a result of damaged glass. Some leaking is occurring through holes in projectile damaged glass, and there is also some leaking through cracked glass. Some cracks appear to be still tight, as a function of the wire glass, and do not appear to leak. Sealants have been used to attempt to seal some cracks or holes in the glass. The sealants are unsightly, and some appeared to have failed.

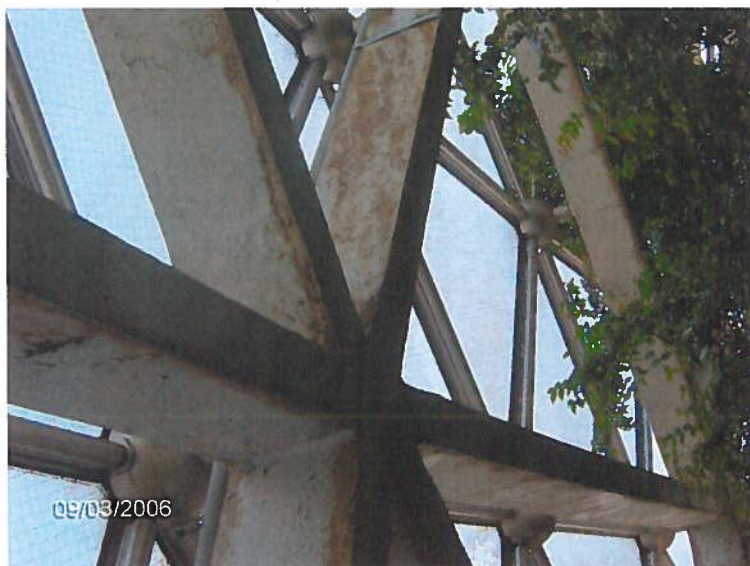
The concrete frame was originally painted with two coats of epoxy paint. This paint was specified to have a life expectancy of 10 to 15 years. The paint has been in service for approximately 40 years, and is fading, chalking and peeling in the Show Dome, as shown in Figure 5. There is also visible dirt streaking on the paint in the Show Dome as shown in Figure 6. Dust propagation from the walkways is believed to be partially responsible for the amount of dust. Water dripping from the façade is believed to be causing the streaking.

**Figure 5:** Typical Paint Peeling and Staining on Concrete Frame

The concrete frame needs to be recoated after leakage problems from the drainage system are fixed and all the damaged glass has been replaced, so that paint work is not immediately stained. Additional temporary air handling equipment may be required to improve air circulation and air quality during recoating. Drop cloths would also be required to keep paint chips from contaminating the soil as the existing paint is removed, and to protect the plants during recoating.

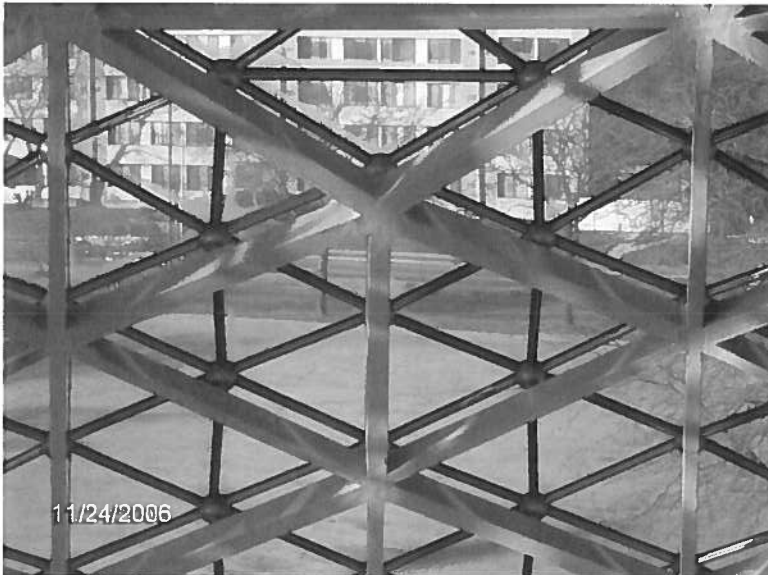
**Figure 6:** Dirt Streaking on Concrete Frame in Show Dome

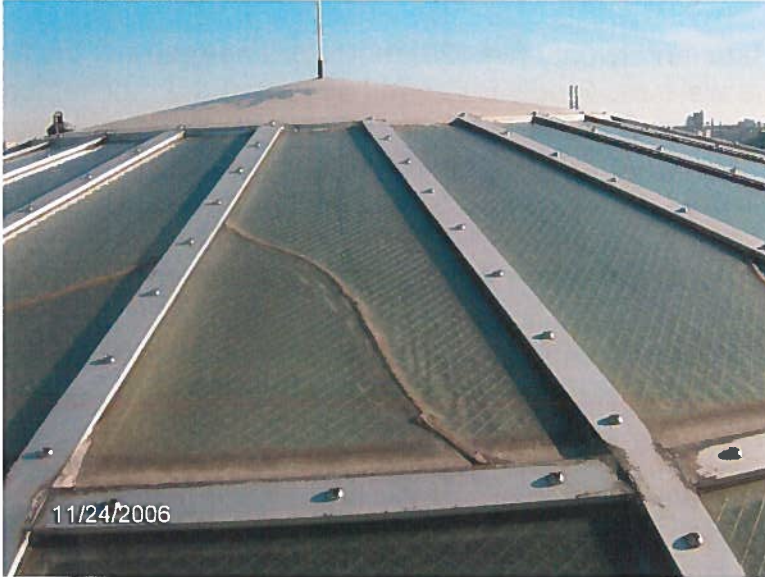
**Figure 8: Damaged Glass Panels at Show Dome Apex**

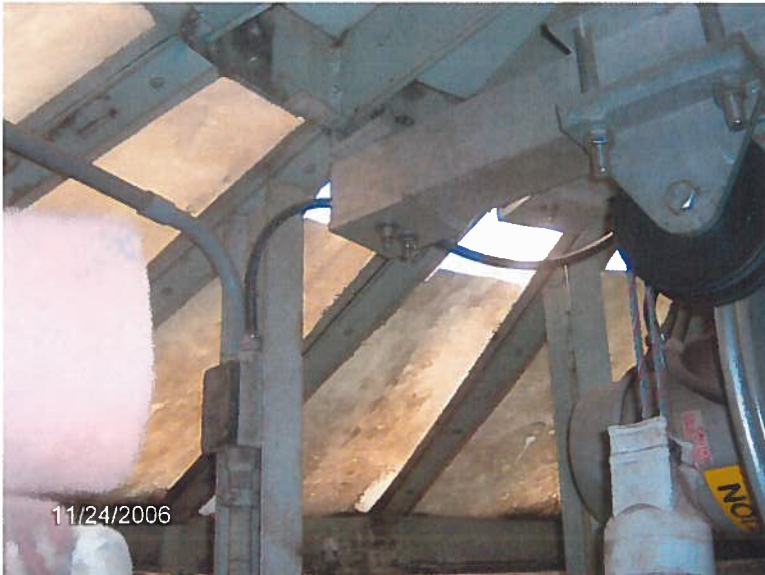
Below the upper ring of 25 glass panels, an additional layer of translucent plastic panels is installed about 8" below the glass as shown in Figure 9. The plastic panels are very dirty on the inside (top) surface. Sections of several plastic panels have been cut out to allow for access to hoist beam connection bolts. It is assumed that these translucent panels were installed to reduce the direct sunlight and heat gain on the apex mechanical equipment.

**Figure 9: Stained Translucent Panels above Mechanical Equipment**
