Ref.: 1811 Tyndall Dr., Tallahassee, Florida
Lead Paint Risk Assessment Report

Lead-Based Paint Risk Assessment Report

1811 TYNDALL ST.
TALLAHASSEE, FL

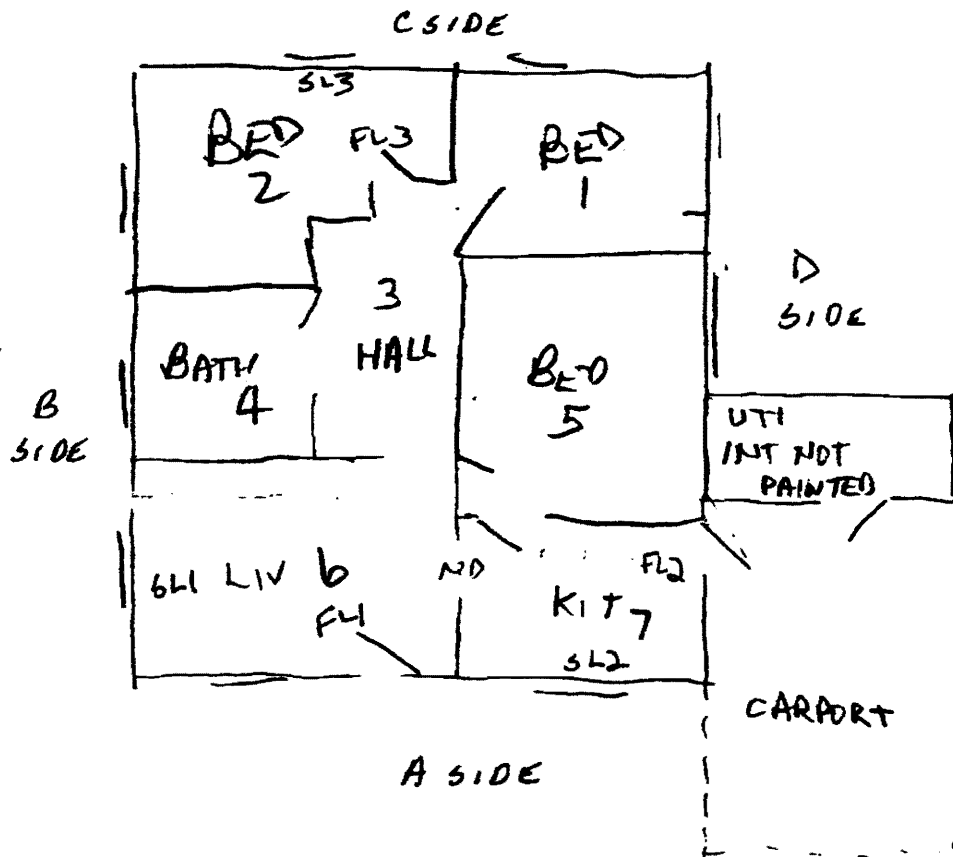
Unit sketch showing dust and soil sampling locations.

Dust Sample Results – Collected 1-09-10		
Sample No.	Sample Location	Pb Concentration ug/ft²
FL1	Living Room Floor	14.2
SL1	Living Room Windowsill	<20.0
FL2	Kitchen Floor	23.1
SL2	Kitchen Windowsill	<20.0
FL3	Back East Bedroom Floor	<5.00
SL3	Back East Bedroom Windowsill	<20.0
ND = Not Detectable		
Blank was Not Detectable		
Concentrations in bold exceed the established hazard standards

Soil Sample Results – Collected 1-19-10		
Sample No.	Sample Location	Pb Concentration ppm
CS1	Perimeter Drip Line Composite	65
S1	Play Area,	<13
ND = Not Detectable Blank was Not Detectable Concentrations in bold exceed the established hazard standards
