**LEAD PAINT INSPECTION AND RISK ASSESSMENT
SINGLE FAMILY DWELLING**

**130 FASHION AVENUE
CONNELLYS SPRINGS, NC 28612
APRIL 7, 2010**

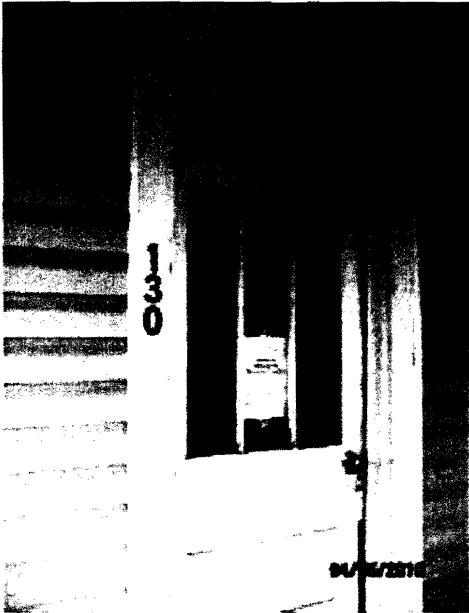
**Photo 1
Side A Door Trim**

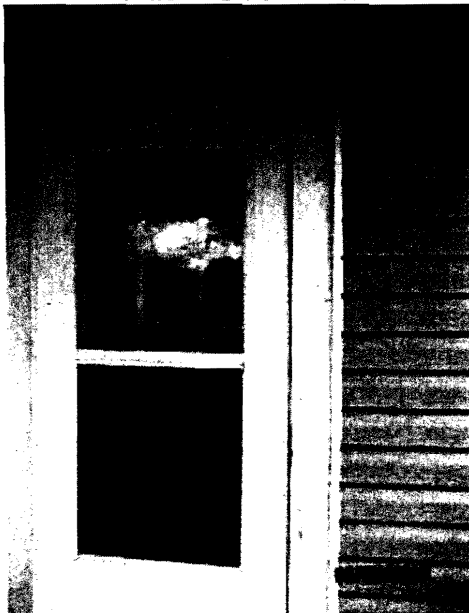
**Photo 2
Side B Door Trim**

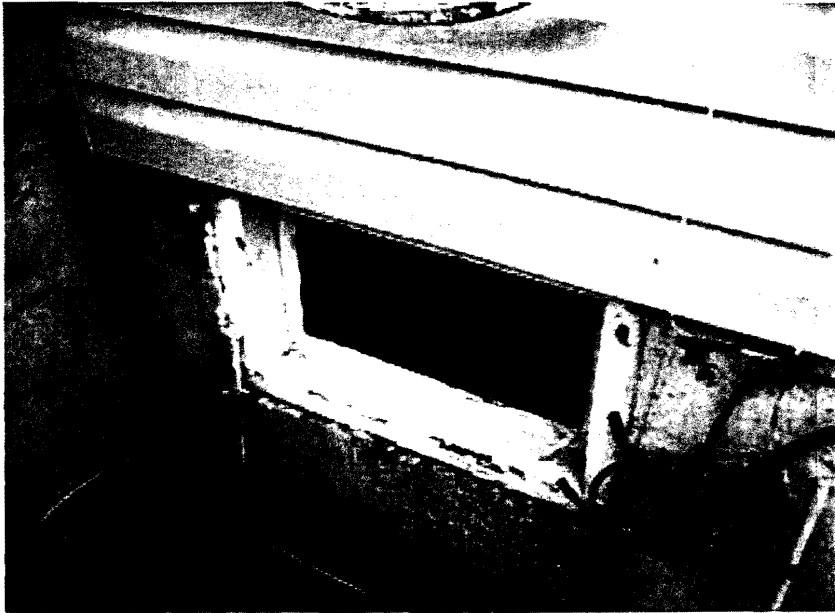
Photo 3
Crawl Space Vent Side B
