**LEAD PAINT INSPECTION AND RISK ASSESSMENT  
SINGLE FAMILY DWELLING**

**2328 OLD KNOXVILLE HIGHWAY  
MARYVILLE, TN  
SEPTEMBER 17, 2013**

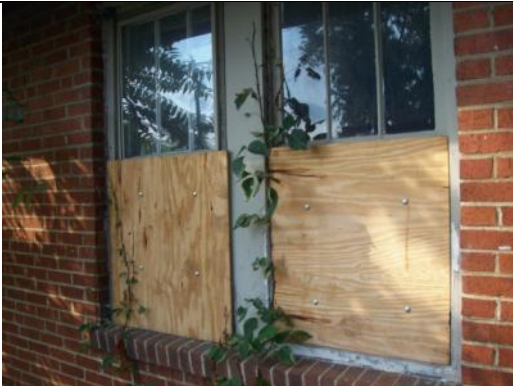
Boarded up windows

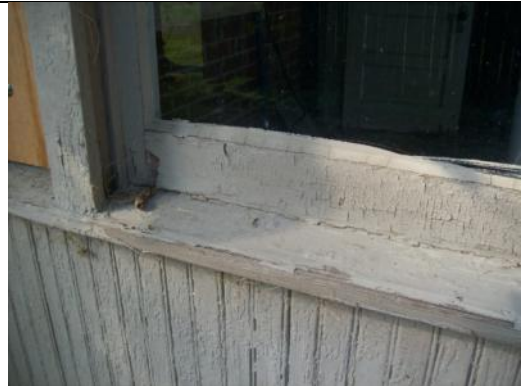
Deteriorated LBP on exterior windows

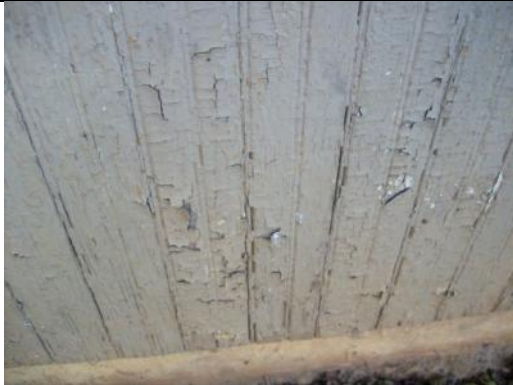
Deteriorated LBP on exterior walls

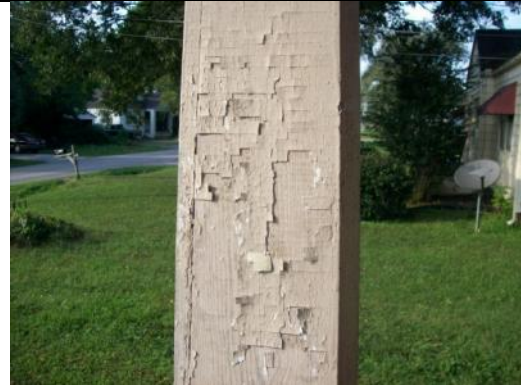
Flaking LBP on porch columns

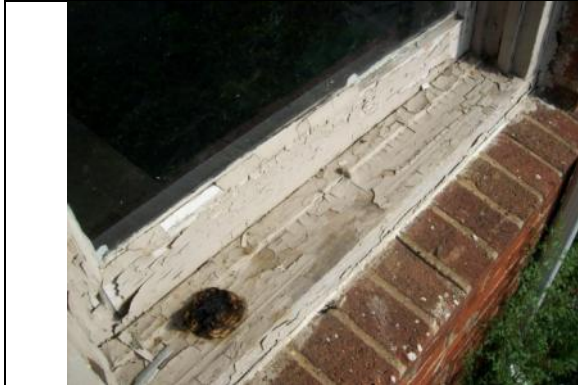
LBP on exterior windows

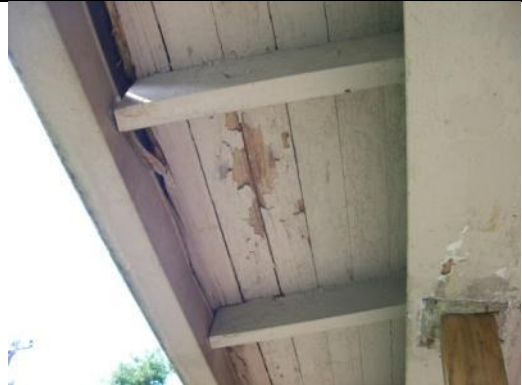
Deteriorated LBP on fascia and soffits

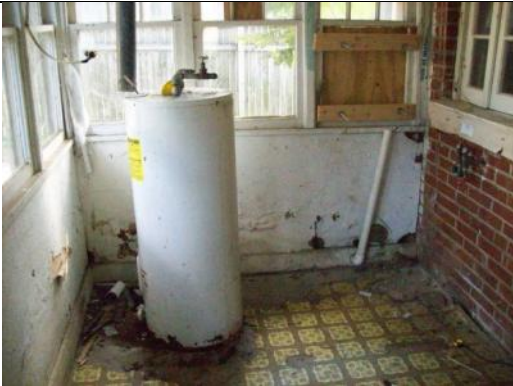
Laundry room (moisture damage)

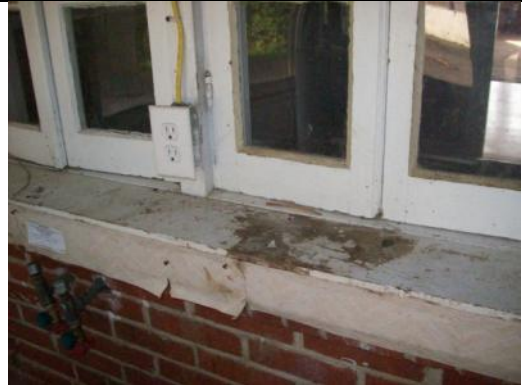
Laundry room windows with LBP
