WEST 6TH STREET ASSESSMENT

Water Damage Scope of Work

Client Name	U.S. Small Business Administration Fresno Commercial Loan Service Center
Client Address	801 R. Street, Suite 101, Fresno, California
Project Location	50 West 6 th Avenue, Oshkosh
Project Date(s)	June 30, 2014
Report Date	July 1, 2014
Project Number

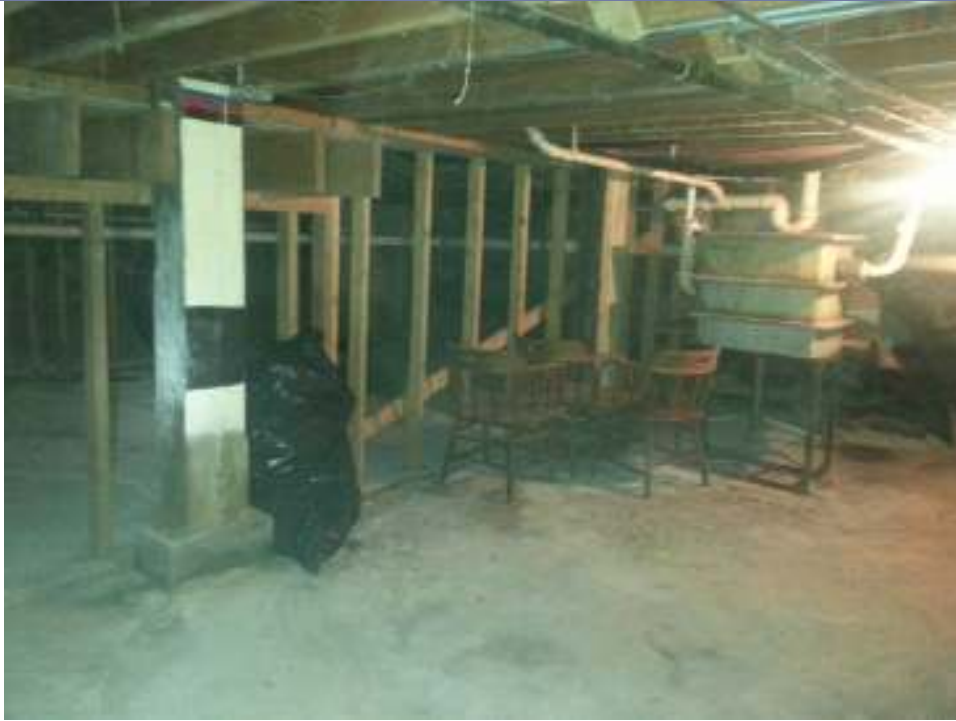
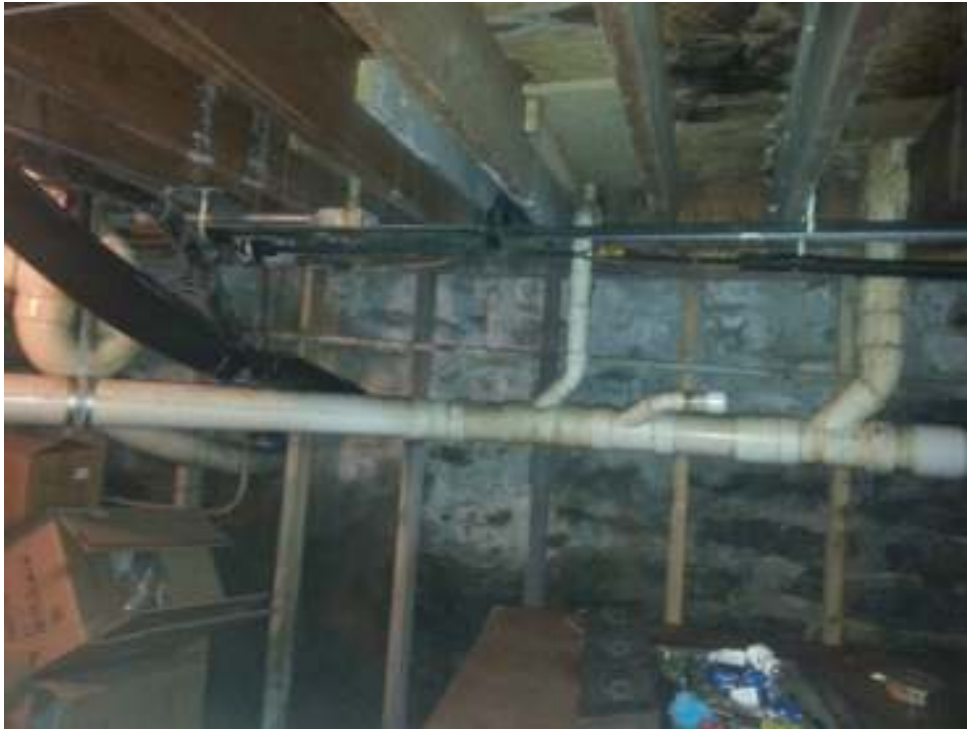
We did not measure the basement space. Based on a visual assessment, the basement is segmented into three main rooms and partial crawlspace area that covers approximately 4,500 square feet (*Pictures 1 & 2*). Water appears to have been present on the concrete floors throughout the basement as the lower four feet of all wall finishes supported dense fungal growth (*Pictures 3 & 4*). The humidity released resulted in fungal growth on wood pillars, floor joists, and subfloor throughout the basement (*Pictures 5 & 6*). We collected samples from surfaces and analyzed those samples on-site with a microscope. Analyses of samples revealed that areas of subfloor and floor joists that were not visibly stained also supported fungal growth.

PICTURE 1: OVER OF SEVERAL BASEMENT ROOMS.

PICTURE 2: ONE OF SEVERAL BASEMENT ROOMS.

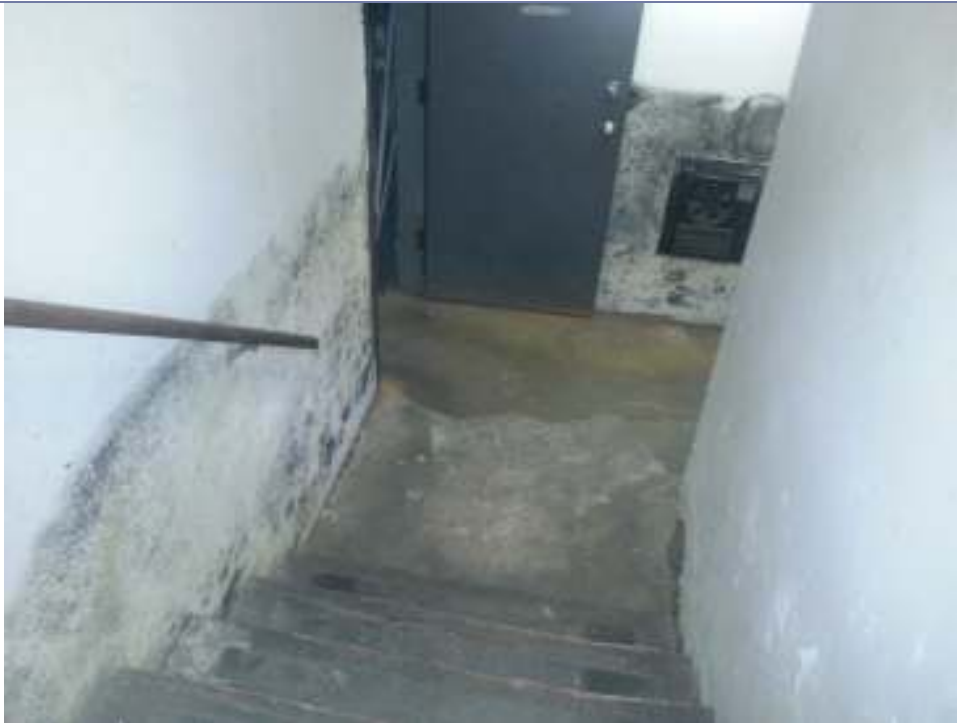
PICTURE 3: FUNGAL GROWTH FROM WATER SOAKING UP THE LOWER SHEET OF WALL FINISH.

- 3) Remove all basement wall and ceiling gypsum board and plastic with exception to the ceiling finish in the mechanical room. In the stairwells, continue removing the wall finish two feet past any water staining or fungal growth on the front or back side of the finish.

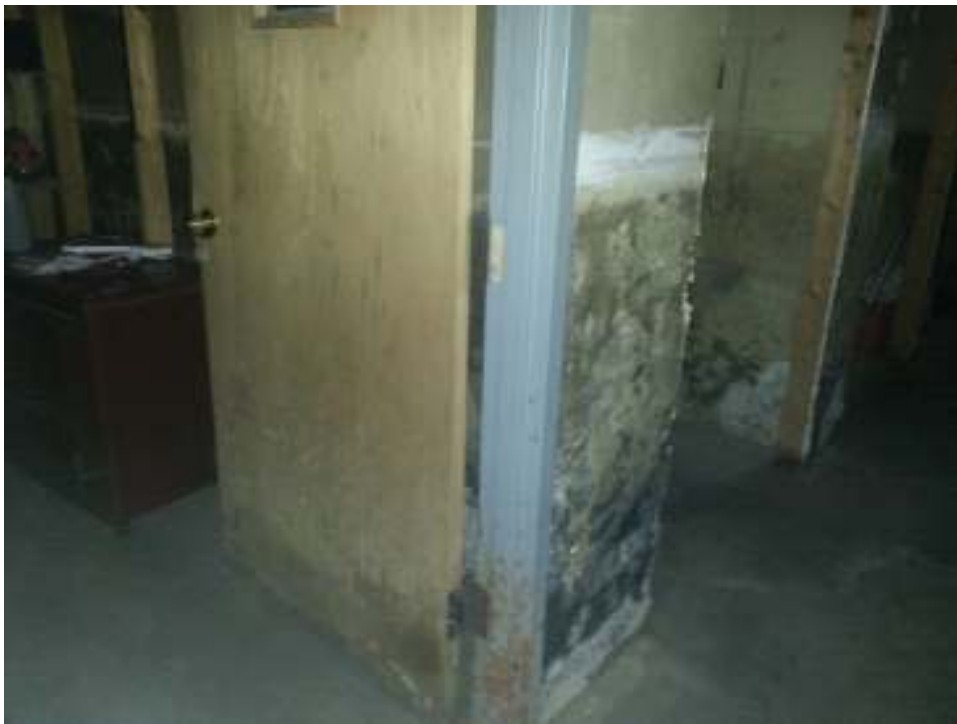
PICTURE 4: FUNGAL GROWTH FROM WATER SOAKING UP THE LOWER SHEET OF WALL FINISH.

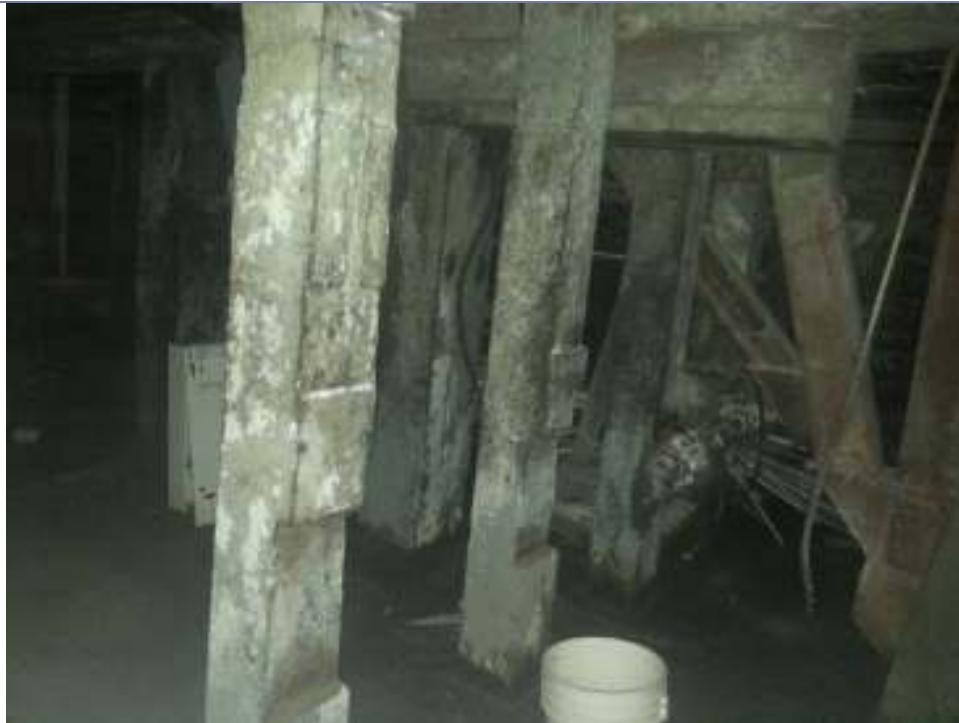
PICTURE 5: THE PILLARS AND OTHER SURFACES IN THE BASEMENT ARE COATED WITH FUNGAL GROWTH.

- 4) Clean all wall framing, floor joists, and subfloor with an aggressive cleaning process such as cry-blasting (“dry-ice blasting”) or soda-blasting.

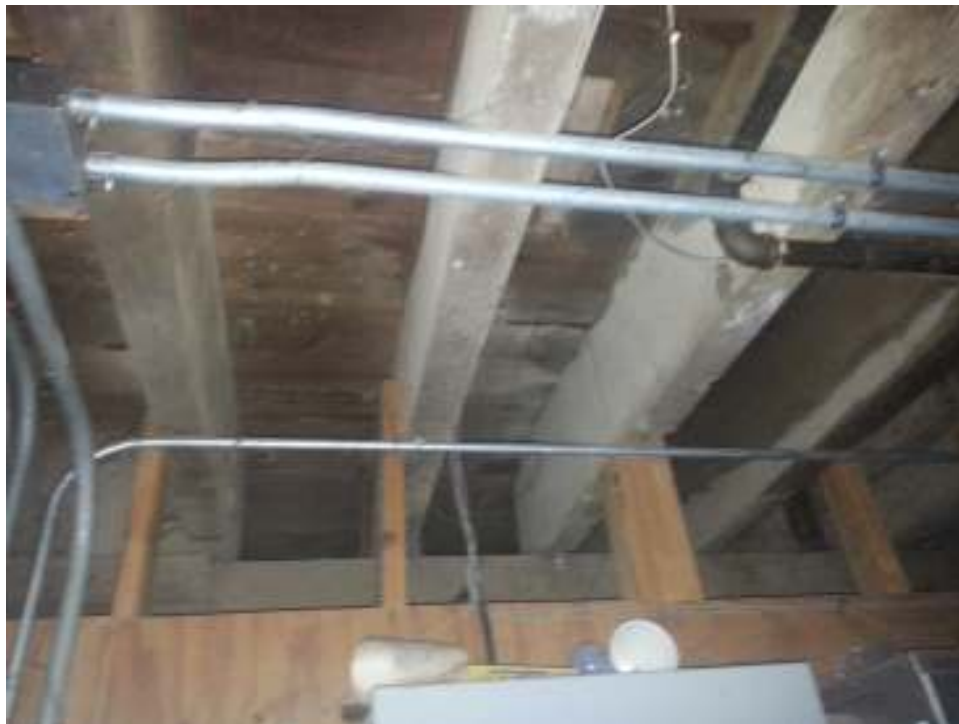
PICTURE 6: THE FLOOR JOISTS AND SUBFLOOR AND OTHER SURFACES THROUGHOUT BASEMENT ARE COATED WITH FUNGAL GROWTH.

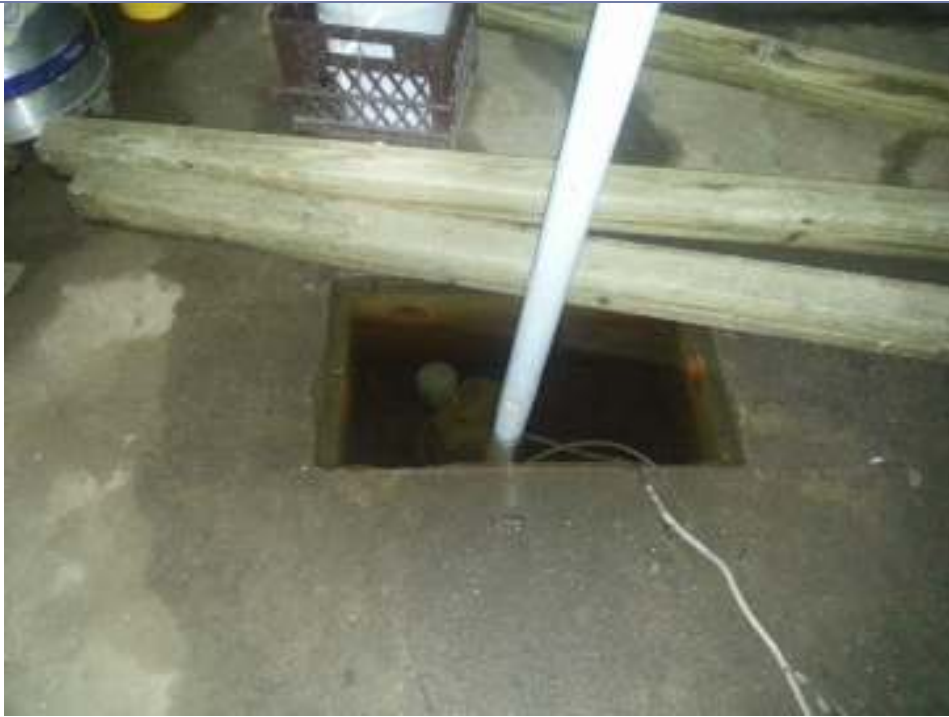
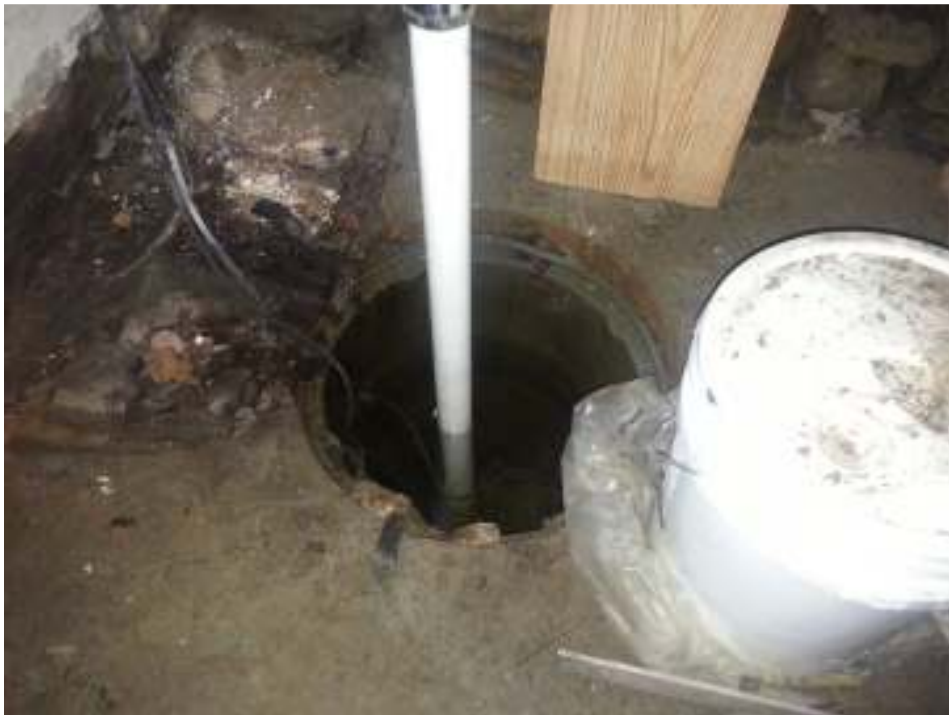
We observed two sump crocks that were both filled with water up to the top of the concrete floor (*Pictures 7 & 8*). One of the sump pumps was not functioning, while the other was attempting to run but was not removing water. With the crocks being filled with water, the concrete floor of the basement and the surrounding soils are likely saturated.

PICTURE 7: SUMP CROCK FILLED WITH WATER.

PICTURE 8: SUMP CROCK FILLED WITH WATER.

The following recommendations address the areas requiring remediation discussed above. In addition to the recommendation below, consult with a contractor to install new sump pumps, grade landscaping to direct water away from the foundation, and identify and repair roof leaks.

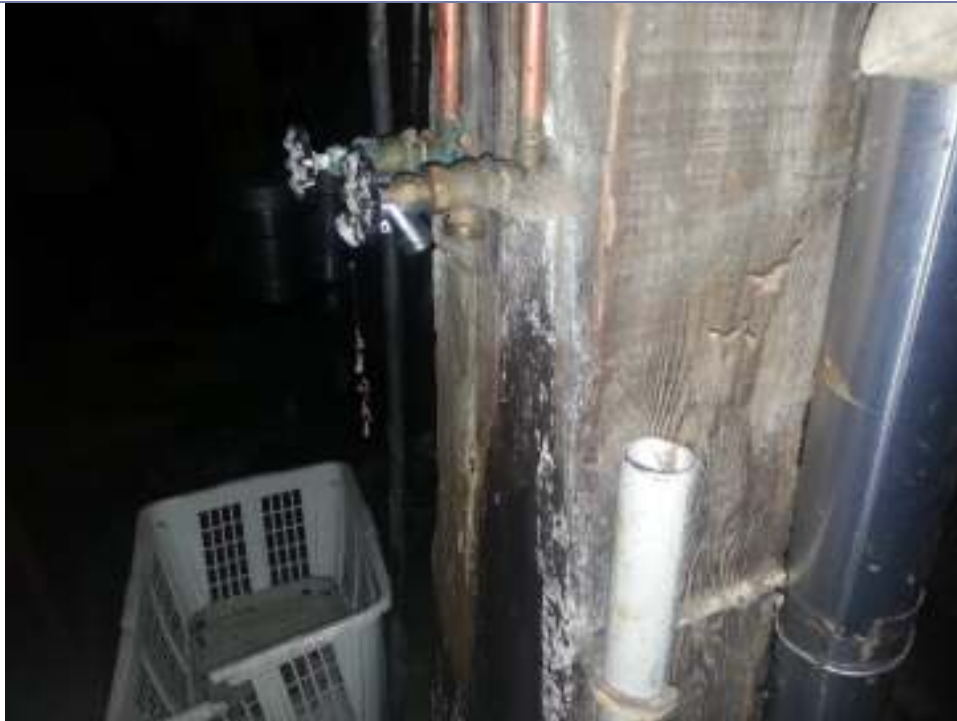
Water was also trickling through the foundation in several areas, likely the result of the landscaping around the building being relatively flat. A water spigot in the basement was also found to be dripping water onto the floor (*Picture 9*).

PICTURE 9: WATER DRIPPING FROM A SPGOT IN THE BASEMENT.

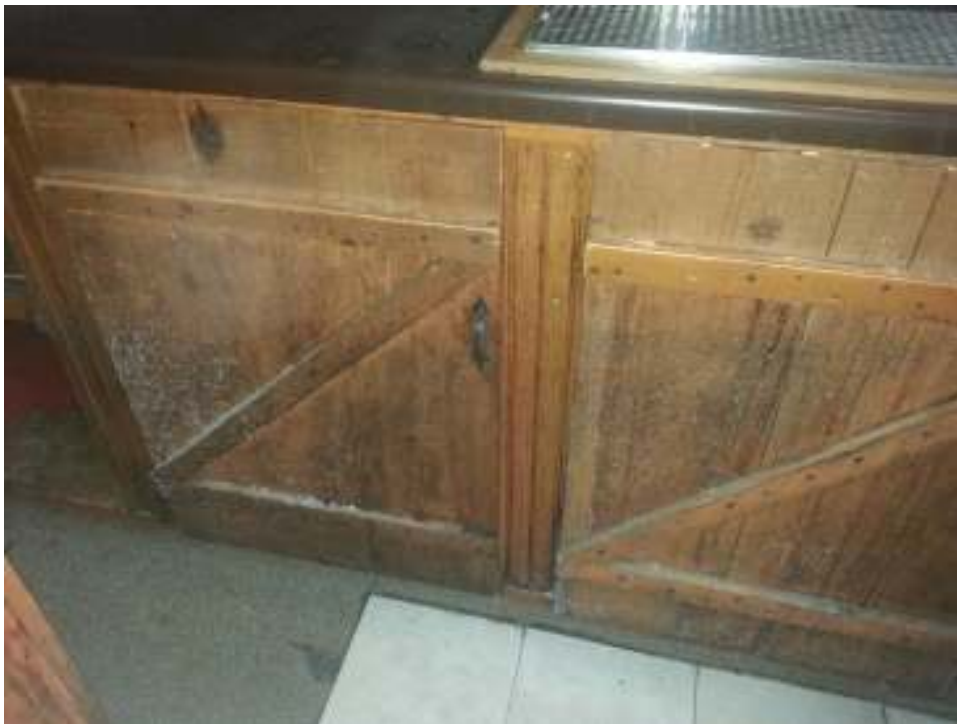
On the first floor, diffuse fungal growth was observed on the majority of the wood surfaces within the first five feet from the floor (*Pictures 10 & 11*). Fungal growth was also observed on the first floor carpeting and bench cushions and in minor areas of the second floor carpeting. There is approximately 4,500 square feet of carpeting. This growth appears to be the result of elevated humidity in the space, likely from moisture releasing from the basement.

PICTURE 10: THE WHITE SPECKLING IS FUNGAL GROWTH ON THE CABINET DOORS BELOW THE BAR.

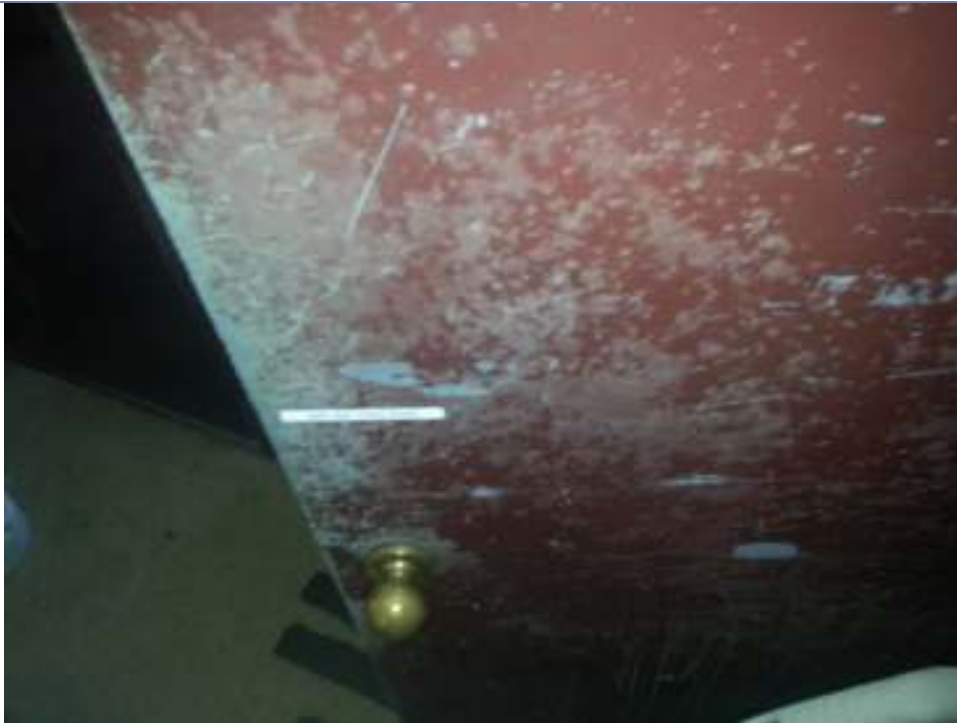
PICTURE 11: THE WHITE DISCOLORATION IS FUNGAL GROWTH ON AN FIRST FLOOR DOOR.

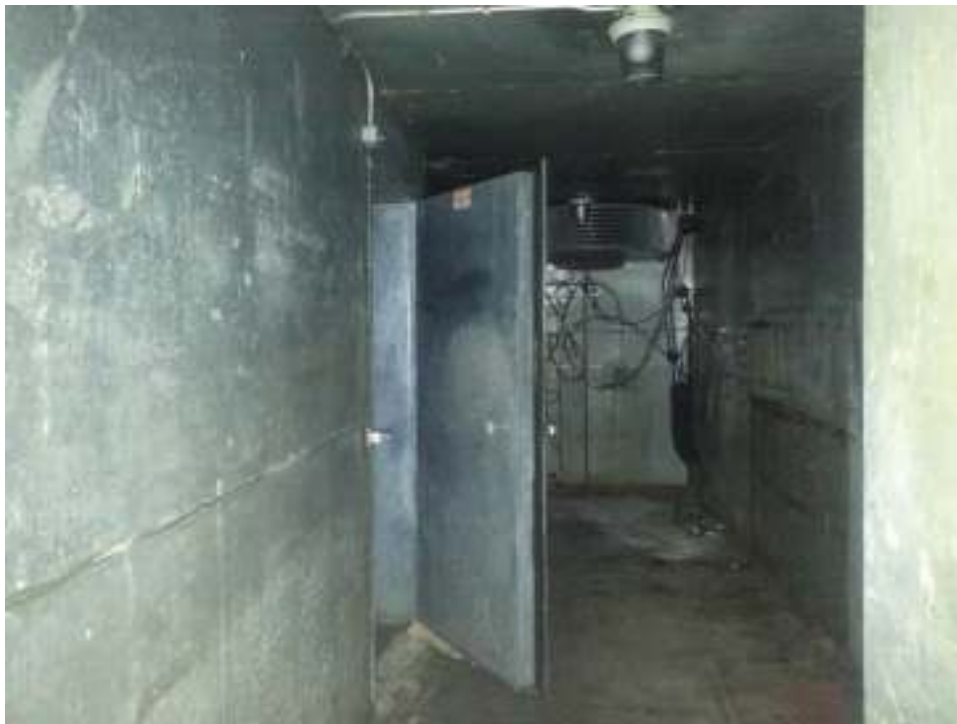
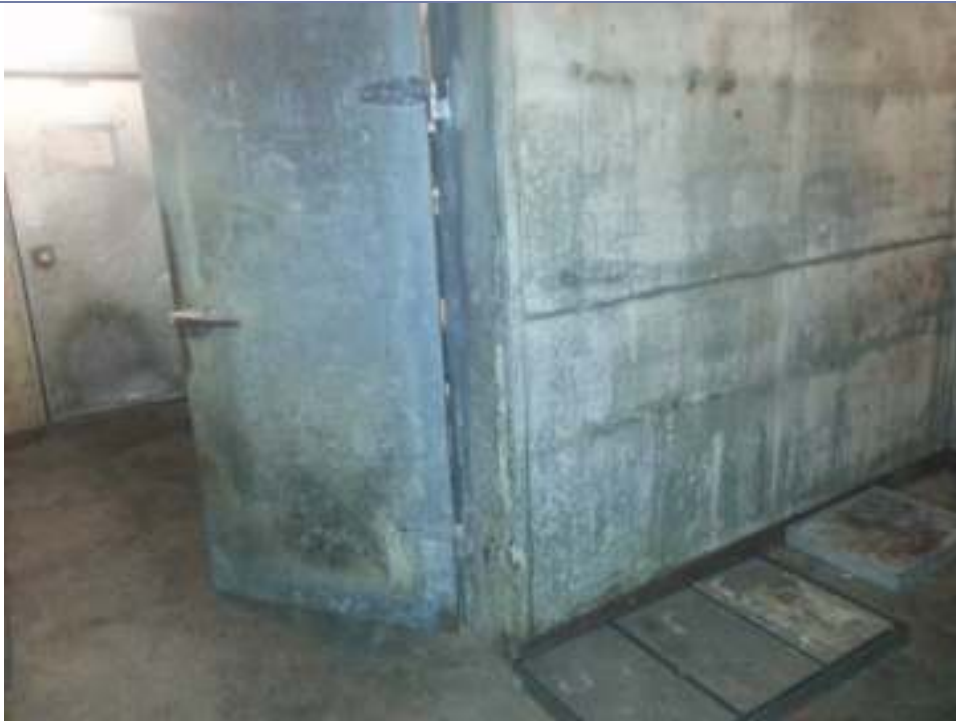
- Walk-in cooler. There is a walk-in cooler located directly adjacent to the larger bar. The gypsum board wall finishes behind some of the metal paneling in the cooler is supporting dense fungal

growth. However, the damage in the cooler is not impacting the facility in general (*Pictures 12 & 13*).

PICTURE 12: WALK-IN COOLER NEAR THE BAR.

PICTURE 13: WALK-IN COOLER NEAR THE BAR.

- 5) If the client desires, remove the walls of the walk-in cooler and clean the exposed framing.
- 6) Thoroughly clean dust from horizontal surfaces throughout the first and second floors. Ladders or scaffolding will be needed to clean the top sides decorative beams (*Picture 17*). Cleaning of the top sides of cross-bracing between rafters of the second floor ceiling is desirable, but not mandatory.
- 7) Following cleaning, operate ten HEPA-filtered air-filtration devices and thirty fans on the first and second floors for 48 hours.

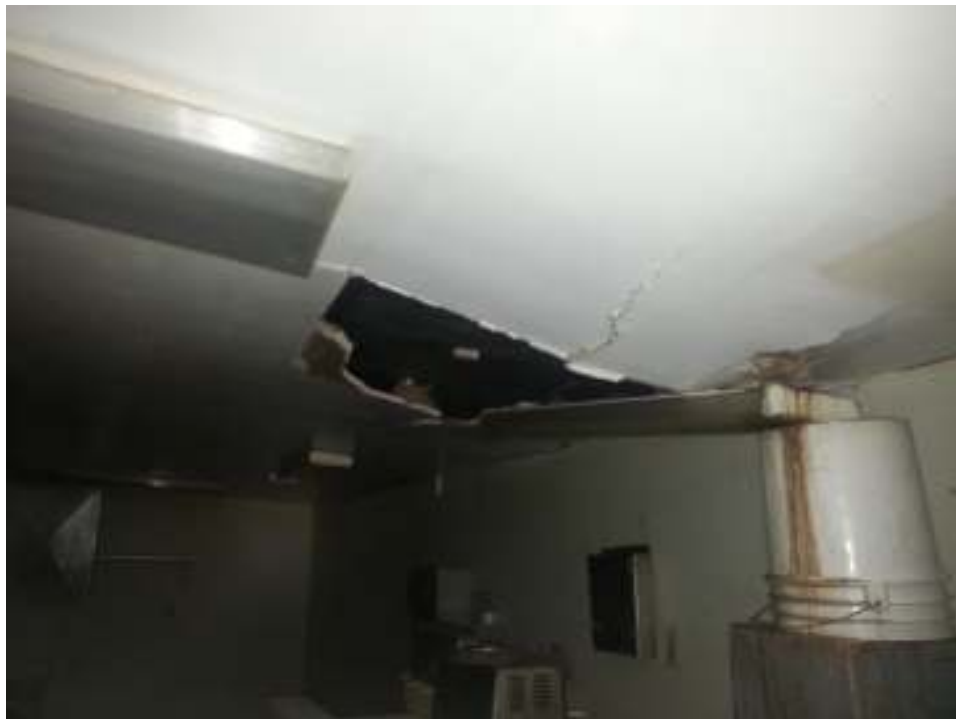
- Kitchen ceiling. A water release above the east wall of the kitchen damaged the ceiling (*Picture 14*)
- Hallway ceiling. A chronic water release damaged approximately 200 square feet of the ceiling finish of the hallway between the two bar areas (*Pictures 15 & 16*).
- Northeast stairwell by walk-in cooler. A chronic water release damaged approximately 200 square feet of the ceiling finish in the stairwell near the walk-in cooler.

PICTURE 14: DAMAGE TO KITCHEN CEILING.

- 1) Remove all loose contents.
- 2) Remove all carpeting and seat cushions.
- 3) Clean all walls, cabinetry, and all other surfaces within six feet of the floor on the first floor and in the stairwells.
- 4) Remove the damaged ceiling finish and insulation from the first floor hallway, damaged area of the kitchen, and the northeast stairwell. Clean all areas of framing that is newly exposed with nylon

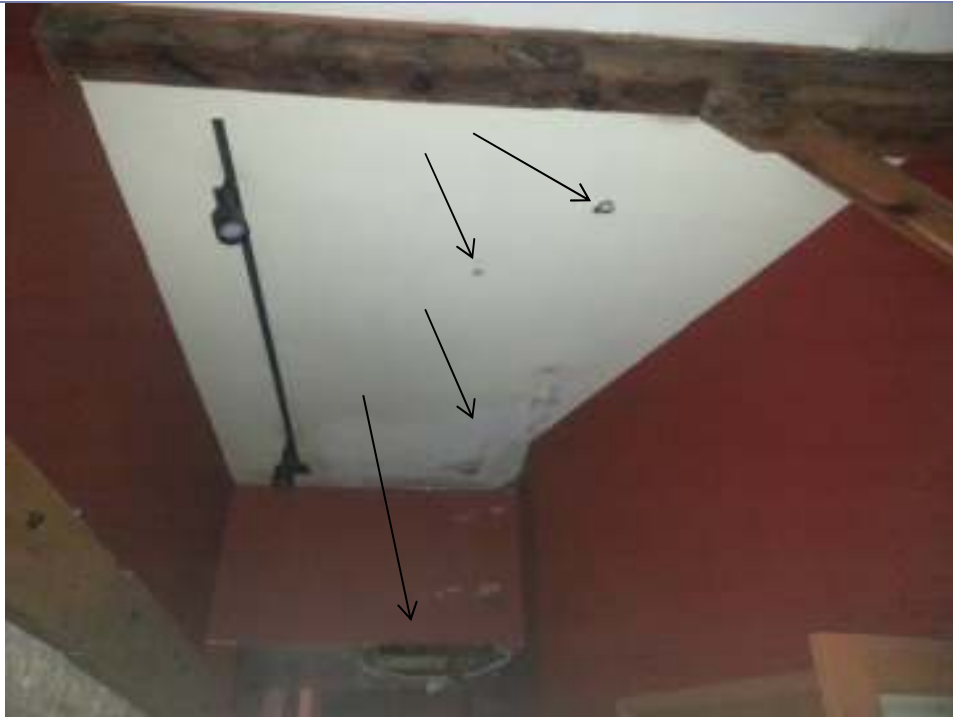
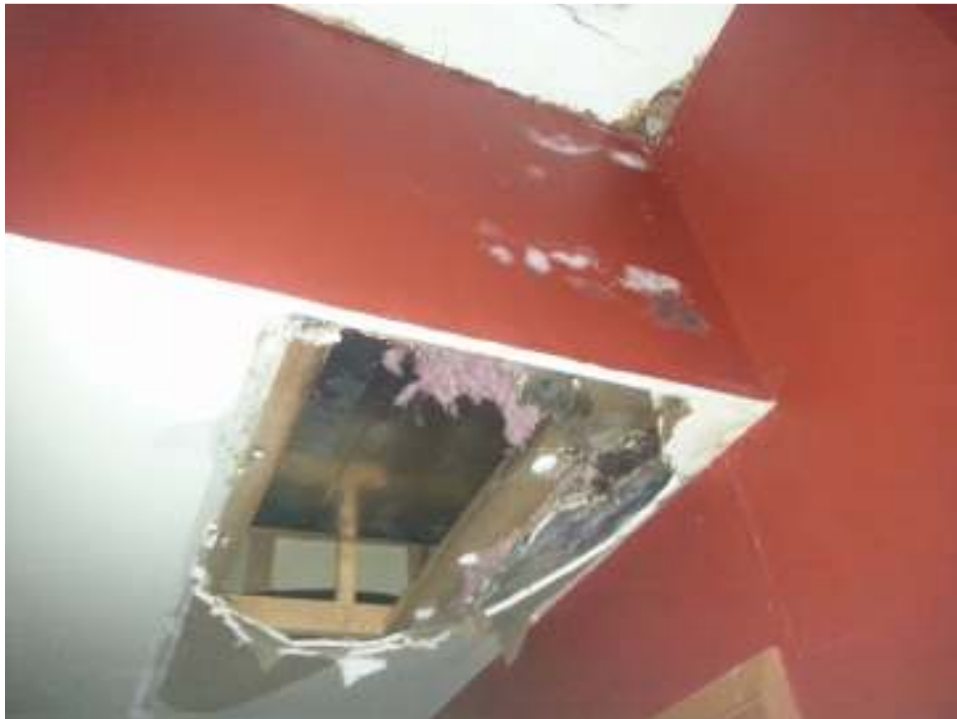
PICTURE 15: DAMAGES TO CEILING OF HALLWAY.

PICTURE 16: CLOSE-UP OF CEILING SHOWN IN PREVIOUS PICTURE.
