Volvo Cars of North America, LLC  
Technical Engineering

Reference: VIDA, VSTG, RTJ 20261

**NOTE! THIS DOCUMENT SUPERSEDES THE PREVIOUS RETAILER TECHNICAL JOURNAL 17644 DATED 05-06-2009. The chassis numbers in the header have been updated. PLEASE UPDATE YOUR FILES.**

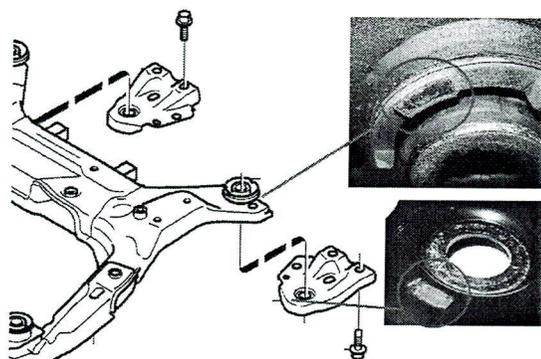
NOK

A customer may also complain of a groaning noise from the front suspension of the vehicle, especially when turning or driving over a speed bump. The root cause may be a rubbing conflict between the front subframe rear bushing and the support plate. Refer to the picture below to the left for abnormal contact. Contact between the bushing and the support plate according to the green areas in the picture below to the right, is normal.

If the bushing show signs of wear or if the cause of the problem is that the bushing is not in the correct position in the subframe metal tube, replace the subframe bushing according to VIDA, RTJ 20261, and the details on page 3. The new subframe bushing will have a different interface (wider contact area) with the support plate. See the photo below.

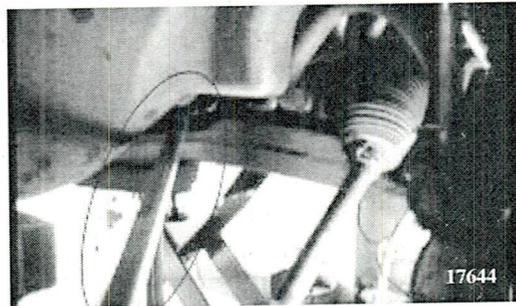
Test 2: Use a pry bar to move the subframe (see picture below) and listen for the noise.

If the knocking noise goes away during test 1 or test 2, replace the subframe bushing according to VIDA, RTJ 20261, and the details on page 3.
