VOLVO CARS SERVICE AND PARTS BUSINESS

# Technical Journal

**TITLE:**  
**Squeaking noise from subframe bushings / Reinforcement plate**

<b>REF NO:</b> TJ 17644	<b>ISSUING DEPARTMENT:</b> Technical Service	<b>CAR MARKET:</b> United States and Canada
<b>PARTNER:</b> 3 US 7510 Volvo Cars North America		<b>ISSUE DATE:</b> YEAR MONTH DAY 2013 07 15
<b>FUNC GROUP:</b> 2182	<b>FUNC DESC:</b> Rubber cushion	Page 1 of 6

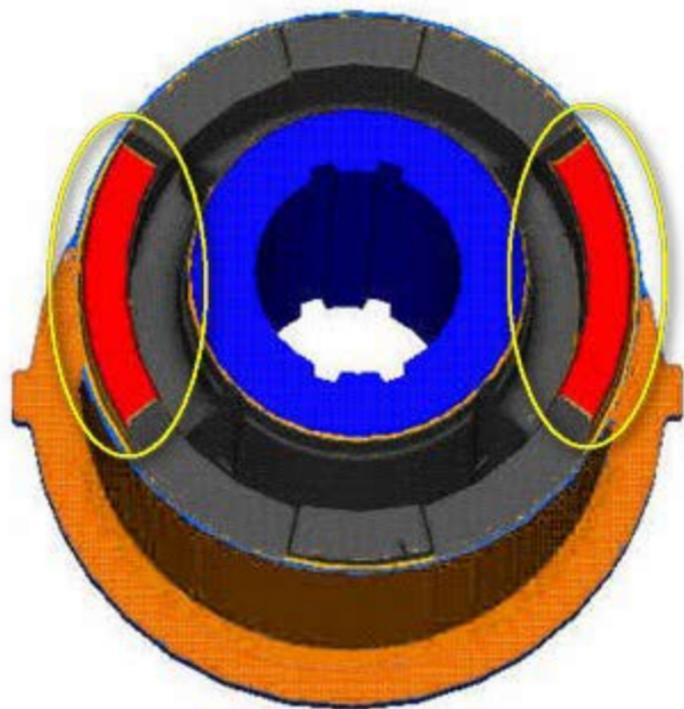
ORANGE BUSHING

The noise usually comes from the rear bushings in the front subframe due to axial travel resulting in a rubbing or squeaking noise between the reinforcement plate and the bushings' front and rear axial movement limiters.

Once the rubber material on the bushing is worn out, the underneath plastic material may cause a soft knocking noise instead. The contact points are illustrated in the attached pictures: TJ 17644 -1.jpg; TJ 17644 -2.jpg
