**SB-10044146-4865**

| <b>Title</b> | Oil consumption, low or uneven idle, "Low oil Level" or "Oil level low" in DIM | <b>Status</b> | Released |

| Volvo Car Customer Service | | |
|---|---|---|
| Title | Excessive oil consumption, low or uneven idle, Low oil Level message in DIM | |

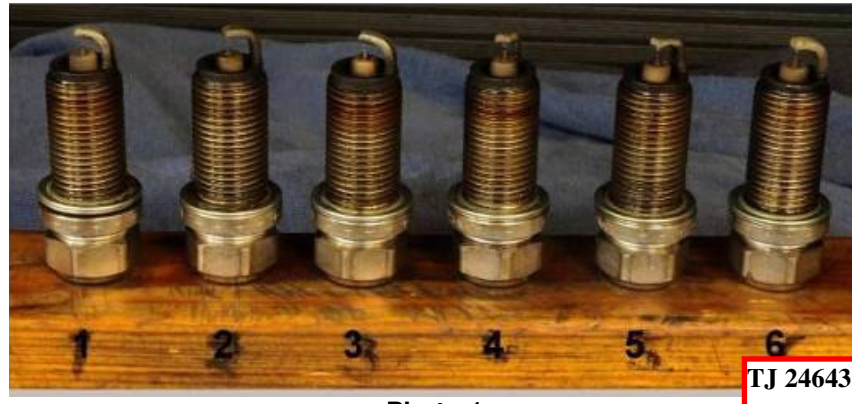
This step is only valid for engine 94, which was introduced in model year 2011. The customer may experience unexpected engine oil usage for the distance covered, e.g. 5,000 miles, the yellow warning symbol may be lit and the "Engine oil level low" message may be displayed in the DIM. The spark plugs may be equally dark (see Photo 1 below).

A new piston and oil control ring was introduced into production at engine date 301011B21530 (DDMMYYxxxxx). Follow the steps below for the service solution for engines built up to this date.

Print out DTCs using VIDA. Remove all spark plugs and compare the deposits / colors of each plug. If some plugs have a lot more soot than others, see Steps 3 and 4. If plugs match Photo 1, follow the steps below. Regardless of what the plugs look like, the latest ECM/TCM Upgrade should be performed (after the proper repair is carried out) before releasing the vehicle to the customer.

- Perform an ECM Upgrade according to VIDA. Note that after this download the customer may notice a slight difference in transmission shifting since the ECM and TCM Upgrades get downloaded together.
- Replace the engine oil dip stick with P/N 31251037
- Exchange the engine oil and refill to a volume 0.6 L (0.6 qts) higher, making the total oil fill volume 7.4 L (7.8 qts). Confirm that the oil level is up to the MAX mark on the new dip stick.
- Install a decal P/N 31349543 showing the new engine oil volume. Clean with isopropanol P/N 1161721 and apply the sticker according to the Photos 2 and 3.

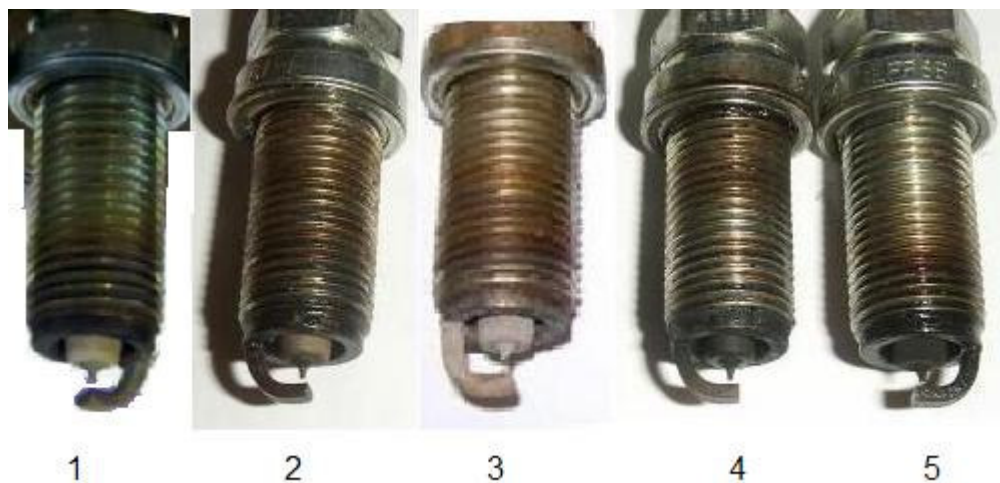
**Spark plug soot level for Prior Approval:** Level of soot on plugs (0 = no soot, 5 = excessive soot), see Photo 4 for reference. A rating of "0" would correspond to a brand new spark plug. You will be asked to provide this information and a picture of the spark plugs when submitting the online form to the Prior Approval Department.

Photo 4. Photo examples for soot level reference

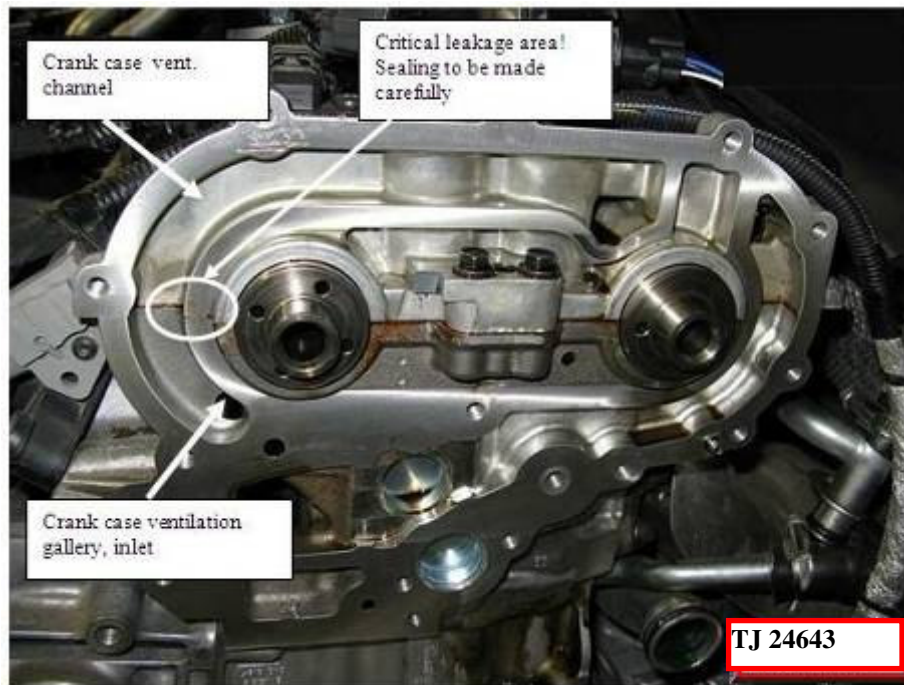
Photo 5. For reference only, not a valid check

If the sealing surface is discolored by oil as shown in the photos, it is most likely that there is a leak between the cam cover and the cylinder head in the area facing the PCV channel connecting the breather box and the PCV gallery. If this is the case, the valve guides should still be checked according to Step 4 before continuing. After checking according to Step 4 (as long as the same cam cover and cylinder head will be re-installed), the cam cover must be resealed according to VIDA. **To get claim approval, contact the Prior Approval Department.**

If the sealing surface is not discolored by oil as shown in the photos, continue diagnosis elsewhere in the engine. The cam cover should be resealed according to VIDA prior to re-installation, as long as the same cam cover and cylinder head will be re-installed.

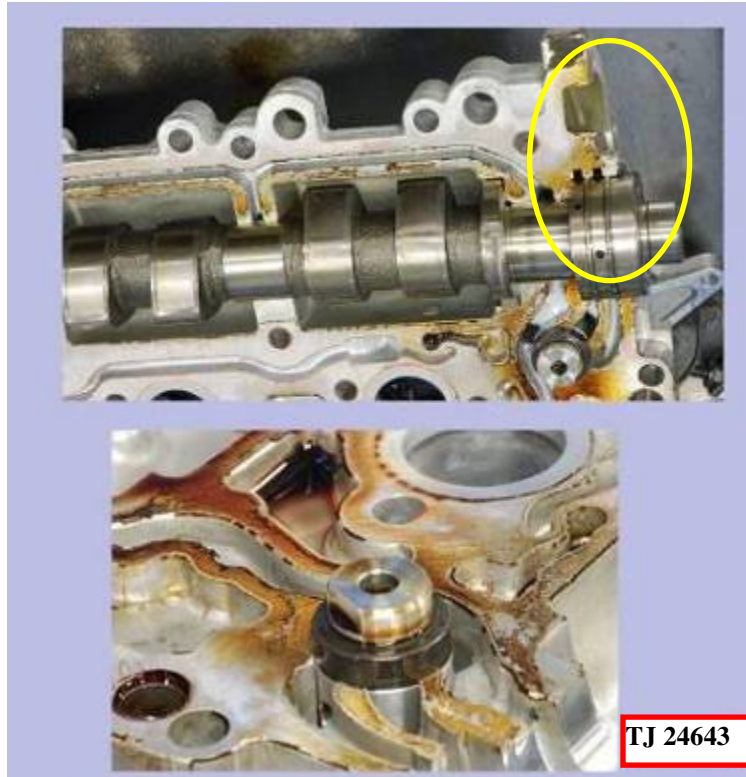
Photo 6. Check method for cam cover sealing surface

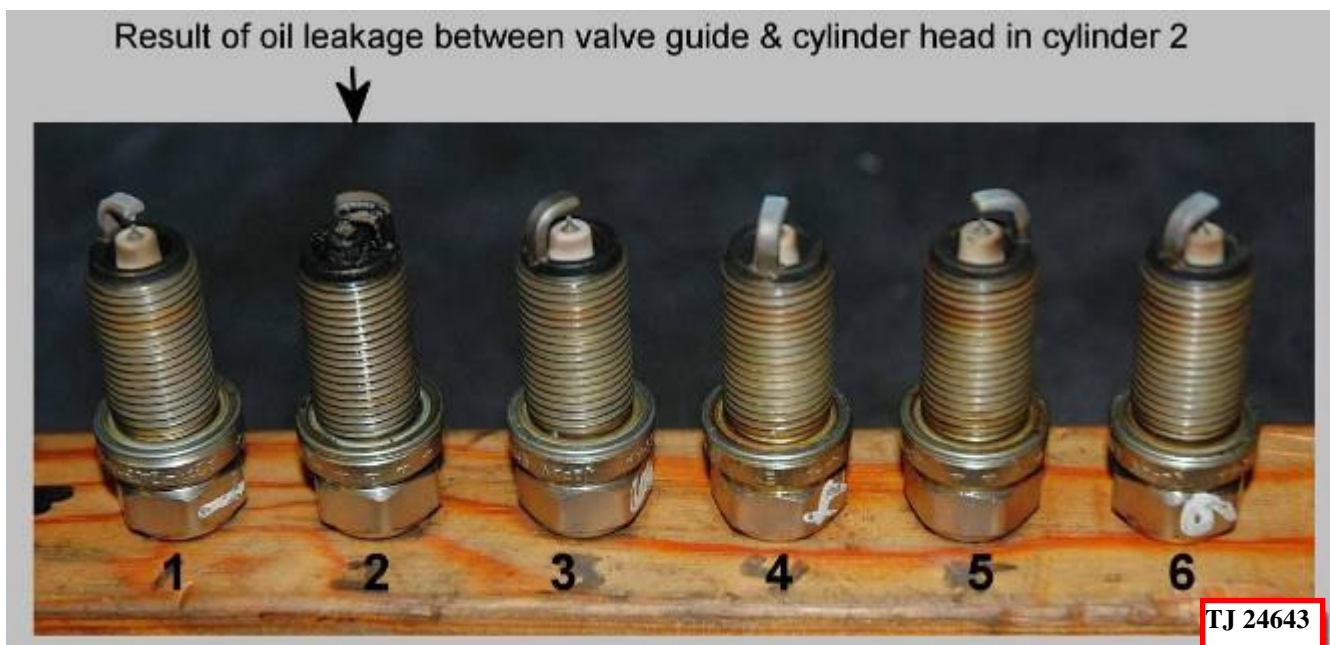
Look at the spark plugs in Photo 7 below. If the valve guide is leaking in a cylinder, the corresponding spark plug will have more soot than the others. In the example in Photo 7, cylinder 2 is consuming oil.

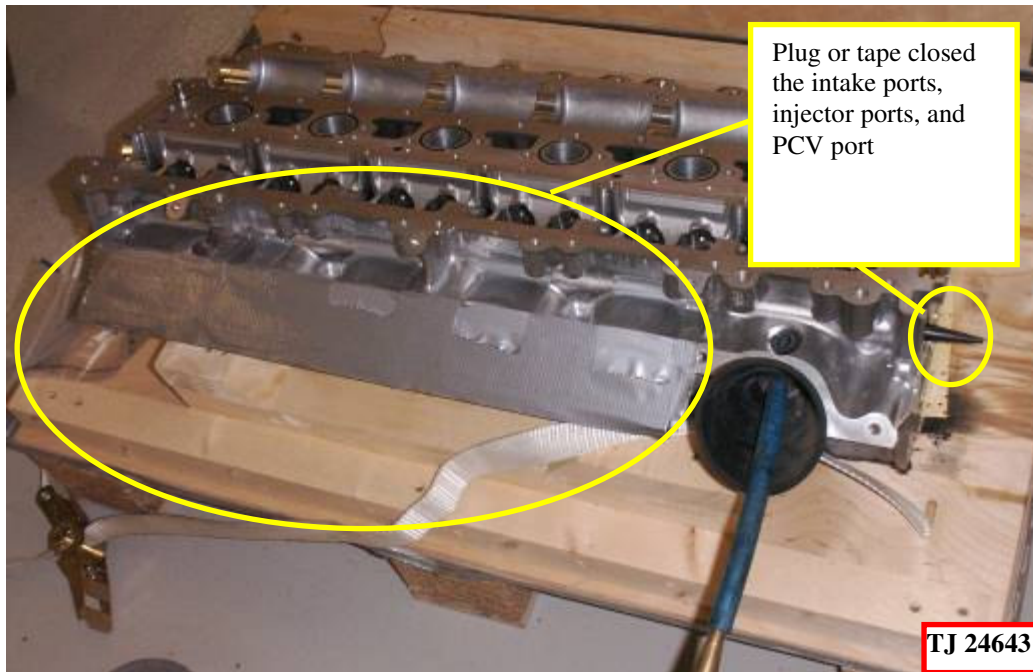
**Note! Use safety glasses!** Remove the valve tappets. Plug all but one intake port, all injector ports, and the PCV inlet. Starting with the intake port that corresponds to the spark plug with the most soot, apply air pressure to one intake port at a time using a plug similar to those found on emissions testers. See Photos 8 and 9, left. Look at the base of the valve spring and check for ripples or bubbling in the ATF as you apply light

**Photo 8.** Note that the cylinder head is removed in this photo but this test should be performed on the vehicle.

air pressure. If the ATF ripples or bubbles, then replace the cylinder head. **To get claim approval, contact the Prior Approval Department.**
