14/09/  
2015.templet\_na\_inv

COMPANY: IPS  
INSPECTED BY: N Joubert  
DATE OF INSPECTION: 14/09/2015  
PREPARED FOR: Temples Nantwich

Agent: Temples (Nantwich)  
Property Type: Four Bedroom – Detached  
Prepared & Inspected By: IPS (NJ)  
Inspection Type: Inventory & Schedule of Condition  
Weather Conditions: Sunshine & Clouds  
Tenant Details: Goldbeck Construction Ltd  
Tenancy Start Date: 15th September 2015  
Landlord: Temples (Nantwich) Ltd

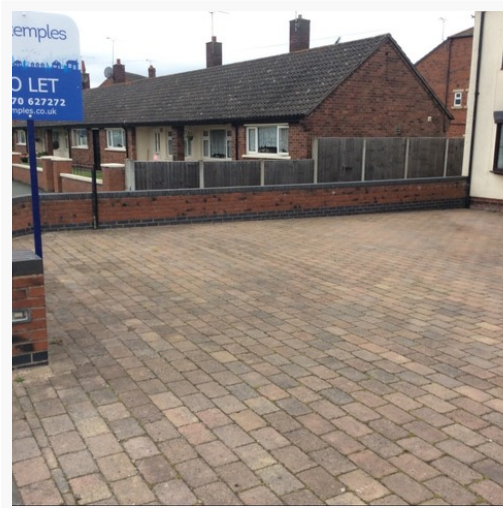
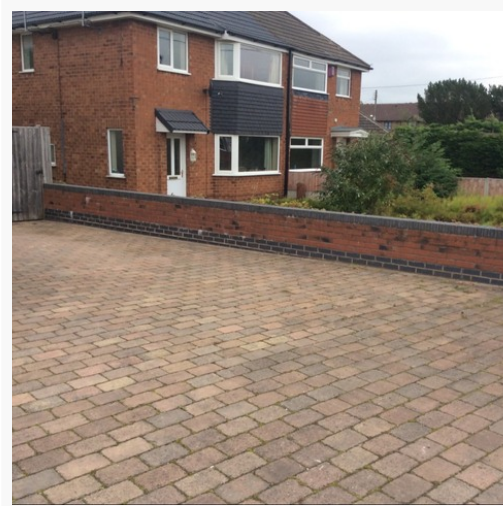
Few weeds are visible between the mono blocks.

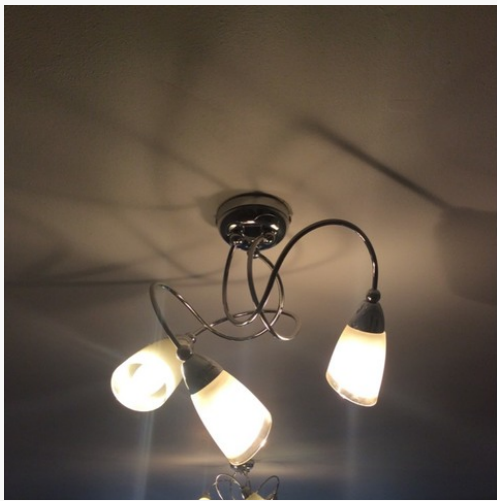
– Lighting

One replacement light bulb is required (T)

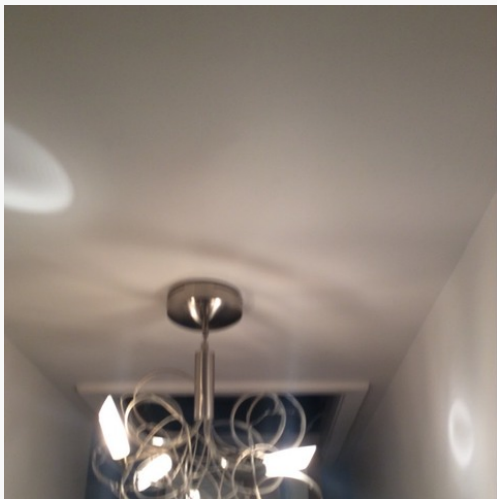
– Lighting

Including one brushed steel decorative pendant fitting with opaque glass shades.  
One replacement lightbulb is required.

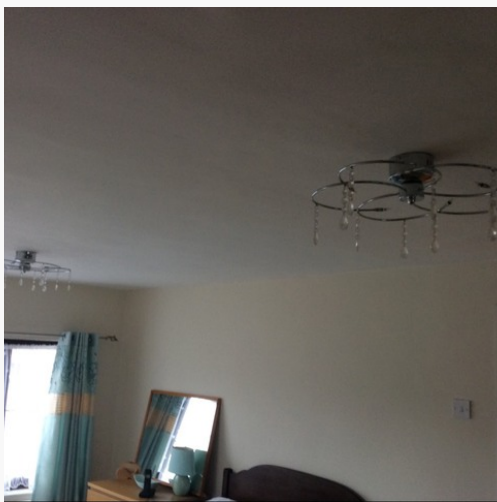
– Lighting

The decorative light fitting is not working.  
Inspection is recommended (L).

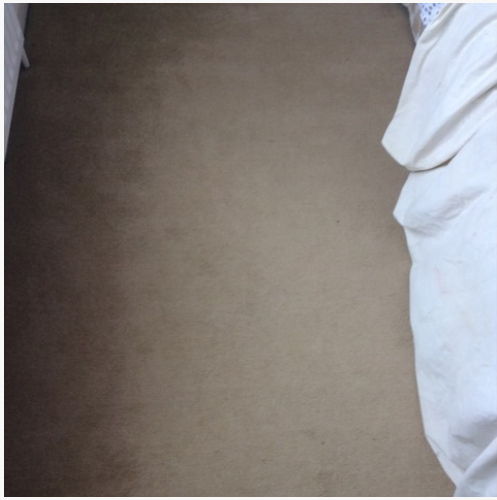
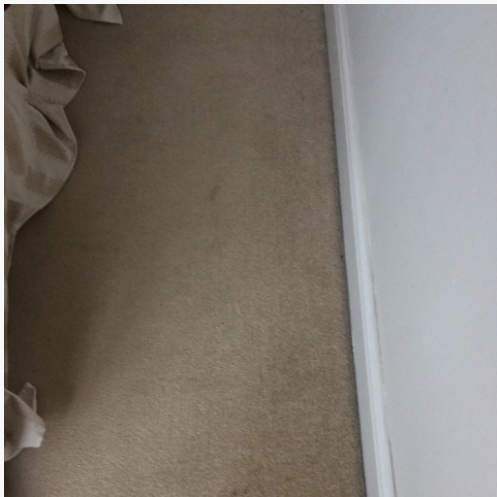
– Flooring

Vacuuming is required under and around furnishings (T)  
One stain now present to the carpet (T)

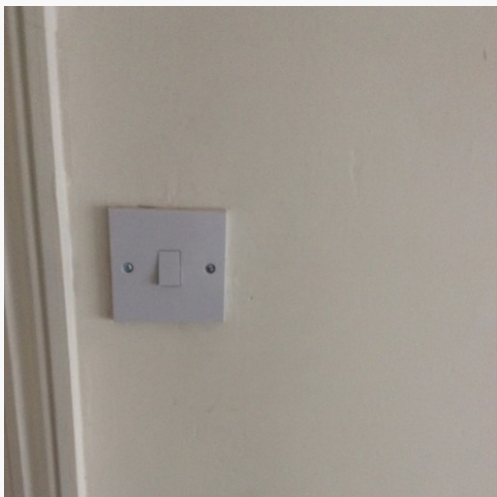
– Walls & Decor

Dust is visible to skirting board surfaces (T)
