*Darb Qirmiz Quarter, Cairo, Egypt*

Madrasa Tatr al-Higaziya: rebuilding of Mirhab

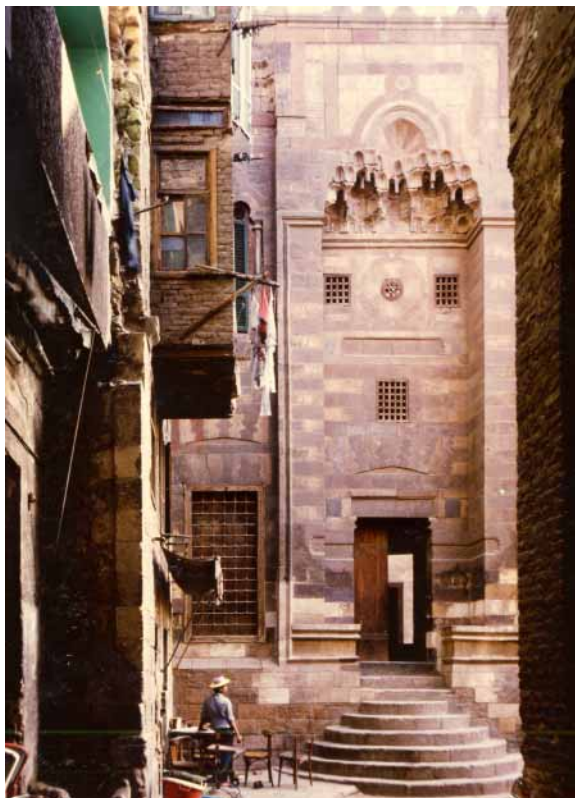
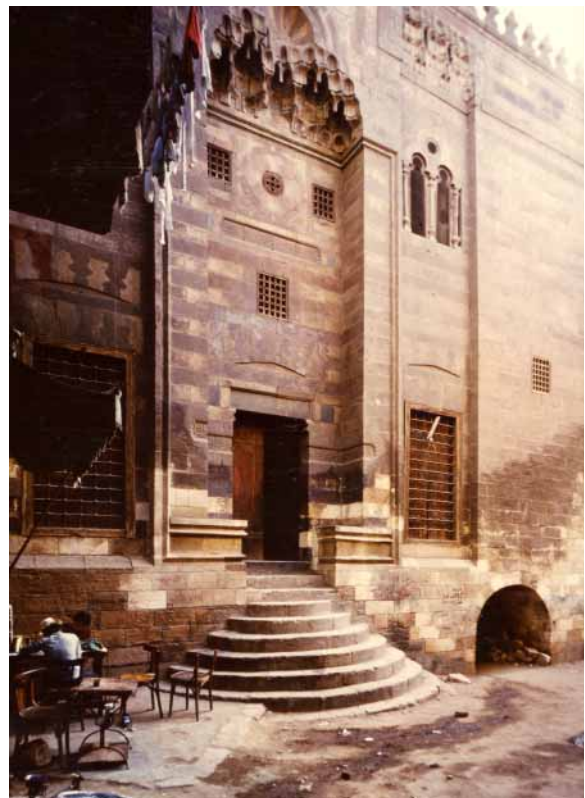
Entry facade of Madrasa. Access to apartments behind monument is through a vaulted passage (lower right)

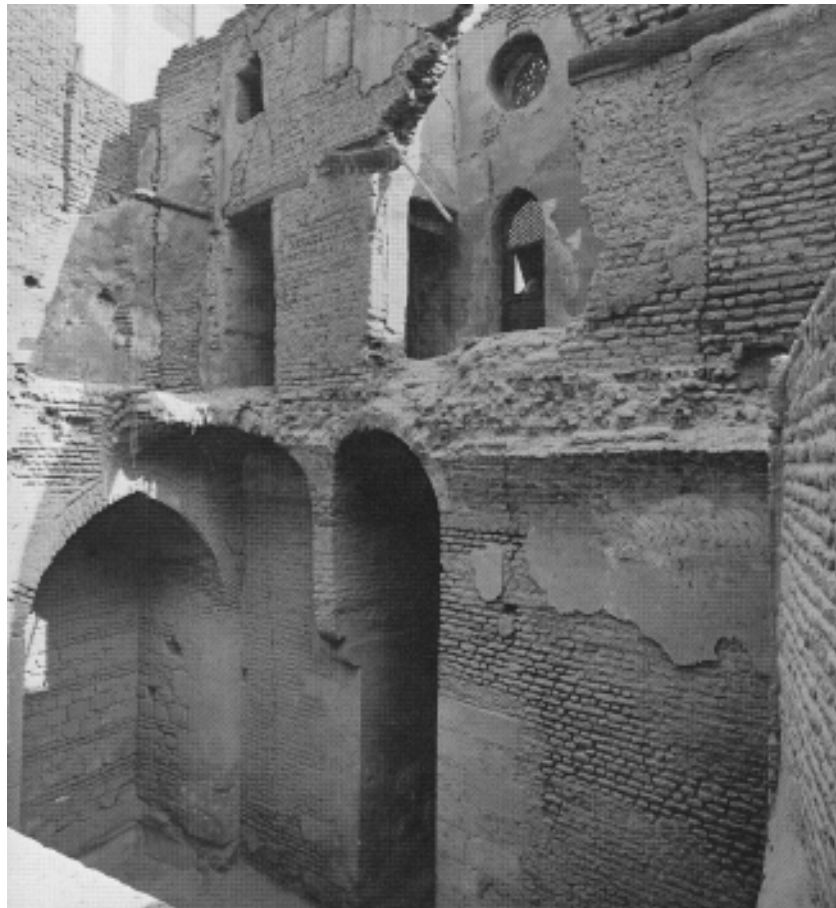
South wing of Madrasa before restoration

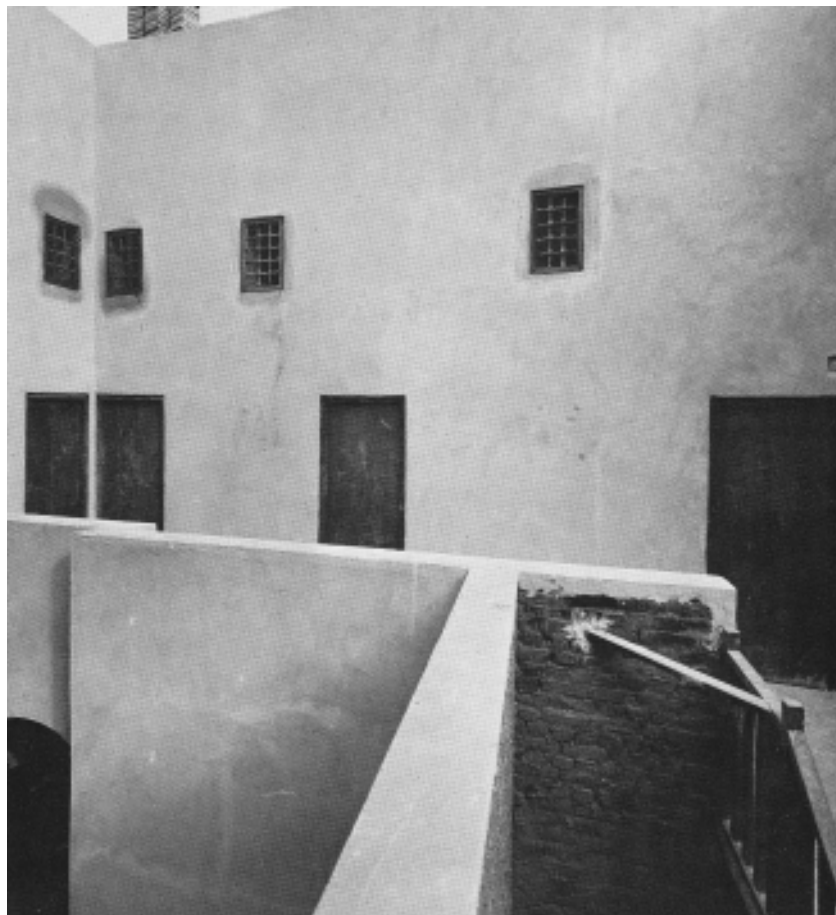
South wing during restoration

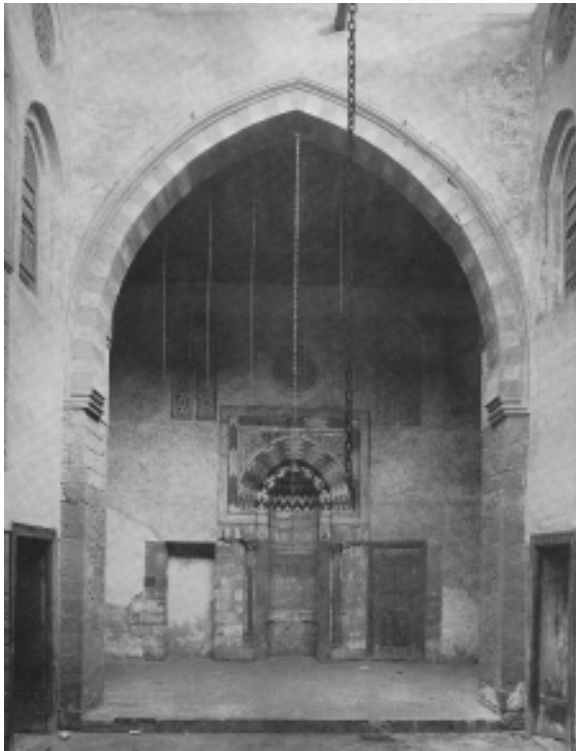
The main "iwan" and paryer niche before restoration

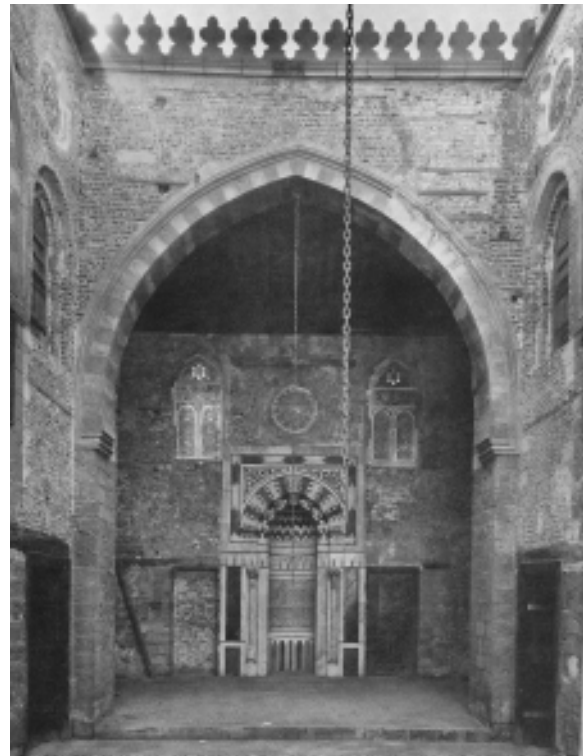
The main "iwan" after restoration.  
Note the reintroduction of parapets.

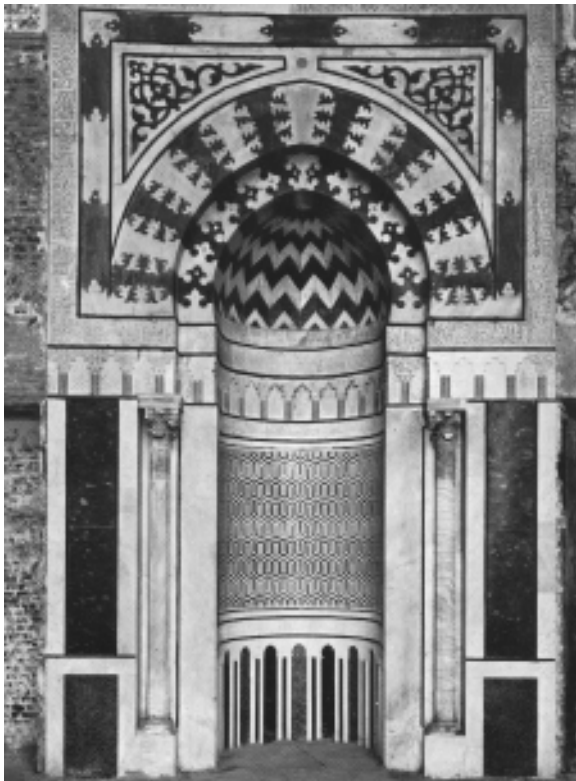
Detail of prayer niche's decoration

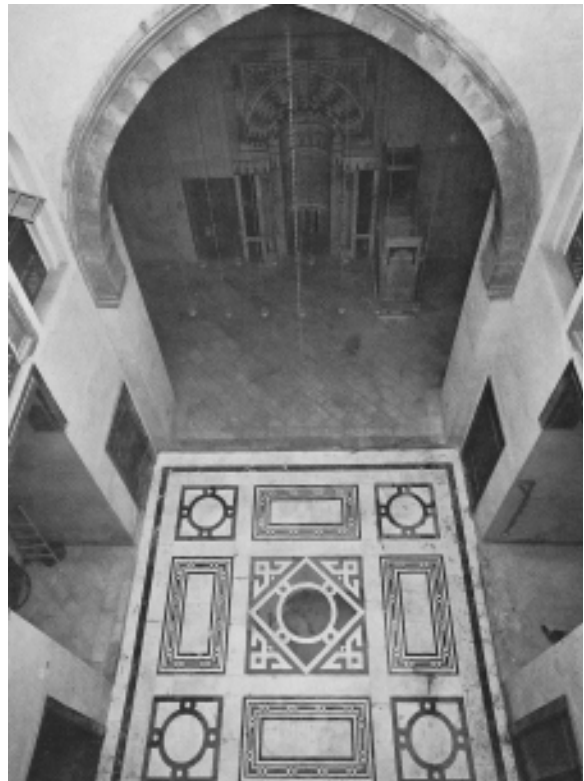
Courtyard paving and main "iwan" after restoration

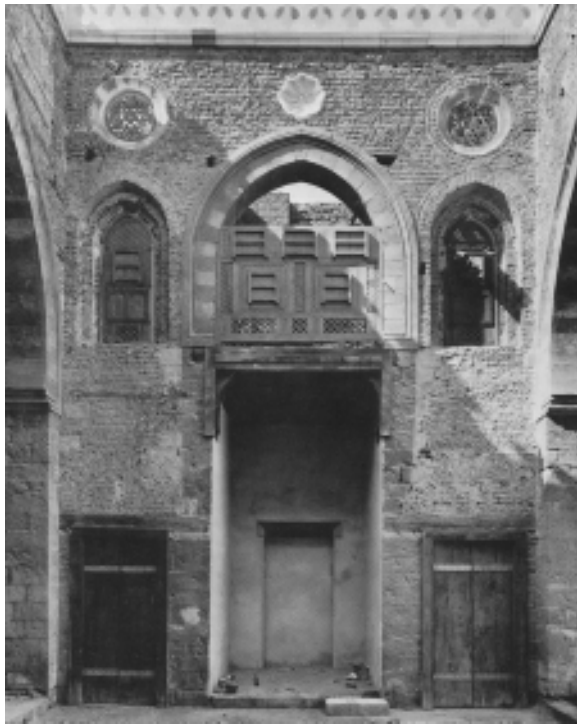
The north “iwan” with the old Mahrabiya  
before restoration

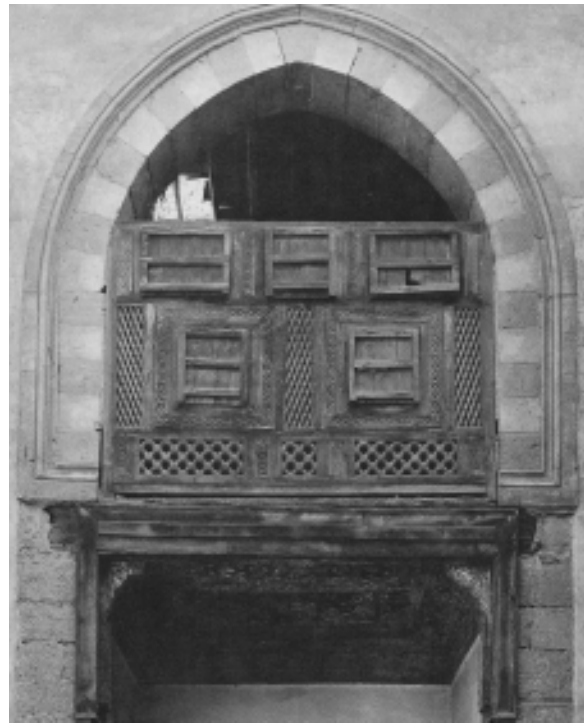
Detail of restored mahrabiya

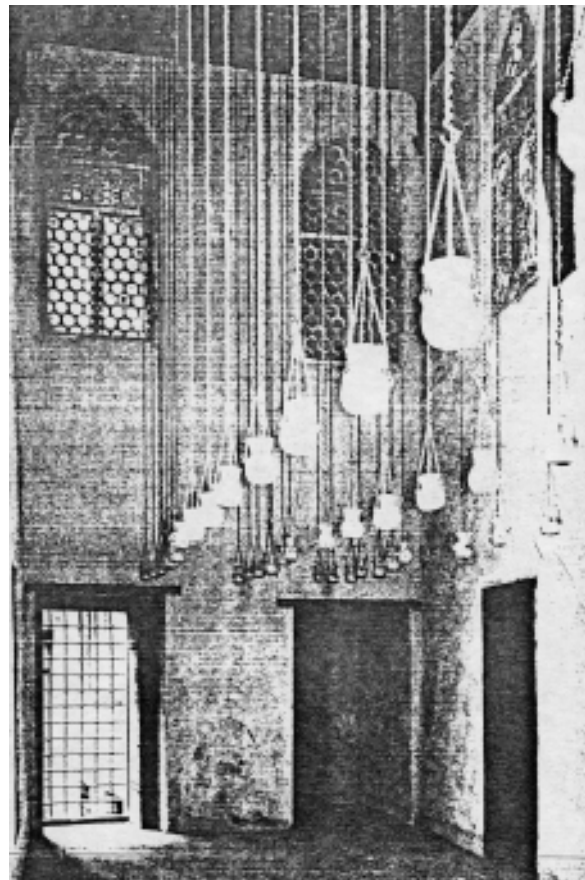
Entrance on north "iwān" with  
suspended lighting system

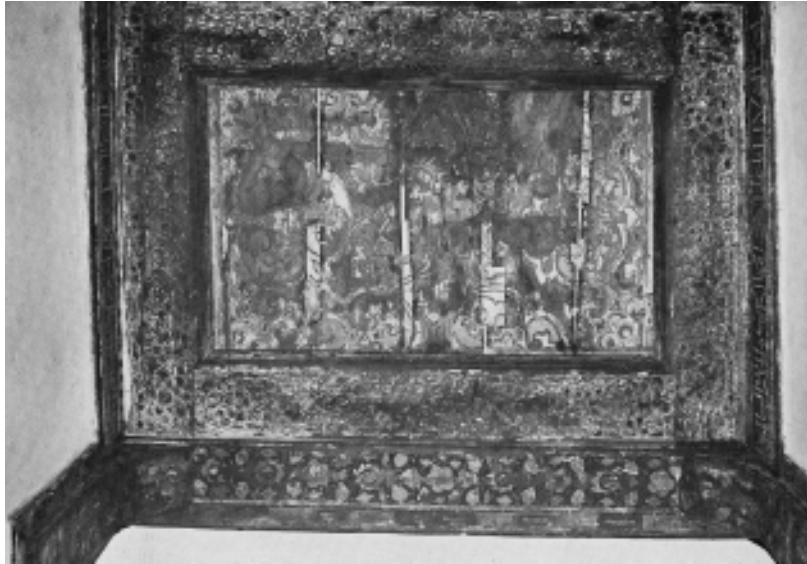
Restoration work  
ot the fine  
chiselled ceilings

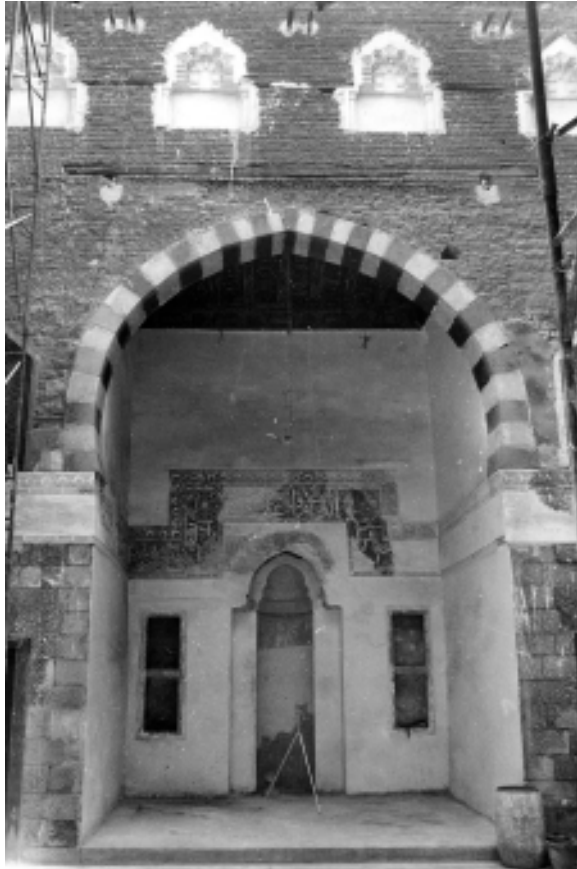
Madrasa Tatar al-Higaziya:  
prayer niche frieze before restoration

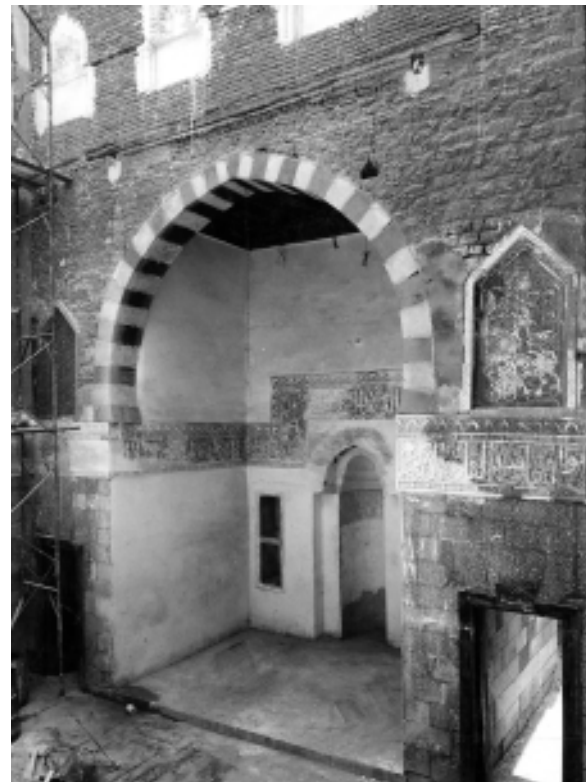
Courtyard and southeast "iwan" during restoration

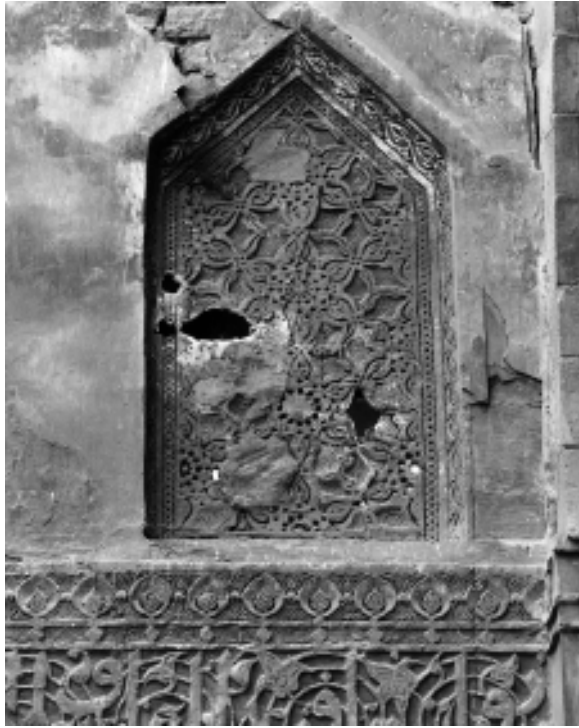
Stucco decoration before restoration

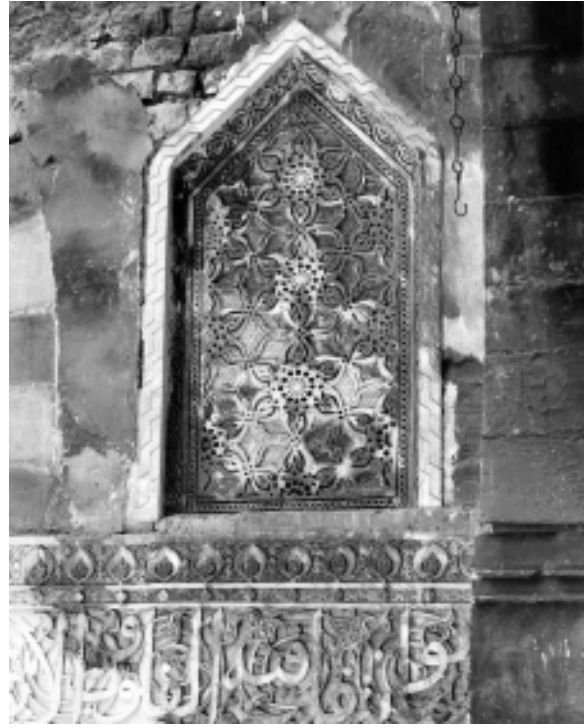
Stucco decoration after restoration

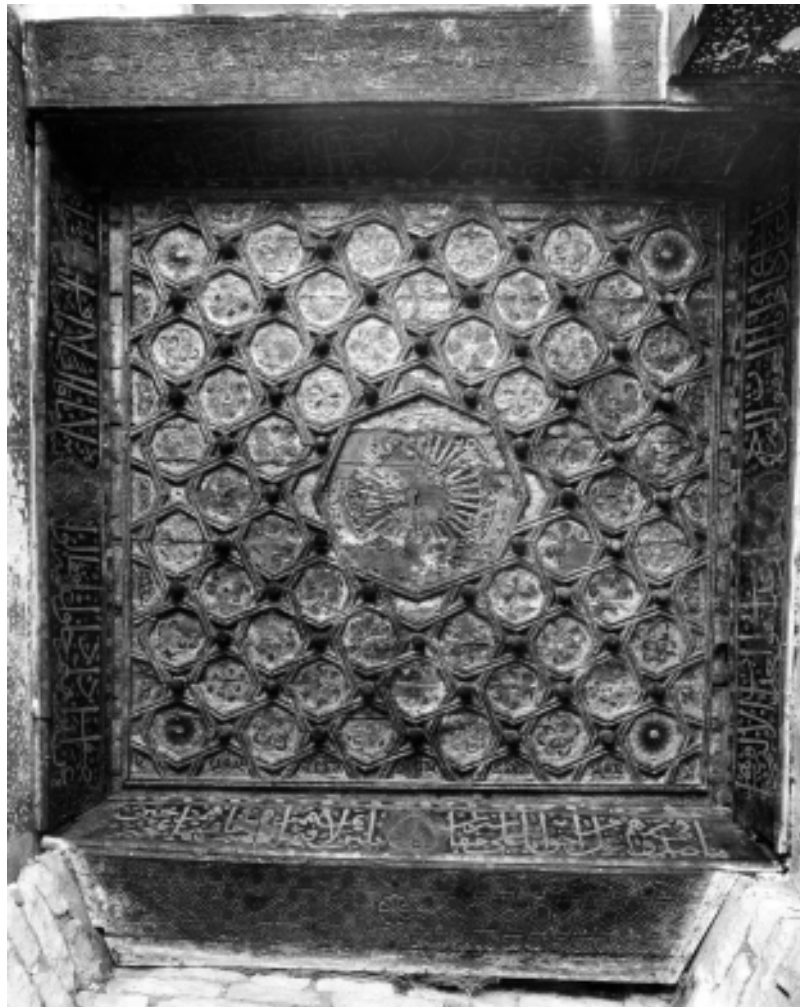
Wooden ceiling after restoration

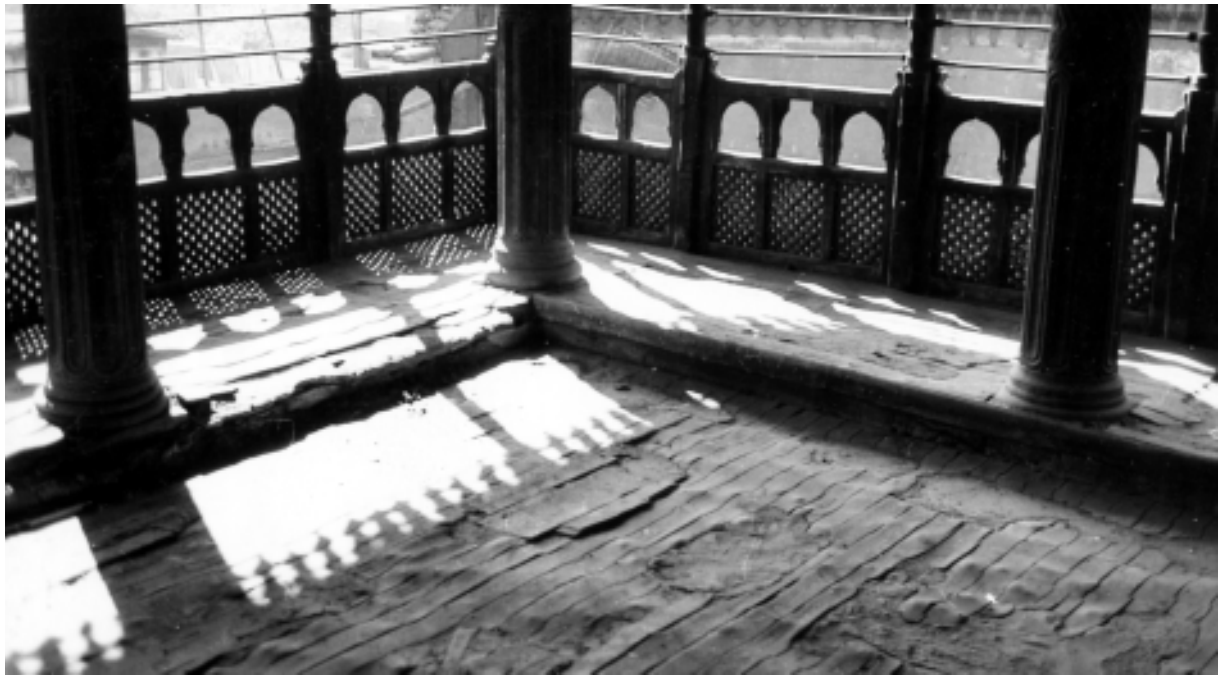
Sabil Kuttab: first floor before restoration

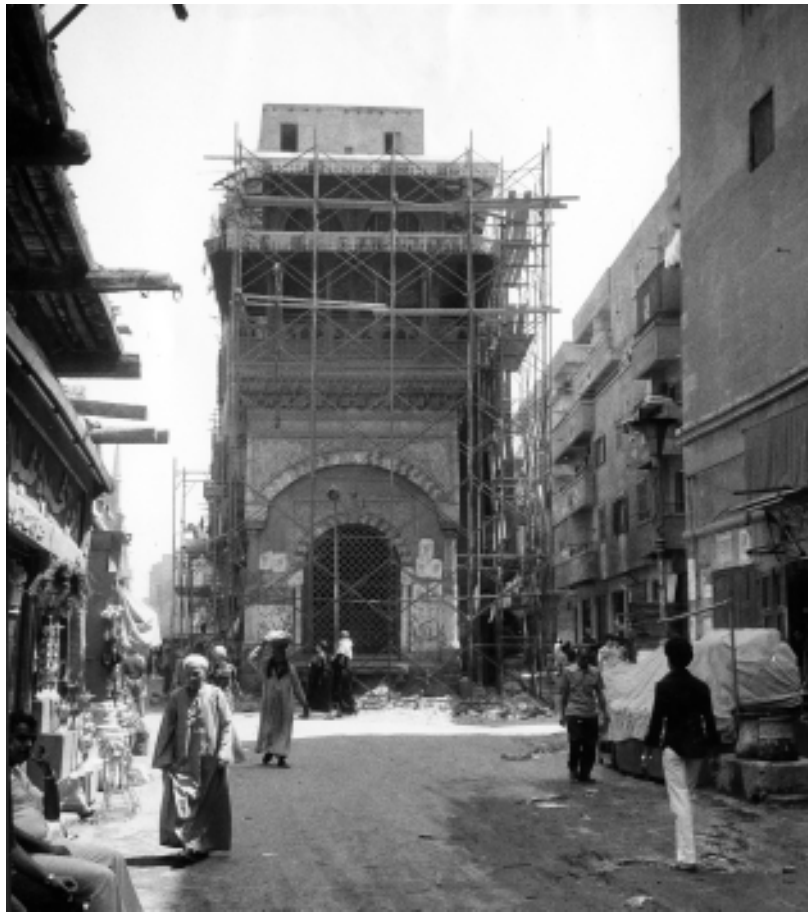
View on Fountainhouse during restoration of the roof

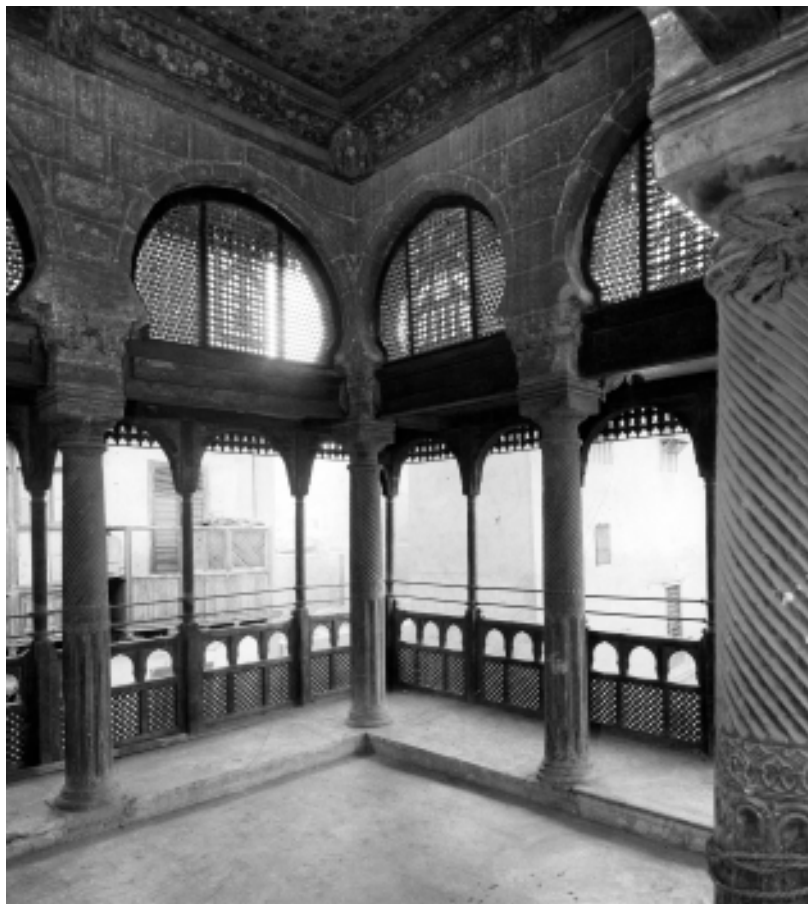
The first floor of Fountainhouse after rebuilding and consolidation

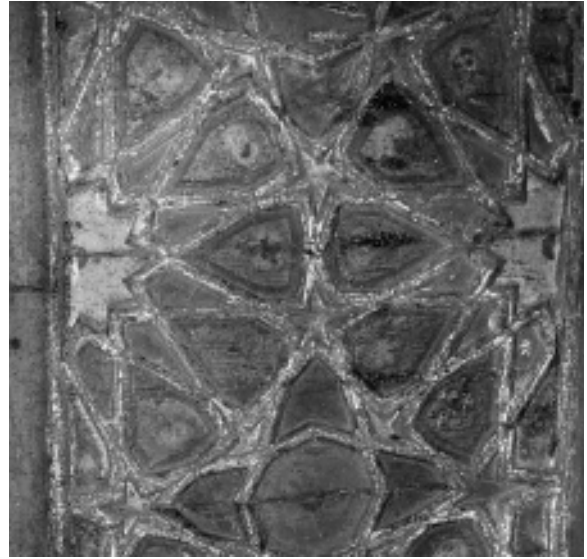
Sabil Kuttab: decorated lower ceiling before cleaning
