Above: The al Abbas Mosque is situated 38km southwest of Sana'a near the village of Asnaf. The ruins of an earlier mosque and a stable can be seen at the left of the mosque.

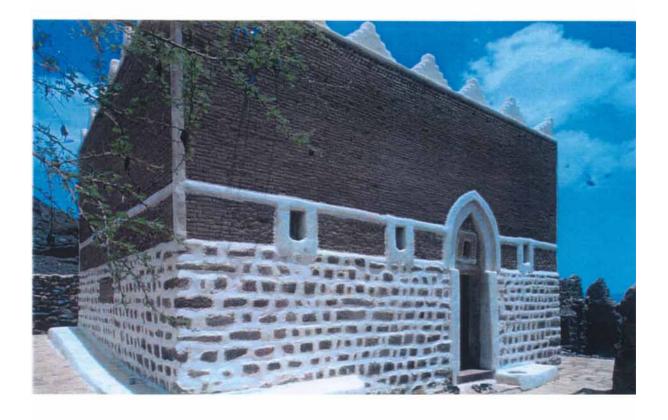
Below: The entrance to the mosque on the west façade.

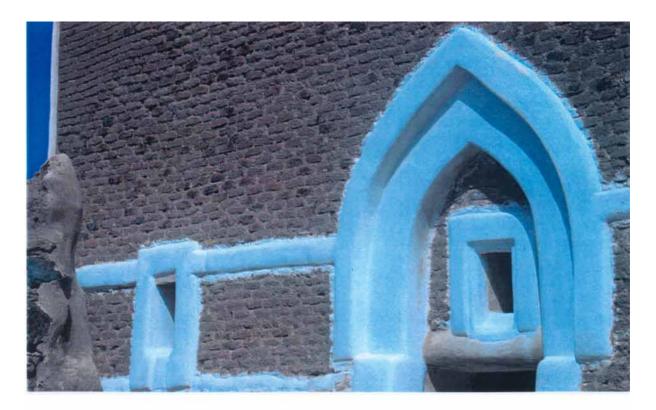
Above: South façade; window and door openings are treated with qudad, which is lime mortar and crushed volcanic stone.

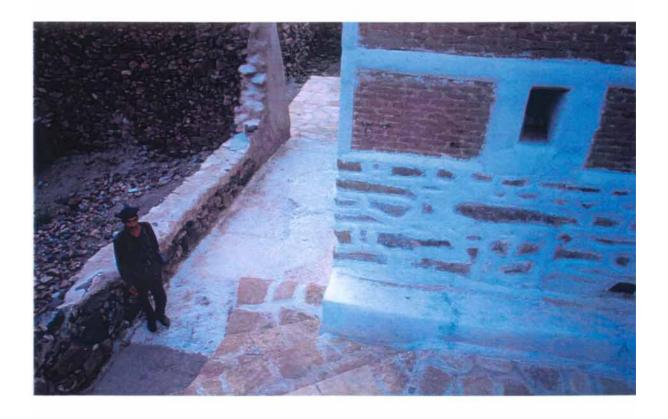
Below: The stove paved platform around the mosque can be removed if excavations around the mosque are necessary.

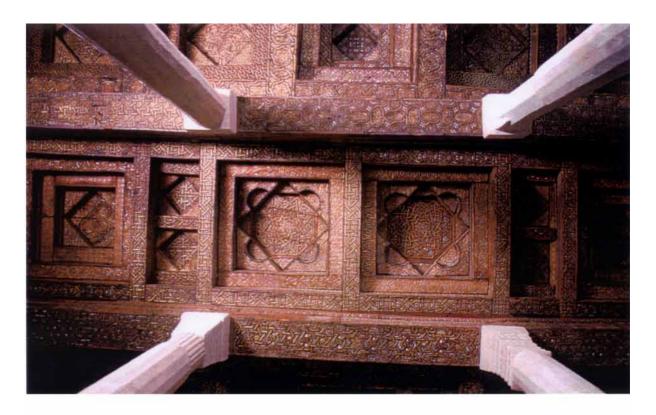
Above: Detail of the timber-coffered ceiling supported by stone columns.

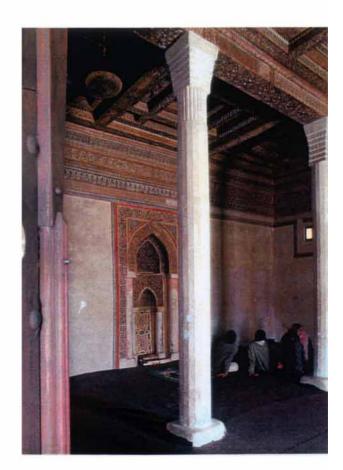
Below: Interior prayer hall; view to the mihrab on the north wall.

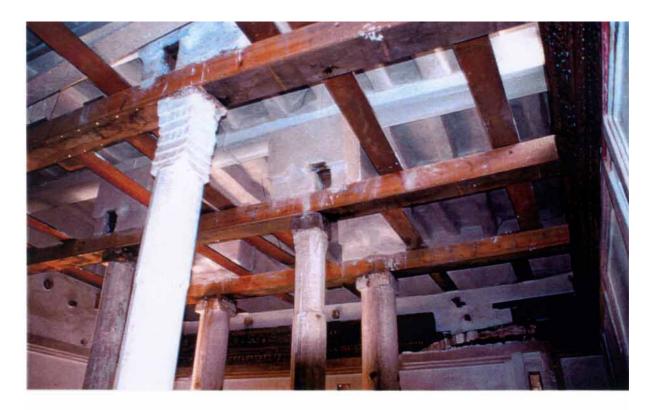
Above: The coffers of the timber ceiling were completely dismantled and reconstituted during the restoration process.

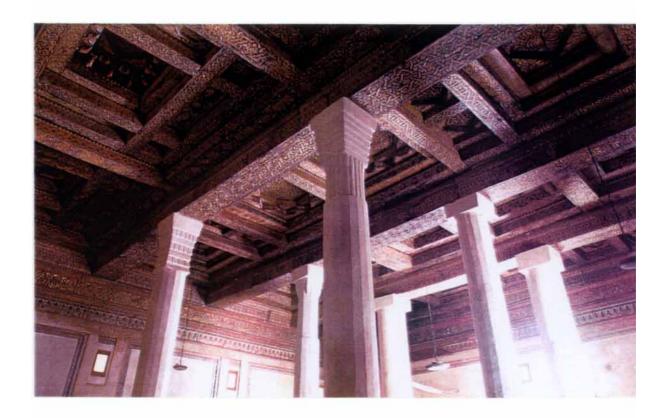
Below: The restored ceiling is decorated with painted and gilded floral and geometric patterns as well as bands of writing.

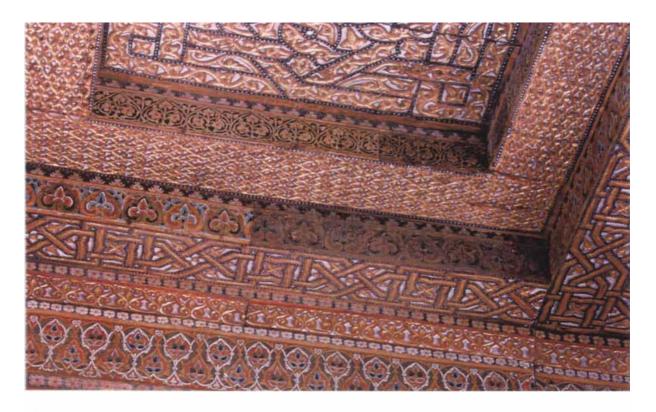
Above: Detail of a coffer; the restoration work involved very careful cleaning of the painted and gilded surfaces.

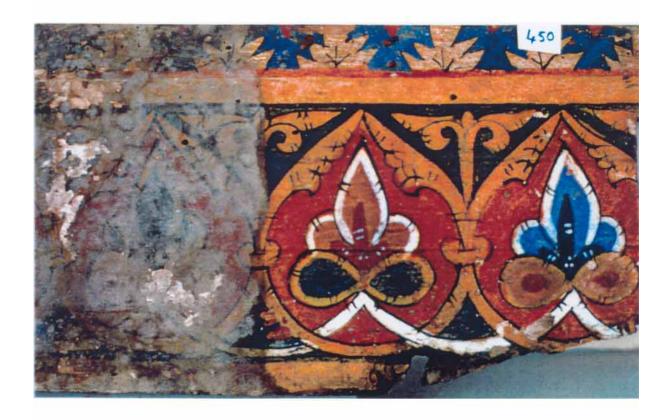
Below: Detail of a floral pattern showing both a restored portion (right) and the condition before restoration (left).

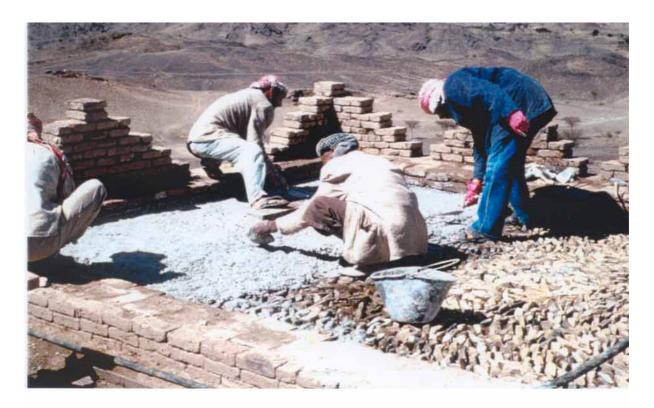
Above: The roof of the mosque was covered with a layer of mud mortar and crushed stones on top of it to hold the qudad.

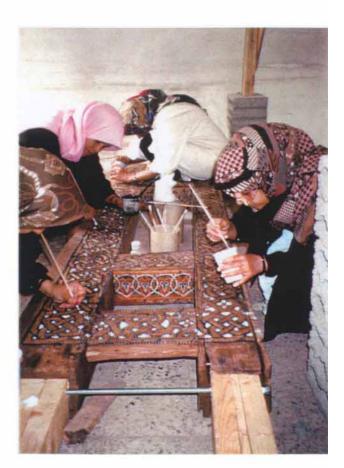
Right: The timber ceiling was removed and carefully cleansed at the Sana'a Museum.
