CONSERVATION OF THE WAZIR KHAN MOSQUE LAHORE

PRELIMINARY REPORT ON CONDITION AND RISK ASSESSMENT

AGA KHAN TRUST FOR CULTURE AGA KHAN CULTURAL SERVICE - PAKISTAN

PART II: DOCUMENTATION AND DAMAGE ANALYSIS

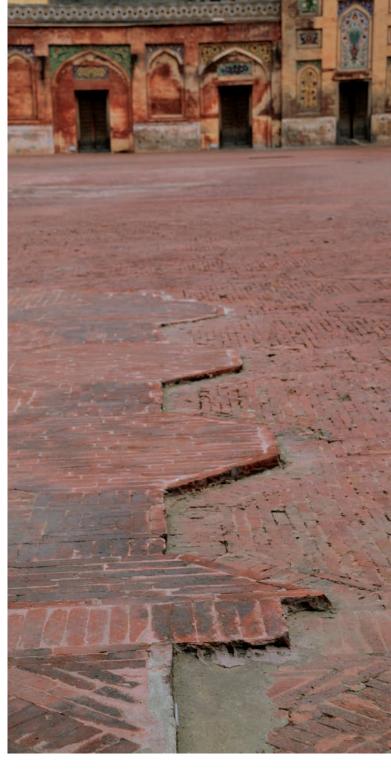
Above: Subsidence and floor repair in the north-west corner of the courtyard has created different levels with badly finished edges.

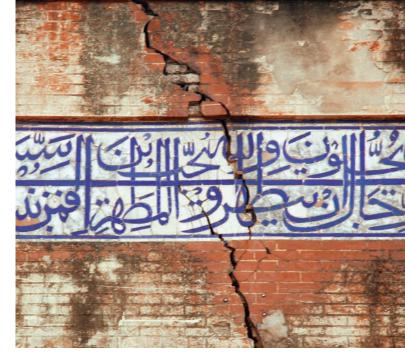
Top: The crack in the apex of the arch forming the southern most entrance into the prayer chamber.

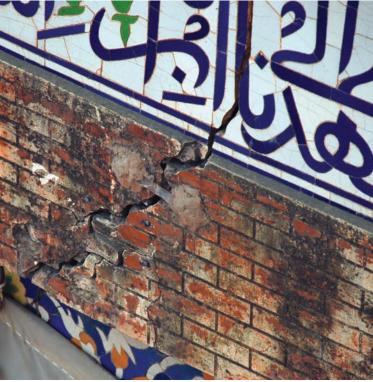
Above: A similar crack affecting the apex of the arch forming the northern most entrance. Both these are instances of the powerful lateral pull exerted by the respective minars.

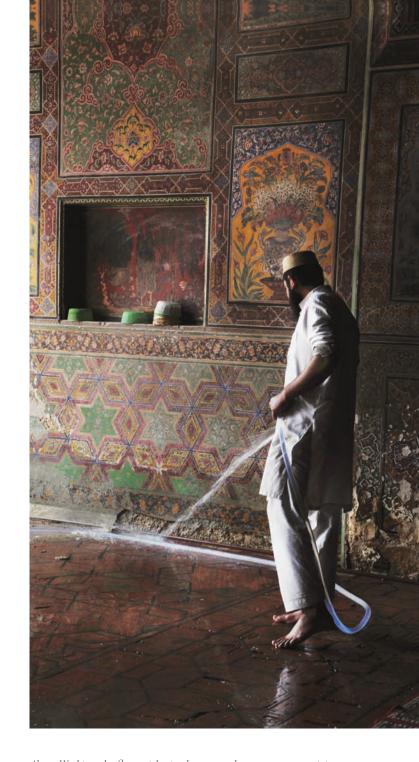
Above: Washing the floor with piped water under pressure, an activity unknown to the 17th century builders of the monument. Note the damp rising up the wall and the plaster render with the precious wall painting breaking out under the force of the stream of water.

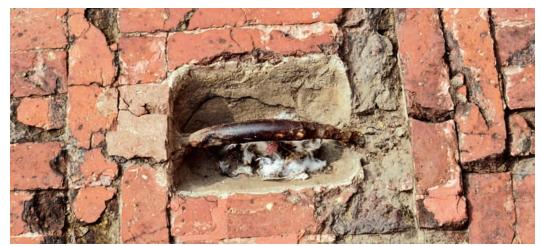
Puncturing of floor to accommodate fixtures such as metal hooks for tying shamiana ropes indicates the need for better and more appropriately located details.

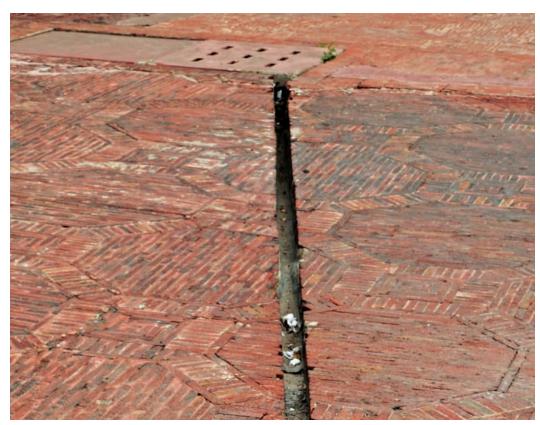
Cutting up the patterned floor to accommodate a collector drain. A better and well distributed system of under floor drains is required.

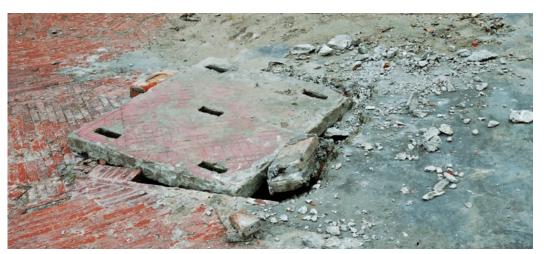
Poor detailing of waste and storm water disposal grating.

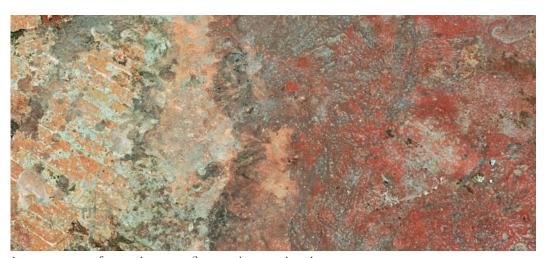
Inappropriate use of materials to repair floor - in this case coloured cement/sand or coloured lime render.

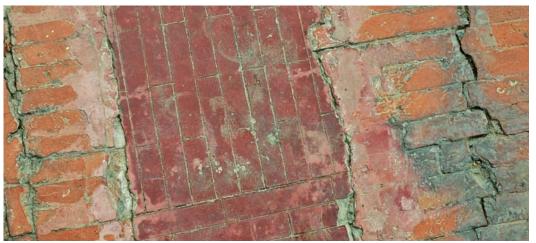
Brick and fake brick markings on cement/sand or lime/sand renders create an unsatisfactory appearance. Note the subsidence crack on the right of the photograph.

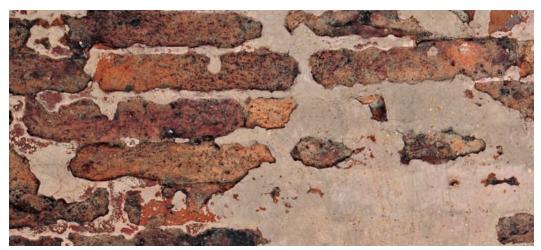
Inappropriate use of cement/sand renders and overgrouting between bricks.

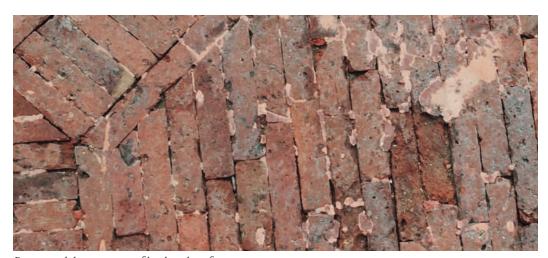
Erosion and disintegration of brick with surface wear.

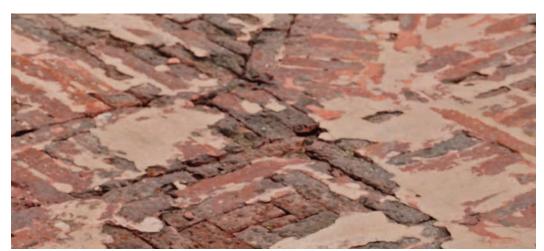
Faster rate of erosion of bricks with the inappropriate use of cement/sand renders used to achieve a water repellent surface.

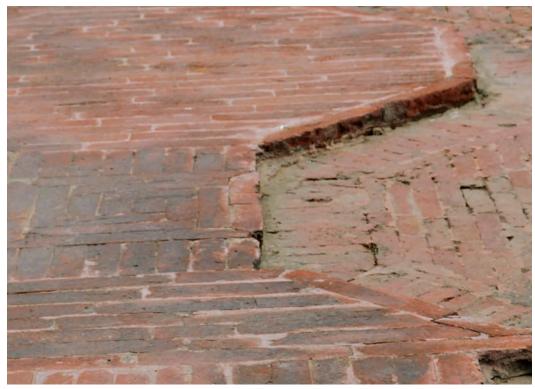
Subsidence and inadequate repair at different levels.

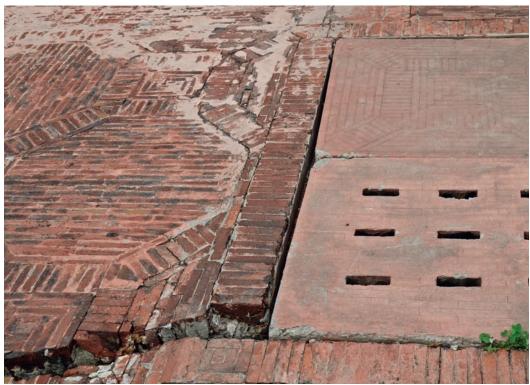
Puncturing of floors for installment of drains, drain outlets and gratings indicate the need for better and more sophisticated detailing.

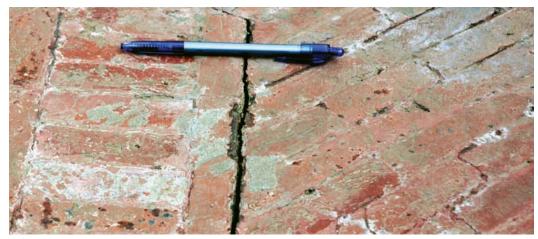
Major crack in the floor of the south-eastern part of the courtyard.

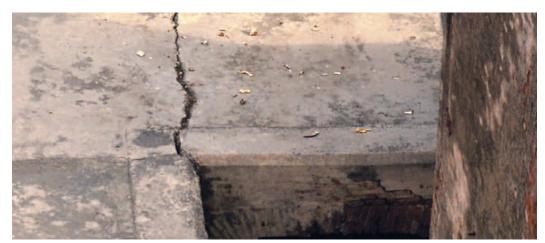
${\it Major\ crack\ in\ the\ roof\ of\ the\ southern\ axial\ pavilion}.$

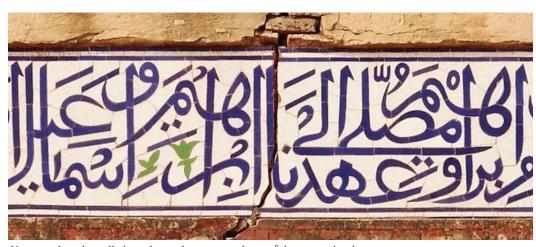
Major crack in the wall above the northern most archway of the prayer chamber.

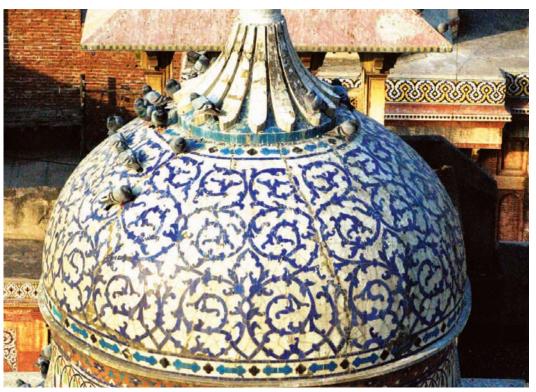
Major crack in one of the domes of the chhatri above the entrance iwan.

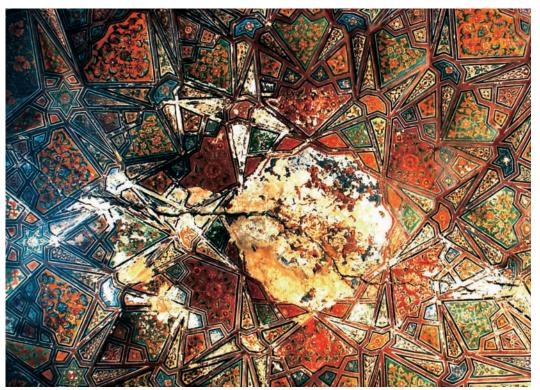
Major crack in the vault of the northern most archway of the prayer chamber.

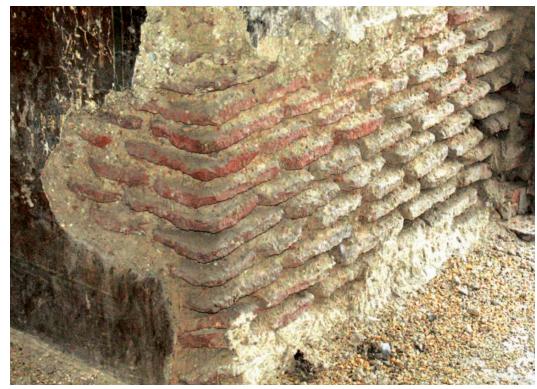
Erosion of mortar between the joints on the exposed surfaces of masonry.

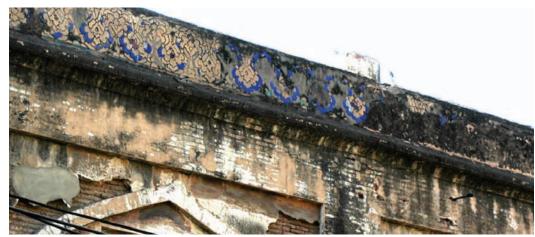
Advanced state of the deterioration of both mortar based external finishes such as faux brick and plain plaster render, as well as deterioration of crenellated tile work on the roof line of the north façade.

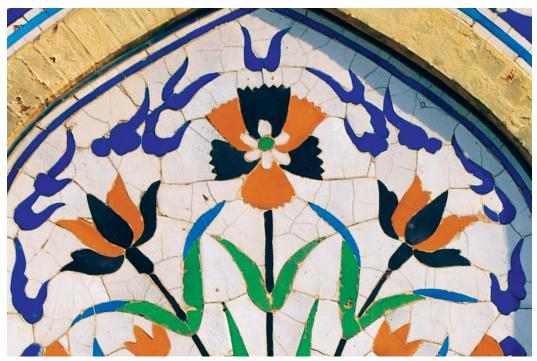
Hairline cracks on the glazed surface of tiles. These cracks are sometimes indistinguishable from the fine joints of the cut-to-shape tiles, but could be the beginning of more advanced weathering processes.

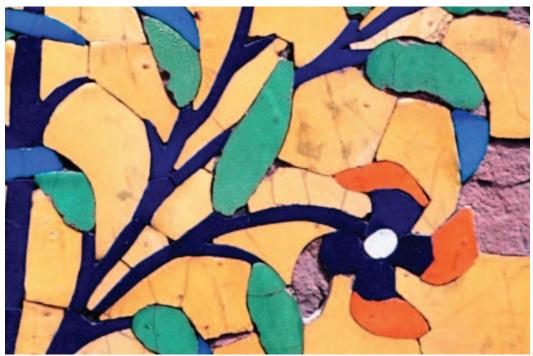
Pitting and spalling of thin layers of terracotta body of the tile. At this stage of deterioration, piece-meal replacement of sections of tile may be considered.

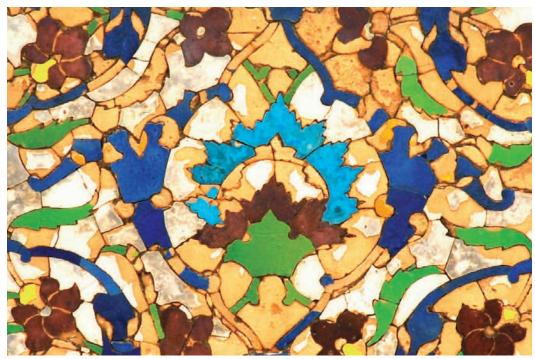
Exfoliation of glaze from the terracotta body of the tile is the most common damage type on glazed tiles. In many instances concurrent existence of exfoliated glaze and tiles with glaze still intact presents a characteristic agevalue of some interest and this situation could be one of the lower priority interventions to be addressed.

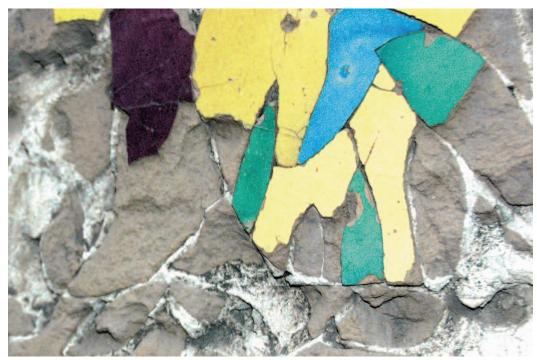
Advanced spalling of the core terracotta body of the tile.
