The Aga Khan Award for Architecture

Conservation of the Mevlevi Sama'khana Cairo, Egypt

<i>Architect</i>	Giuseppe Fanfoni Roma, Italy
<i>Client</i>	Egyptian Antiquities Organization Cairo, Egypt
<i>Consultant</i>	Scuola Orientale dell'Università di Roma "La Sapienza" Roma, Italy
<i>Contractor</i>	Centro Italo-Egiziano per il Restauro e l'Archeologia Cairo, Egypt
<i>Completed</i>	May 1987
<i>Site area</i>	3'850 square metres
<i>Ground floor</i>	256 square metres
<i>Total floor</i>	628 square metres
<i>Costs</i>	not available

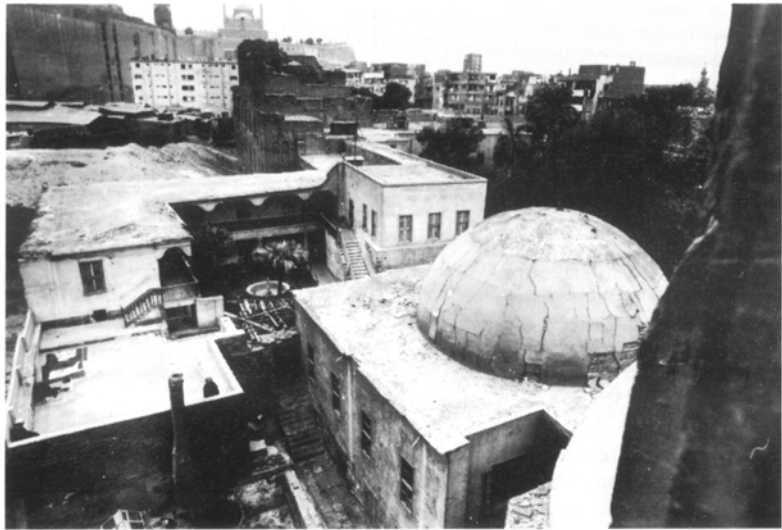
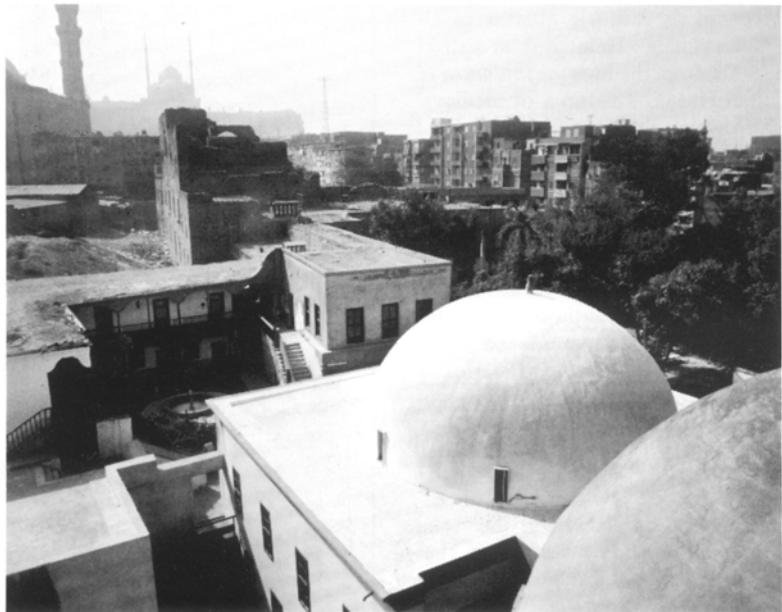
1. & 2. View from above before & after restoration with the Yazbak Palace and the Citadel in the background

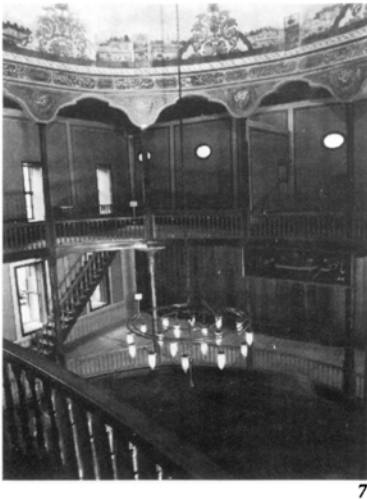
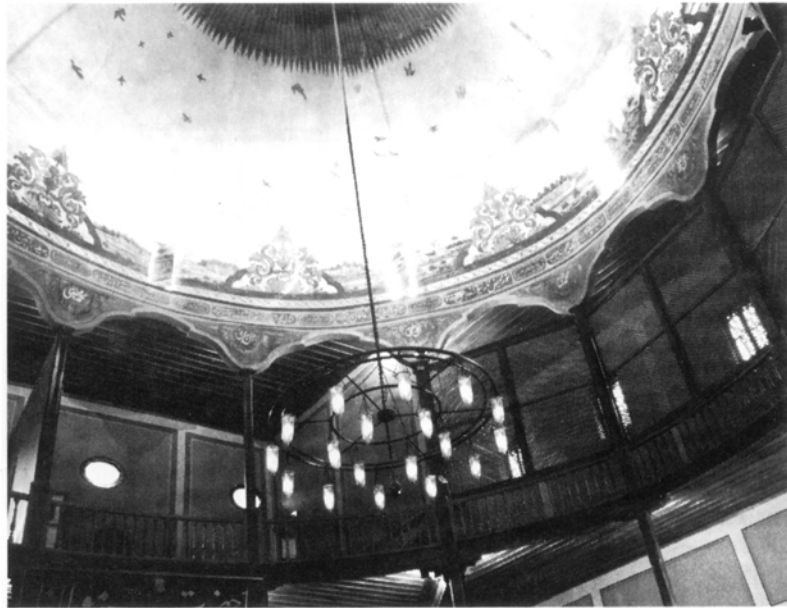
7. & 8. Interior views after restoration showing how the dome paintings were conserved

The cracks in the wooden structure of the dome were partially tightened to restore its original shape and all the wooden ribs were treated and reinforced; the original columns of Lebanese pinewood supporting the interior structure and dome underwent a similar treatment. The paint-

ings were carefully restored and a mechanical system to open the eight windows of the dome was devised to preserve the later decorations they display. The major works, including consolidation of the walls and insula-

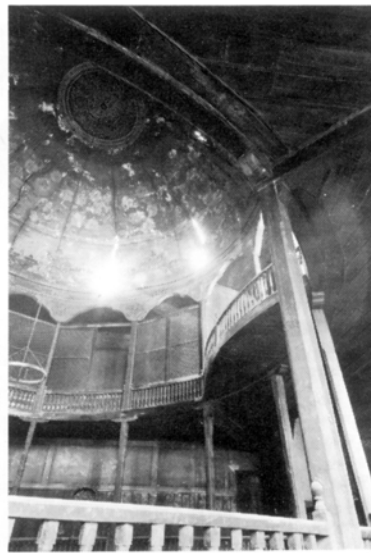
The Sama'khana is a wooden structure which occupies a 15x15m square and features a central circular area reserved for performances and surmounted by a 10.65m/diameter wooden dome. Two levels of circular galleries line the height of the central performance hall and are supported on slender wooden columns. The sandstone walls were cracked in some areas and the interior surface of the dome was plastered and painted with landscape scenes. Due to water infiltration and dampness, these paintings were flaking off and some parts of the dome itself were crumbling.

9. Interior view before restoration

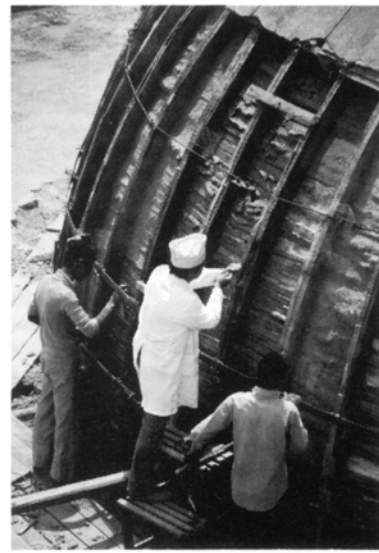
10. The dome during restoration

Excavations were carried out for the consolidation of the foundations and revealed the *sahn* of Sunqur Sa'di's *madrasa*. A system of support was placed under the Sama'khana's floor to enable visitors to see the perfectly preserved remains of this part of the *madrasa*. Scaffoldings were set up to allow the repairs of the wooden structure and to support the dome's inner shell during the restoration of the paintings. These scaffoldings were erected according to local methods, using wooden sections tied with ropes to avoid metal clamps which have to be hammered: undue vibrations would have further damaged the brittle and flaking painted plaster.
