# **FINAL NARRATIVE REPORT**

STABILIZATION OF THE SUBHAN QOLI MADRASSA GATE, KHWAJA PARSA, BALKH

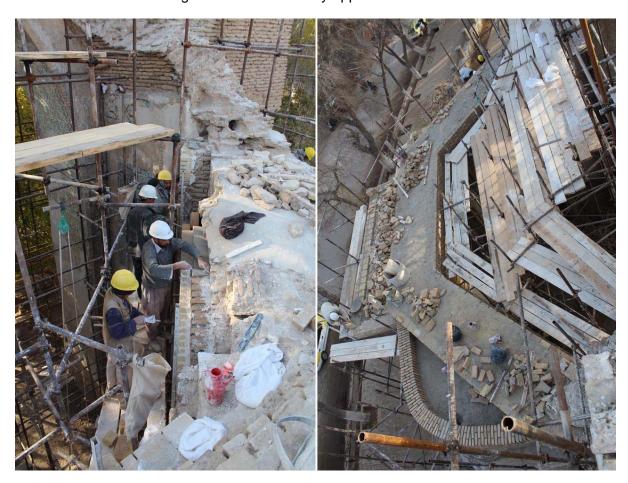
During previous building works undertaken in 2006, two large buttresses were constructed on either side of the main *Iwan* structure of the madrassa gate. Upon further investigation, it was discovered that what seemed to be a well-built buttress structure had in fact been built using large quantities of earth & rubble infill deposited behind a thin wall (30cm thickness) that spanned more than 4 meters in height. Assessed to be dangerous and undermining the structural integrity of the monument, the inappropriate intervention was dismantled and a suitable buttress was reconstructed using baked brick masonry applied with lime mortar.

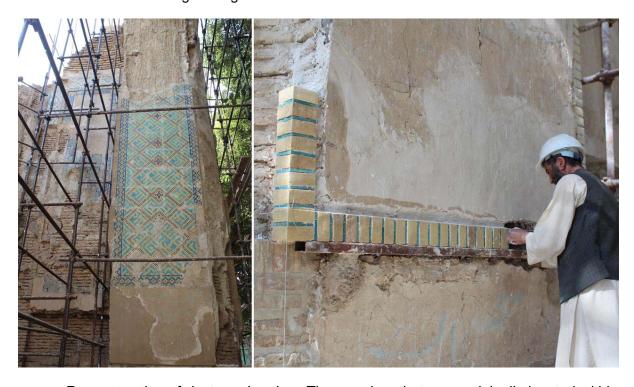
Historic Tiles: Originally covered completely with glazed colour tiles, the few remaining areas of the tiled decoration are the only remaining reference to the magnificent madrassa that had once occupied this site. Suffering from centuries of neglect and exposed to the elements, what remained of the tiled decoration were in an extreme state of disrepair. As part of the consolidation project, the remaining areas of tiled decoration in the upper areas of the gate was carefully cleaned and consolidated in place using gypsum grout. In total, more than 45 square meters of

historic tiles were consolidated and conserved. Where the brick masonry backing structure of the decoration require repair, teams carefully consolidated the masonry by using lime mortar. In areas where the decoration had fallen off and there was high risk that water would flow into the cavities and result in the collapse of additional tiles, the voids were filled using masonry and the surface was finished using more than 75 square meters high-quality gypsum plaster. In addition to this, more than 6 square meters of new turquoise colour glazed tiles were produce and applied to the surface in areas where the "framing" of existing designs, including arches and flat surfaces of tile-work, improved the durability and visual impact of the historic tile work. The incorporation of new tiles in the consolidation works was based strictly on clear evidence that the area had historically contained similar tile-work and intended to ensure the safeguarding of historic tiles.

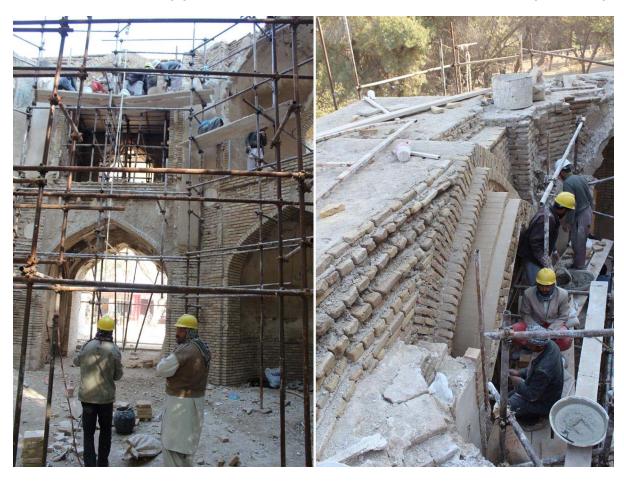
Consolidation and repair of masonry walls: Masonry walls located behind the main iwan, which had once been connected to the rest of the destroyed madrassa building remained in a state of disrepair. These walls had been exposed to weathering and the penetration of water, resulting in erosion of the masonry and severe cracking as a result of the "frosting cycle". These areas were consolidated and preserved using a mixture of measures, including the application of large quantities of new baked brick masonry using lime mortar and the re-pointing of all exposed surfaces. The stepped and jagged form of this area behind the main iwan was retained as a clear indication that the remaining gate structure had once been connected to a much larger building.

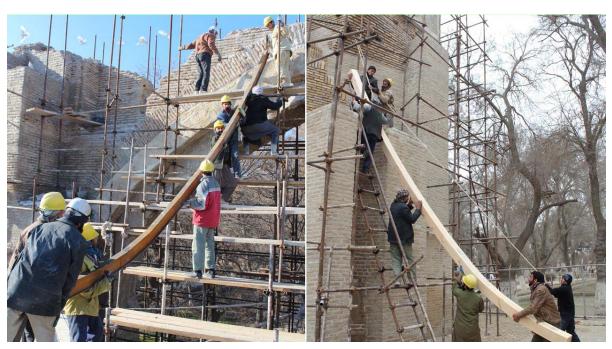
Structural stitching and retrofitting of metal tie-rods: The main arch of the *iwan* was constructed in two distinct periods. The first arch had suffered extensive damage due

to the thickness of the arch which was insufficiently design to carry the loads above the structure. When the settlement and cracking of the arch was discovered, probably shortly after the building was built in the 17<sup>th</sup> century, a second stronger arch was built immediately below the original structure. With the passage of time and the collapse of much of the madrassa gate, the original arch had become exposed to rain water and the "frost cycle". At the time of consolidation works carried out under this project, the deformation of the original arch had reached to more than 15cm off axis of the center of gravity on both sides. With the bricks of original arch beginning to rotate at more than 4 degrees from the vertical axis, it became apparent that the sides of the original arch required structural "stitching" using stainless steel elements. Five horizontal holes were drilled to a depth of 2.5 meters through the width of the masonry at the apex of the arch using a special low-vibration diamond tipped core drilling unit. As commercially produced drill-bits could not be located, the conservation team designed and produced the 2.5 meter drill bit using locally available materials. 24mm stainless steel treaded rods were inserted in the holes and connected to a stainless steel tension plate on the external elevation and a steel Ibeam on the internal face of the arch. The rods were put in tension by the use of nuts which were fastened to the treaded ends. Once the tied rods had been installed, the backs of the brickwork above the arch were cleaned and a gypsum grout was injected into the masonry in order to fill cracks within the arch. The exposed apex of the arch was covered with 23 cm thick baked brick paving on edge. Beneath the iwan and adjacent to the main arch, small sections remained of the masonry half-dome that had collapsed. These important remains of the original half-dome were consolidated in place using tie-rods inserted with a special lime mortar compound into holes drilled into the bricks.

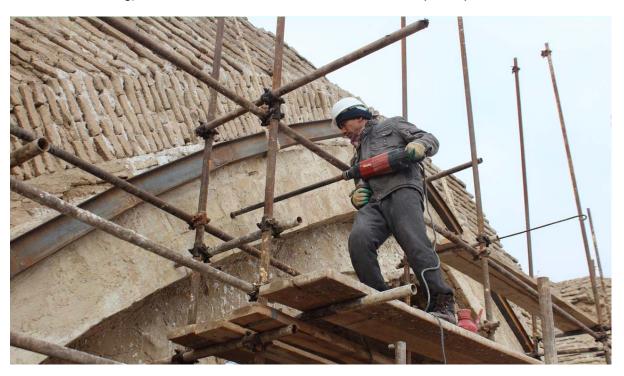
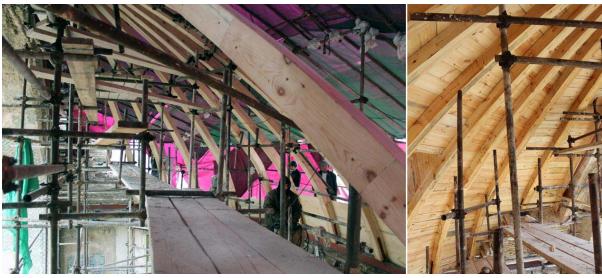
As the intent of the consolidation works was to protect the remains of the madrassa gate for the foreseeable future, the decision was made to construct a light-weight wooden structure in place of the brick masonry half-dome masonry that had collapsed. In order to proceed with this work, a five sided steel base for the light-weight wooden structure was anchored into the masonry work above the smaller arches of the *iwan* walls. Together with the large steel I-beam that had been installed vertically along the internal face of the main *iwan* arch, the foundations (springing and landing) of the wooden rafter construction had been put in place.

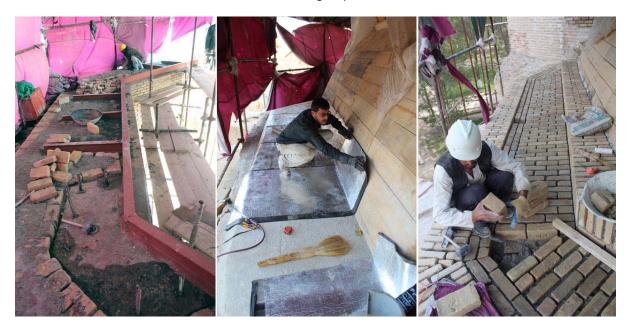
With the completion of consolidation works involving the application of brick masonry and steel works, the focus of the last part of the project became the construction of a lightweight laminated wood rafter roof above the internal space of the main *iwan*. When completed the structure would ensure that most of the tiled elevations together with remaining sections of historic plasterwork would be kept safe from direct exposure to rain and ice. In order to complete the roofing structure, 15 eight meter long pine wood laminate beams were constructed with a cross-section of 15cm (w) by 20cm (h). The rafters were installed using metal U-channel plates at the base of the walls and locked in place at the apex of the arch, where all the rafters converge, using a specially designed five-sided metal structure.

Once installed, the long triangular spaces between the rafters were covered using more than 80 square meters of 2 cm thick wooden planks. Three wind passages in the shape of windows were constructed in the wooden half-dome structure in order to reduce wind load. The external base of the wooden half-dome was sealed using reinforced Isogam tar insulation and finished with a layer of baked brick paving. The final external finish of the dome was applied using more than 95 square meters of galvanized steel sheeting. Water has been diverted away from the structure with the construction and installation of 4 drainage spouts.

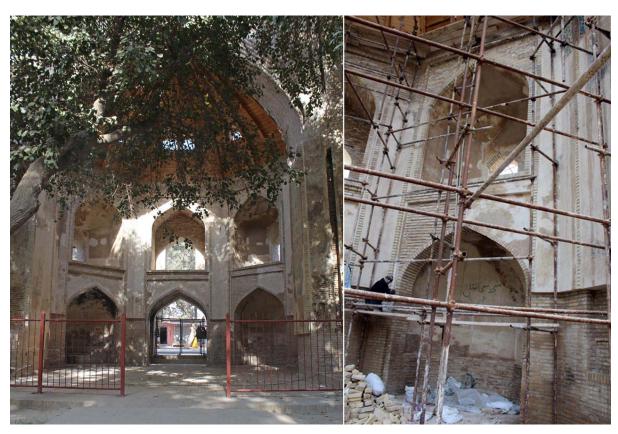
All exposed and internal brick masonry surfaces were sealed through the application of more than 500 square meters of pointing using lime mortar. Together with the rendering of more than 80 square meters of lime plaster finished on the internal walls, the remains of the 350 year Subhan Qoli madrassa gate has been

consolidated to a high standard. A 2-meter high metal fence with two metal gates has been constructed around the perimeter of the gate in order to prevent unauthorized access to the building during off-hours.

Lastly, in order to prevent future damage by nesting doves and feral pigeons all openings in the masonry structure have been blocked and surfaces more than 10cm in width have been sloped to appropriate falls.

The ground surface within the main *iwan* and the external perimeter of the gate, up to seven meters on all sides that open towards the Khwaja Parsa Park, has been finished using more than 525 square meters of durable baked brick paving laid on edge. Several cenotaphs that had been relocated within the main *iwan* have been left standing within the structure, protected from the elements.
