# INTERIM PROPERTY INSPECTION REPORT

| <u>Address:</u> 57 Chandlers Walk, Haven Banks, Exeter, EX2 8BA | | <u>Inspected by:</u> Jade Newman | <u>Date:</u> Dec 14 |

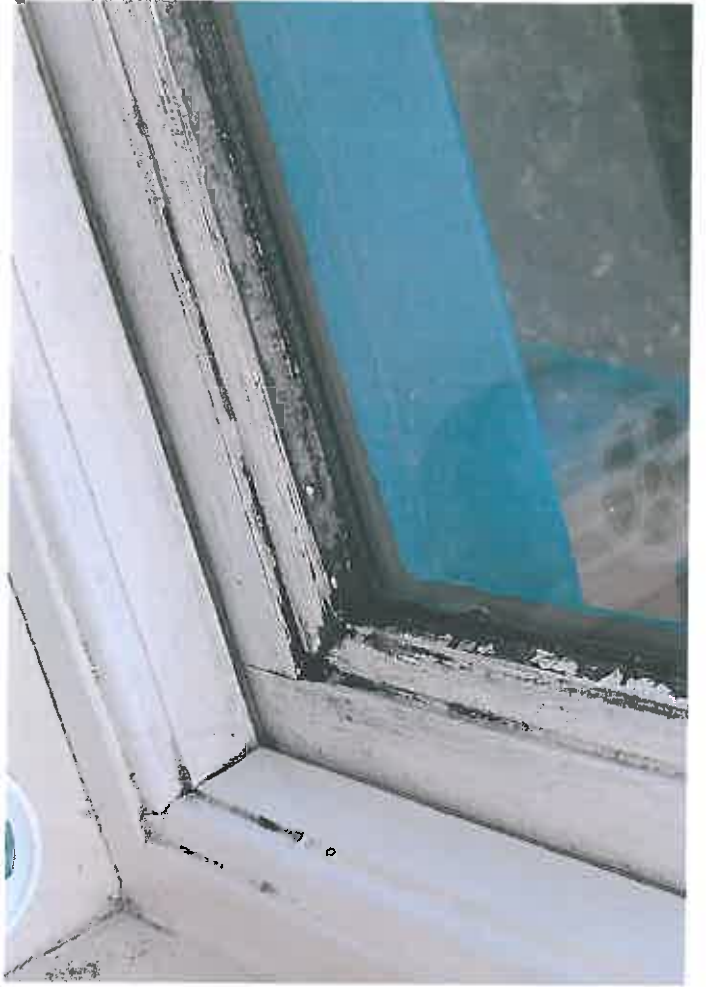
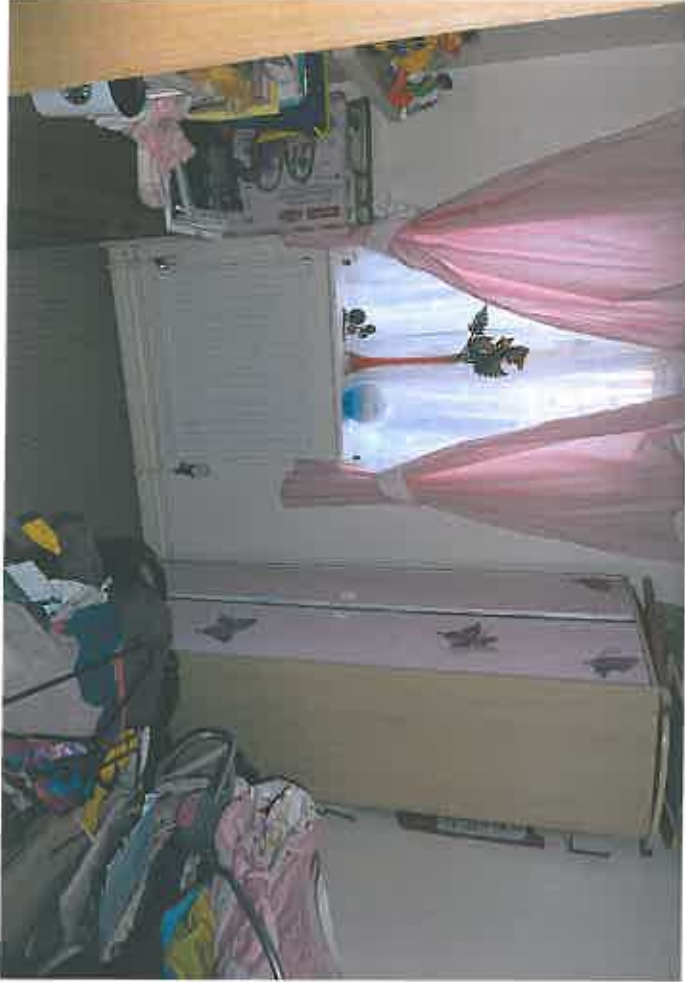
| <u>Item/room</u> | <u>Condition</u> | <u>Comments and maintenance required</u> | <u>Tenant Request or Agent Observation</u> |
|---|---|---|---|
| Bedroom 2 | Average | Mould around windows. | |

The tenant is also very concerned with the amount of damp and mould in the property. She has 3 - 4 dehumidifiers in almost every room. She has to constantly wipe down the windows from mould. Their furniture is getting mouldy, as well as some of their clothes, shoes and bags.

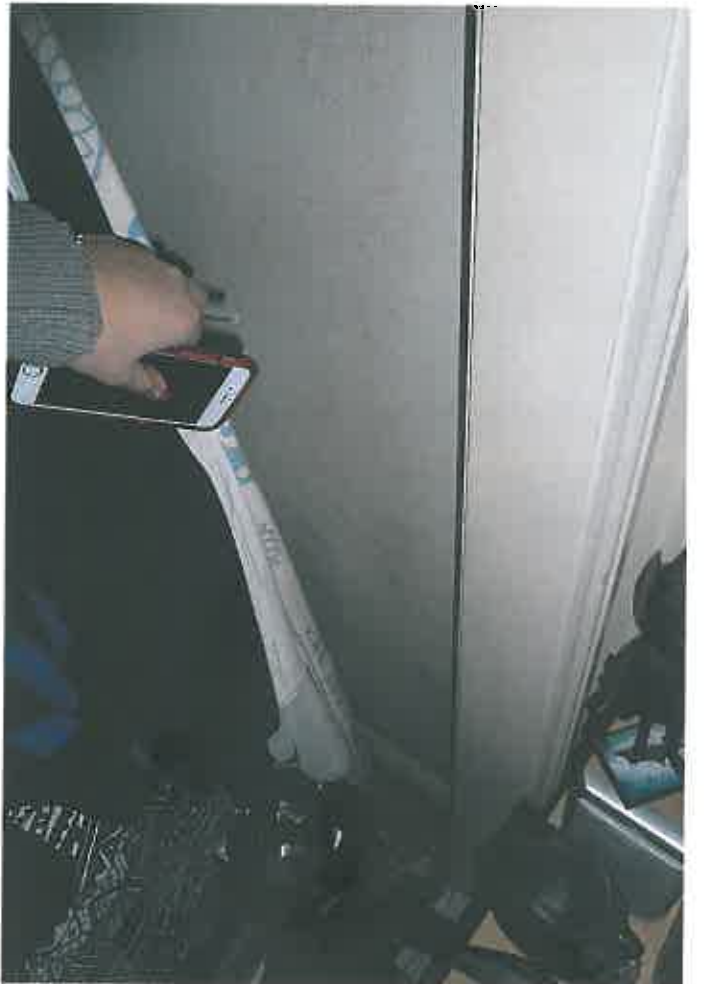
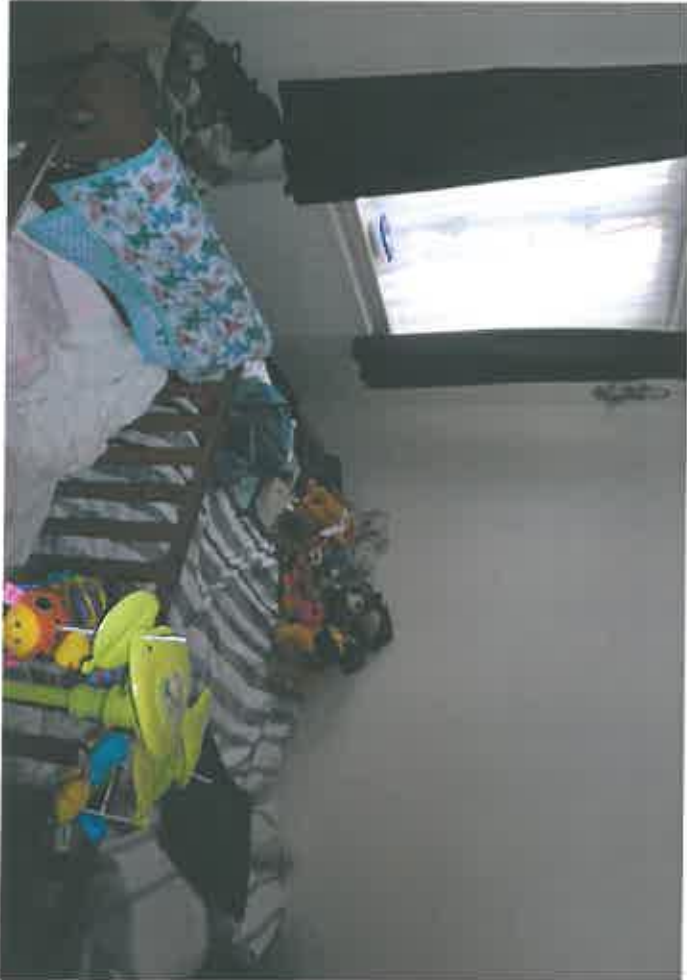
| <u>Item/room</u> | <u>Condition</u> | <u>Comments and maintenance required</u> | <u>Tenant Request or Agent Observation</u> |
|---|---|---|---|
| Bedroom 1 | Average | Damp/mould on walls in wardrobe and around window. | |

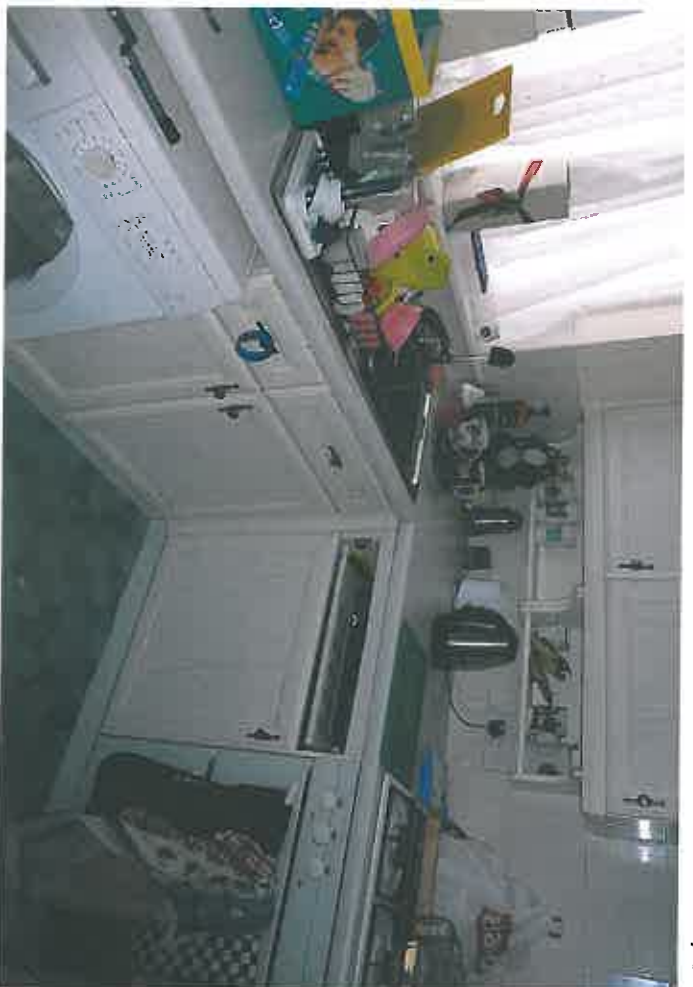
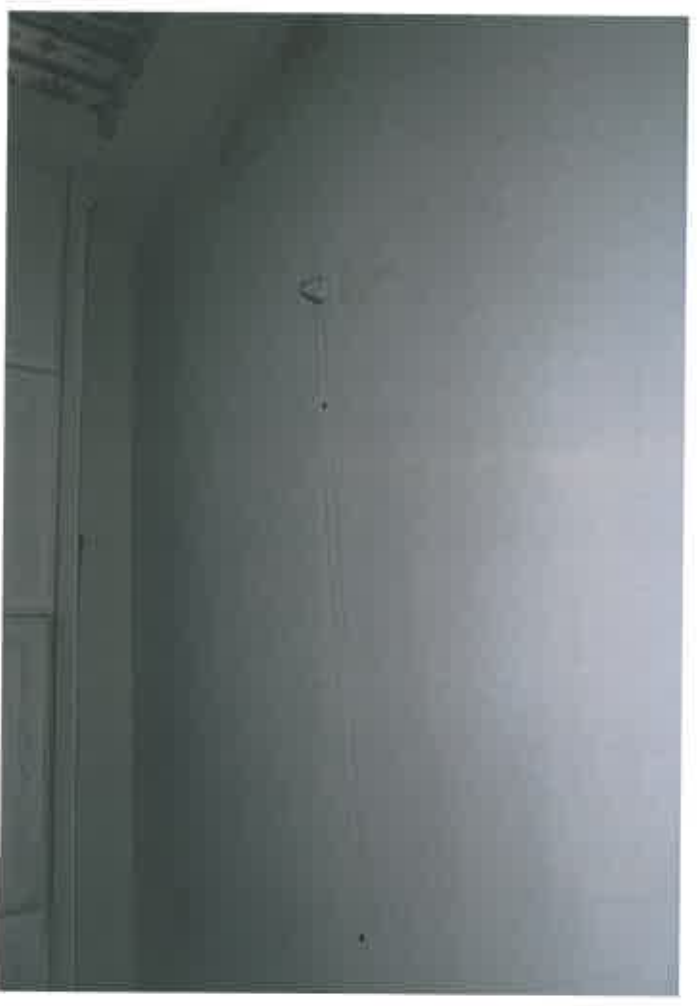
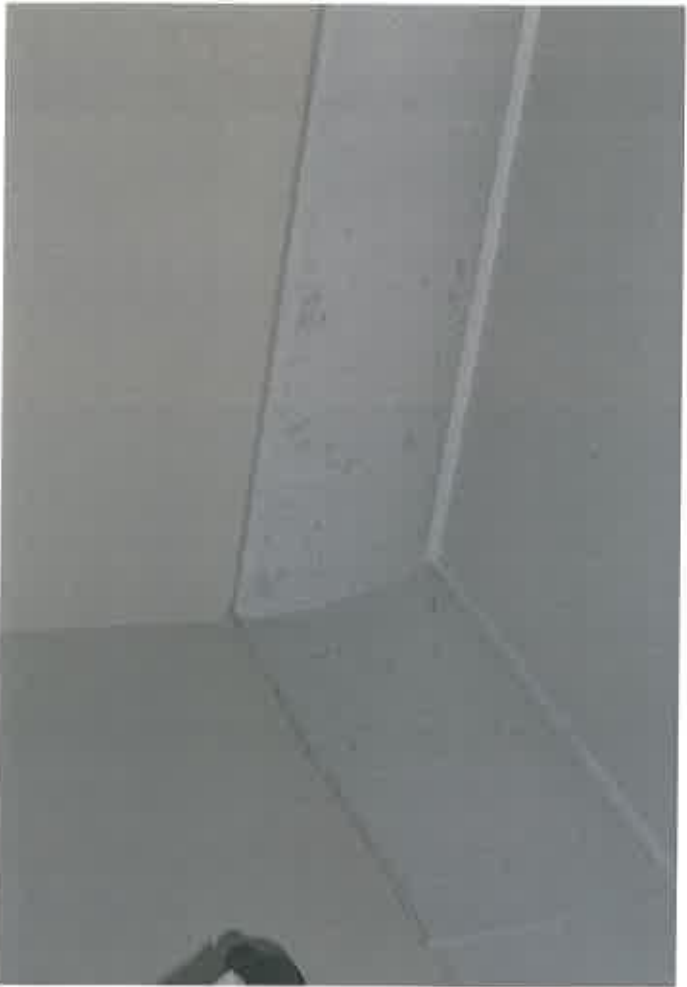
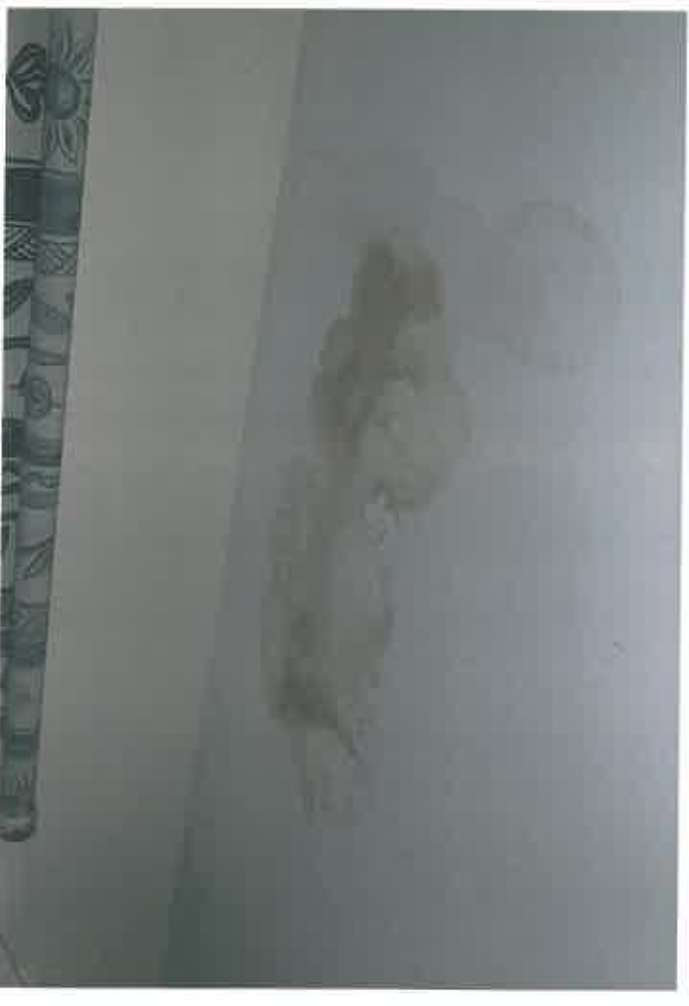
KITCHEN

| <u>Item/room</u> | <u>Condition</u> | <u>Comments and maintenance required</u> | <u>Tenant Request or Agent Observation</u> |
|---|---|---|---|
| Kitchen | Poor | Water stain to ceiling and no lights due to leak. | |

There is a large water stain to the kitchen ceiling due to there being a leak in the above property. The tenants commented that they are struggling as there are no lights in the kitchen. The electrician removed the light fitting following the leak. A drawer front has come off but the tenant said she is going to fix it back on herself.
