Mould & Moisture Assessment Amherst Cove Consolidated School

Project No. 12620

Prepared for:

May 18, 2011

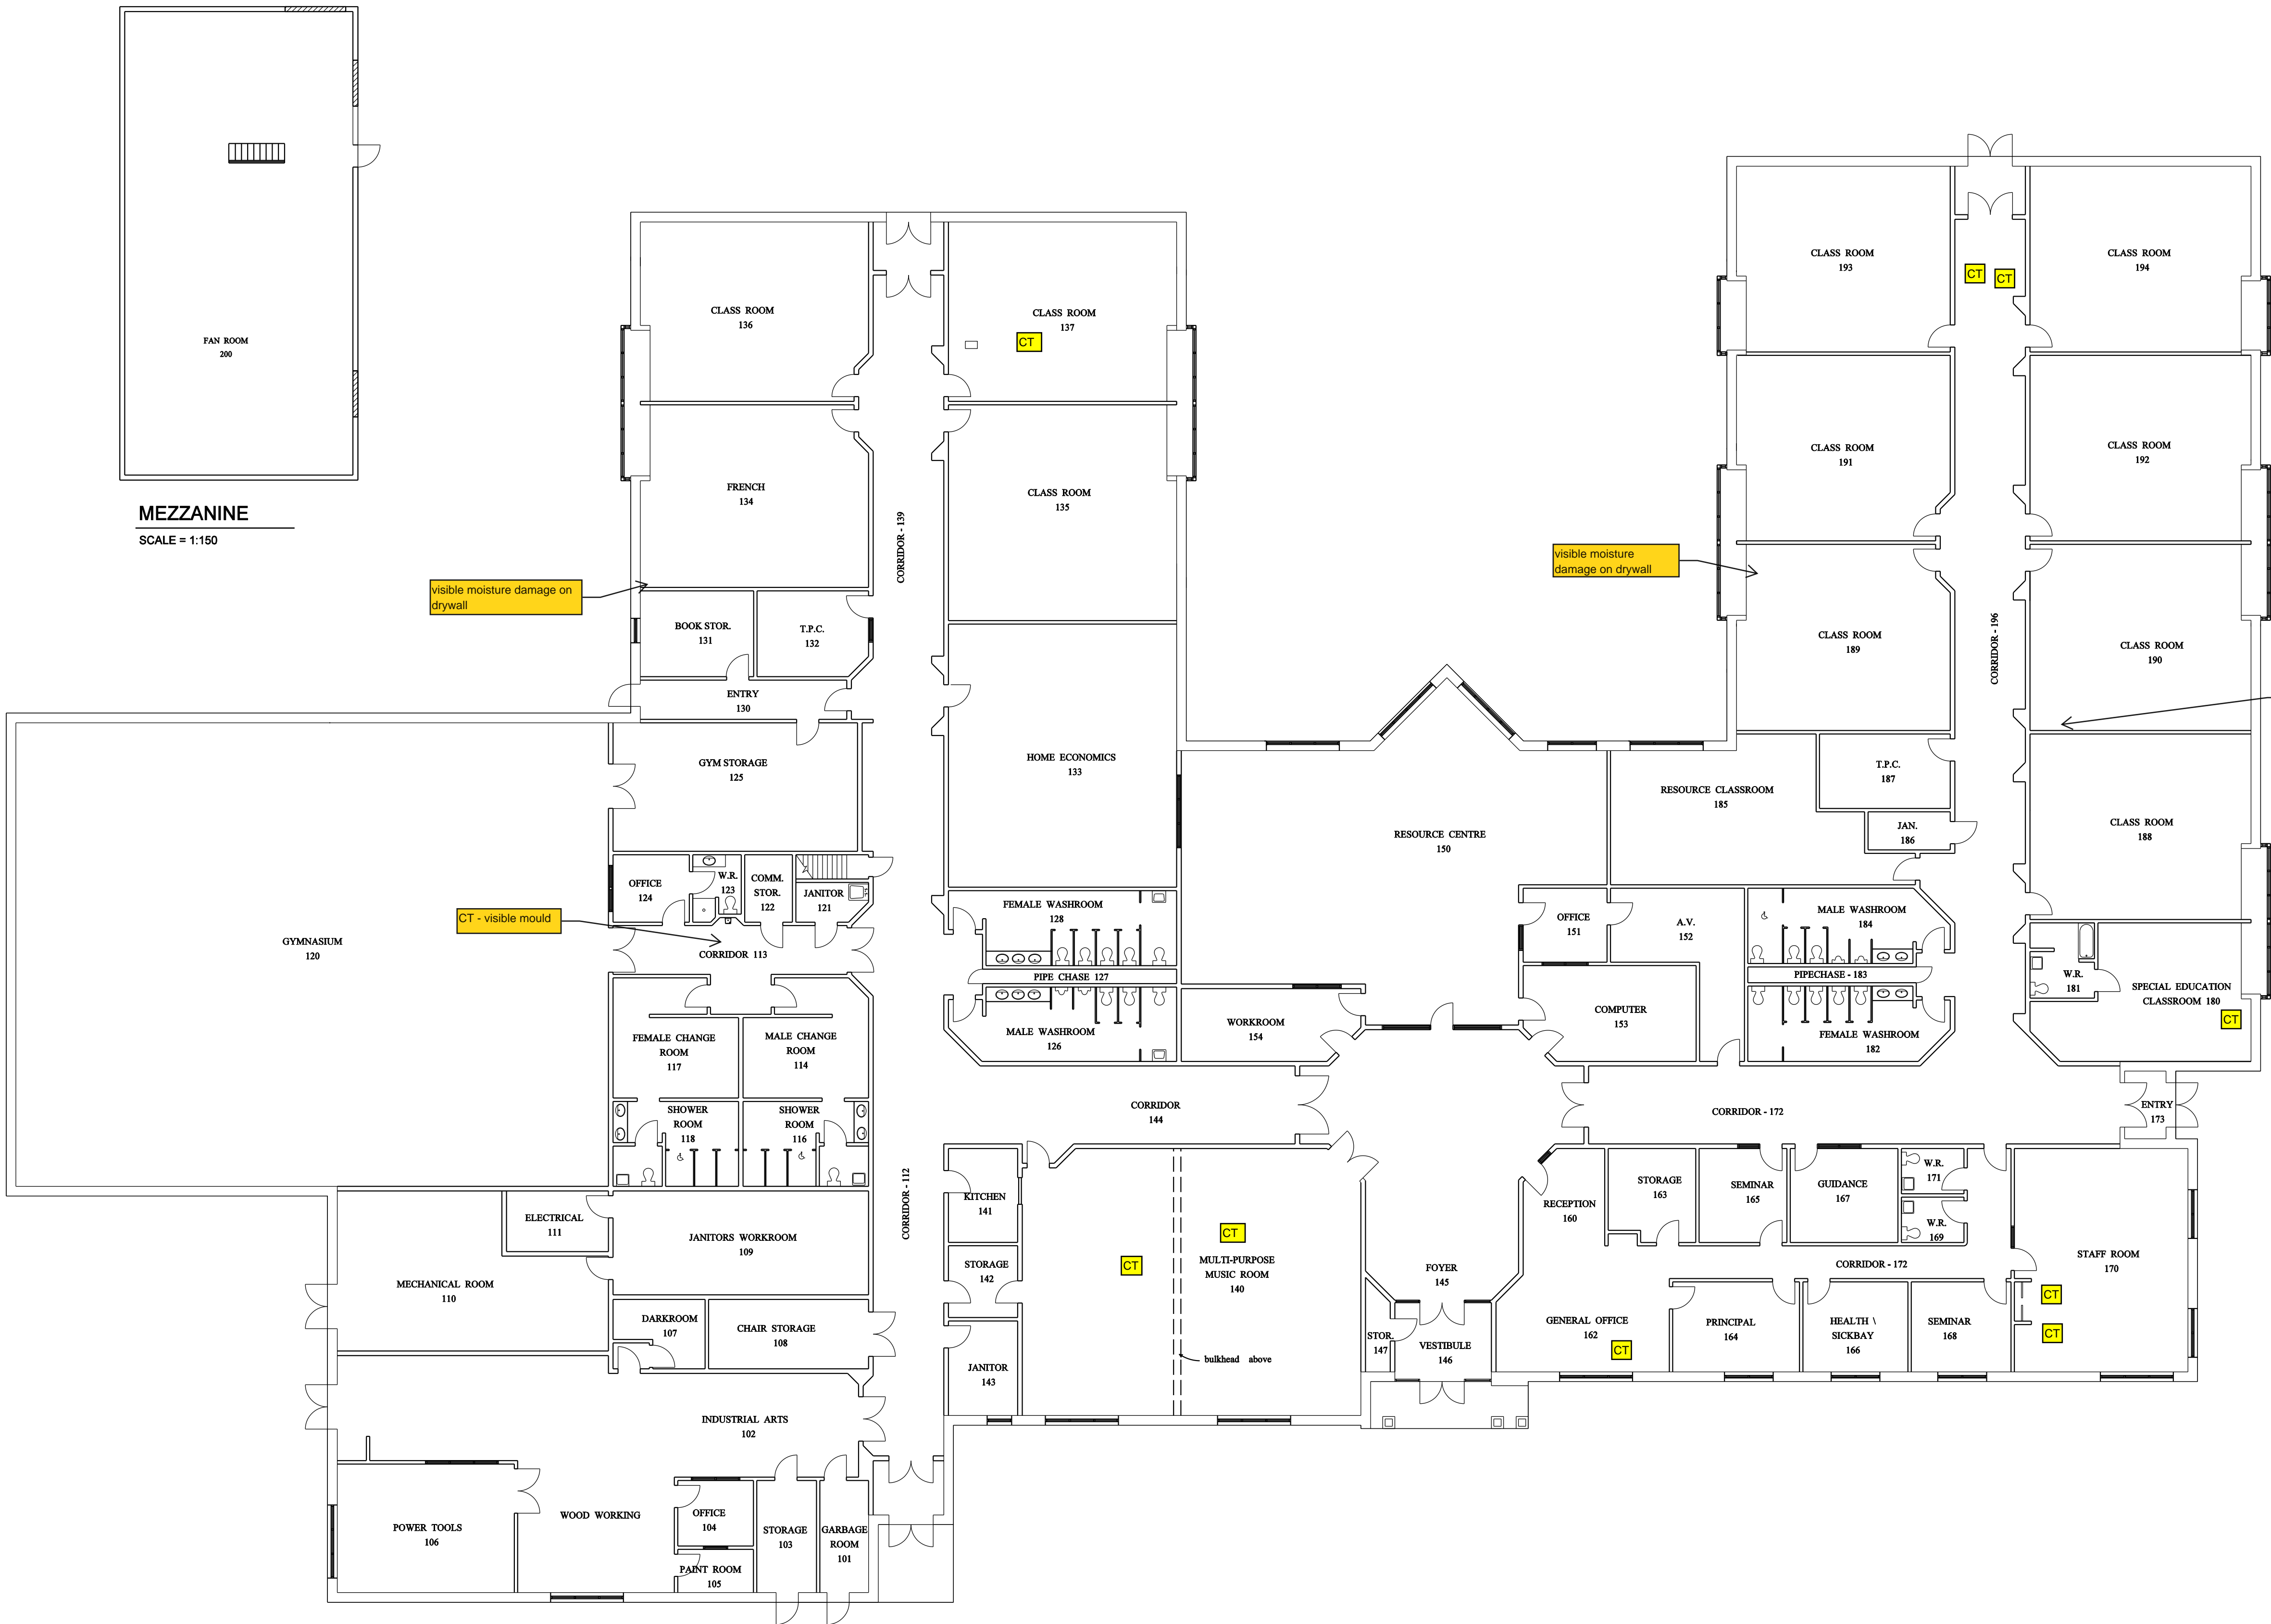
MAIN FLOOR PLAN

Table III Summary of Moisture affected areas		
Room No. / Description	Comments / Observations	Action required
Rms 137; 140; 162; 170; 180; 196	Stained ceiling tiles observed and reported in noted areas (see site floor plan - Appendix I for location markings).	Replace ceiling tiles as precautionary measure and to assist in detecting further water leaks. Some mechanical leaks reported at the time of assessment.
Rms 134; 189	Visible moisture damage to drywall ceiling. No elevated moisture detected at time of inspection. No visible mould observed.	Before repairs are made to these areas, conduct further investigation above ceiling by opening small section to assess for potential hidden moisture and / or mould growth.
