# Mould & Moisture Assessment Bloomfield Elementary School

**Project No. 12620**

**April 26, 2011**

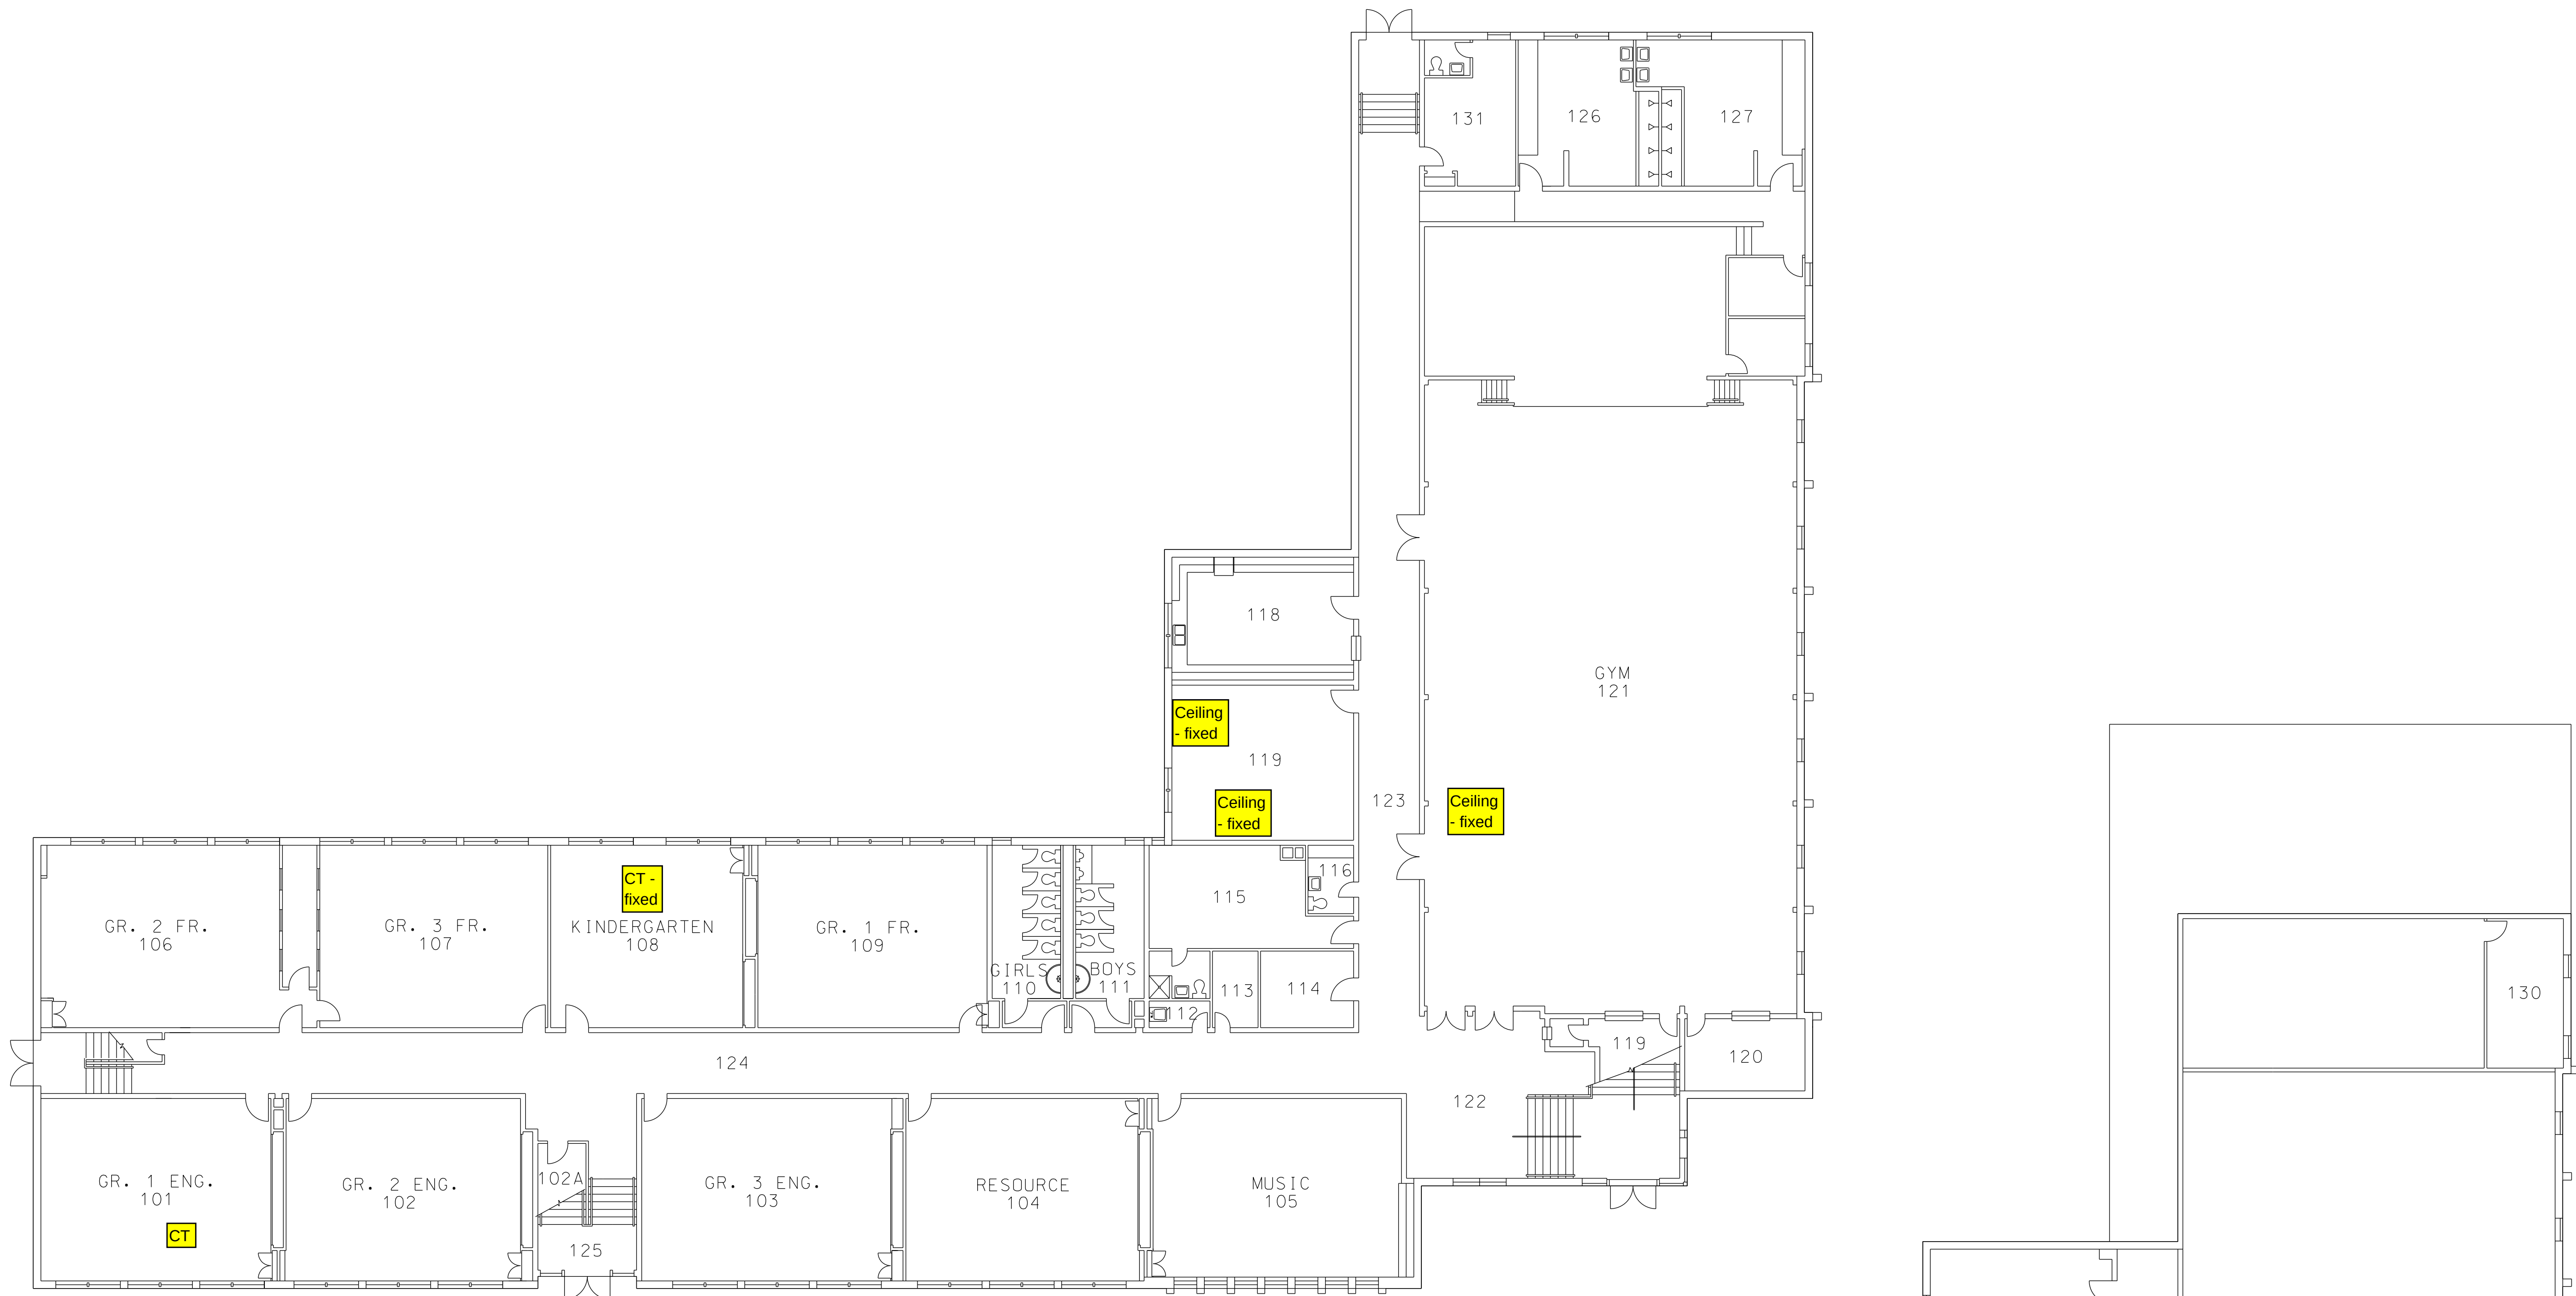
LOWER LEVEL

| <b>Table II</b><br><b>Summary of Moisture affected areas</b> | | |
|---|---|---|
| Rm 101; 206; 208 | Stained ceiling tiles observed and reported in the noted areas (see site floor plan - Appendix I for location markings).<br>No moisture sources detected at the time of the assessment. | Replace ceiling tiles as precautionary measure and to assist in detecting further water leaks. |

CT - affected ceiling tile area
