Mould & Moisture Assessment Bluefield High School

Project No. 12620

Prepared for:

March 9, 2011

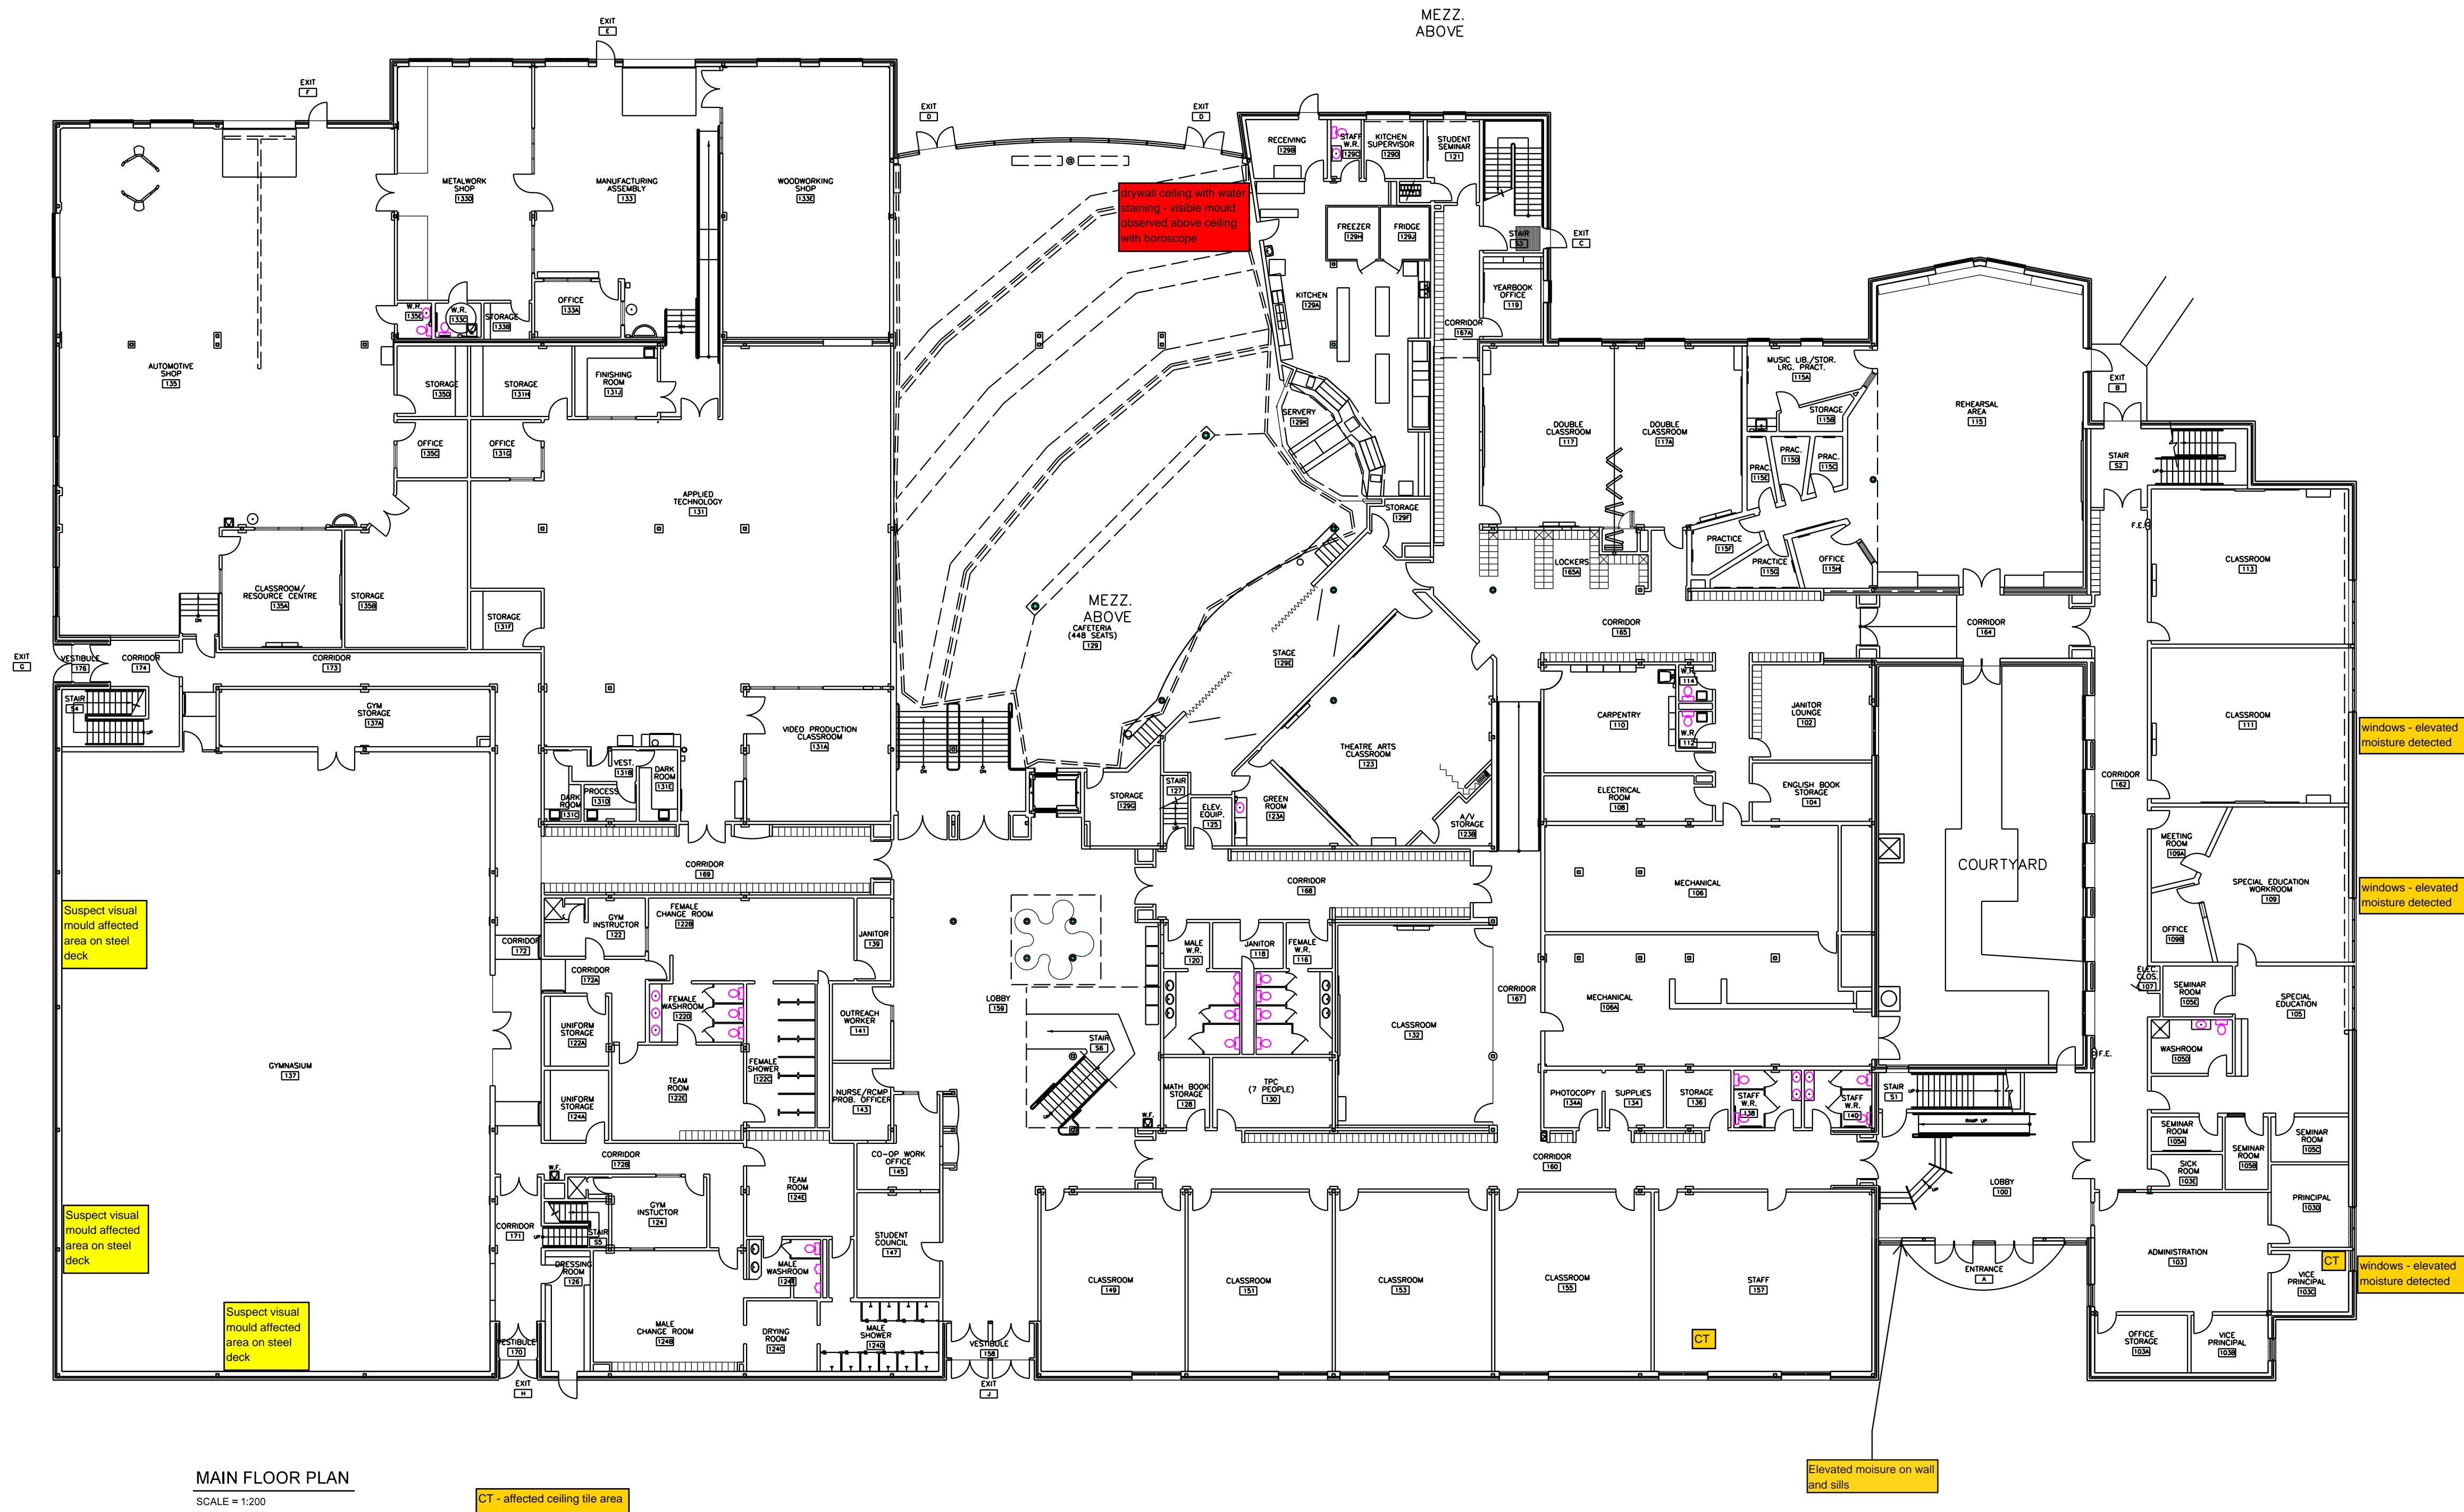
Drawing Title :
Main Floor Plan

Table II Summary of Visible Mould affected areas		
Room No. / Description	Comments / Observations	Level of Remediation
Rm 129 - Cafeteria	Extensive water damage on drywall ceiling of the cafeteria. - North East corner and middle of cafeteria	Affected areas with water damage should be removed using Level 2 procedures and to assess the full extent hidden mould and water damage.
Rm 203; 281	Window sills removed. Visible mould within window casing. Bore holes were drilled in the window casing and no further mould growth was reported within the wall cavity.	Further investigation required into addressing water infiltration. Level 1 (<10 ft ² (<1 m ²)) clean up of mould affected areas
Rm 226G	Visible mould on ceiling tile	Level 1 <10 ft ² (<1 m ²)
Rm 218 Gymnasium	Suspect visual mould on steel deck of Gymnasium	Level 2 10 - 100 ft ² (1 - 10 m ²)

Table III Summary of Moisture affected areas		
Room No. / Description	Comments / Observations	Action required
Rms 103C; 157; 223; 226G; 257 115; 210; 230	Stained ceiling tiles throughout various areas noted	Replace ceiling tile for cosmetic purposes and to assist in detecting further water leaks. Current leaks were reported at the time of

assessment.
Rms 100; 103C; 109; 111; S2; S3 (stairways); 203; 207; 209; 211; 213; 259; 261; 263; 265; 281 (walkway); 282 (corridor)	Water damage and elevated moisture around window and block wall	Further investigation required into addressing water infiltration and possible hidden mould

CT - affected ceiling tile area
