# Mould & Moisture Assessment Cardigan Consolidated School

**Project No. 12620**

**April 15, 2011**

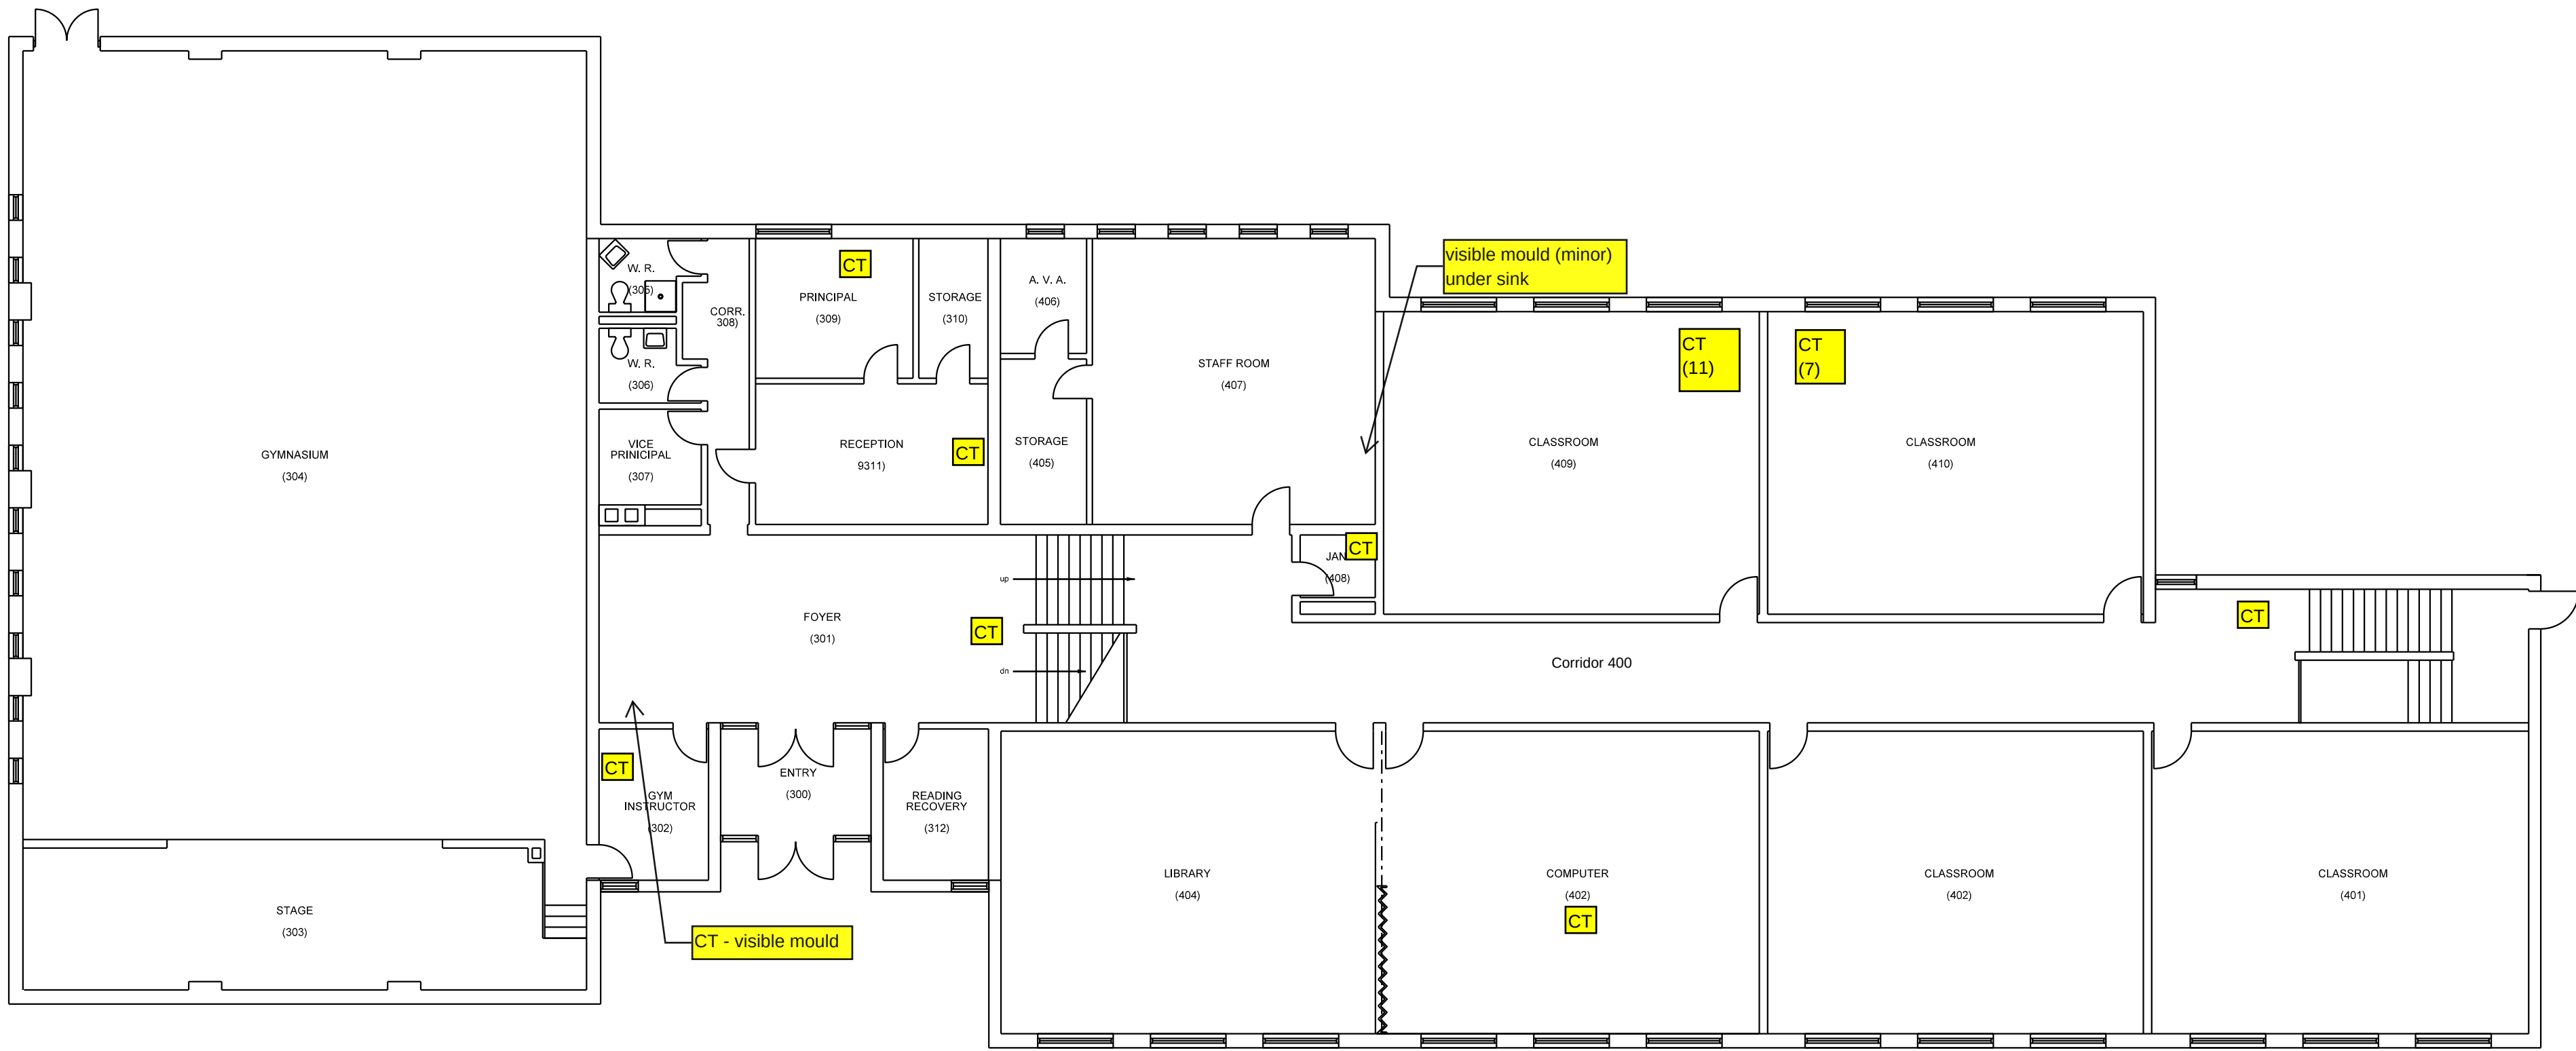
MAIN FLOOR PLAN

| Rms 103; 205;<br>301; 302; 309;<br>311; 400; 402;<br>408; 409; 410 | Stained ceiling tiles observed and reported throughout the building (see site floor plan - Appendix I for location markings). | Replace ceiling tiles as precautionary measure and to assist in detecting further water leaks. Some leaks were reported at the time of assessment. |

CT - affected ceiling tile area
