Mould & Moisture Assessment Central Queens Elementary School

Project No. 12620

March 31, 2011

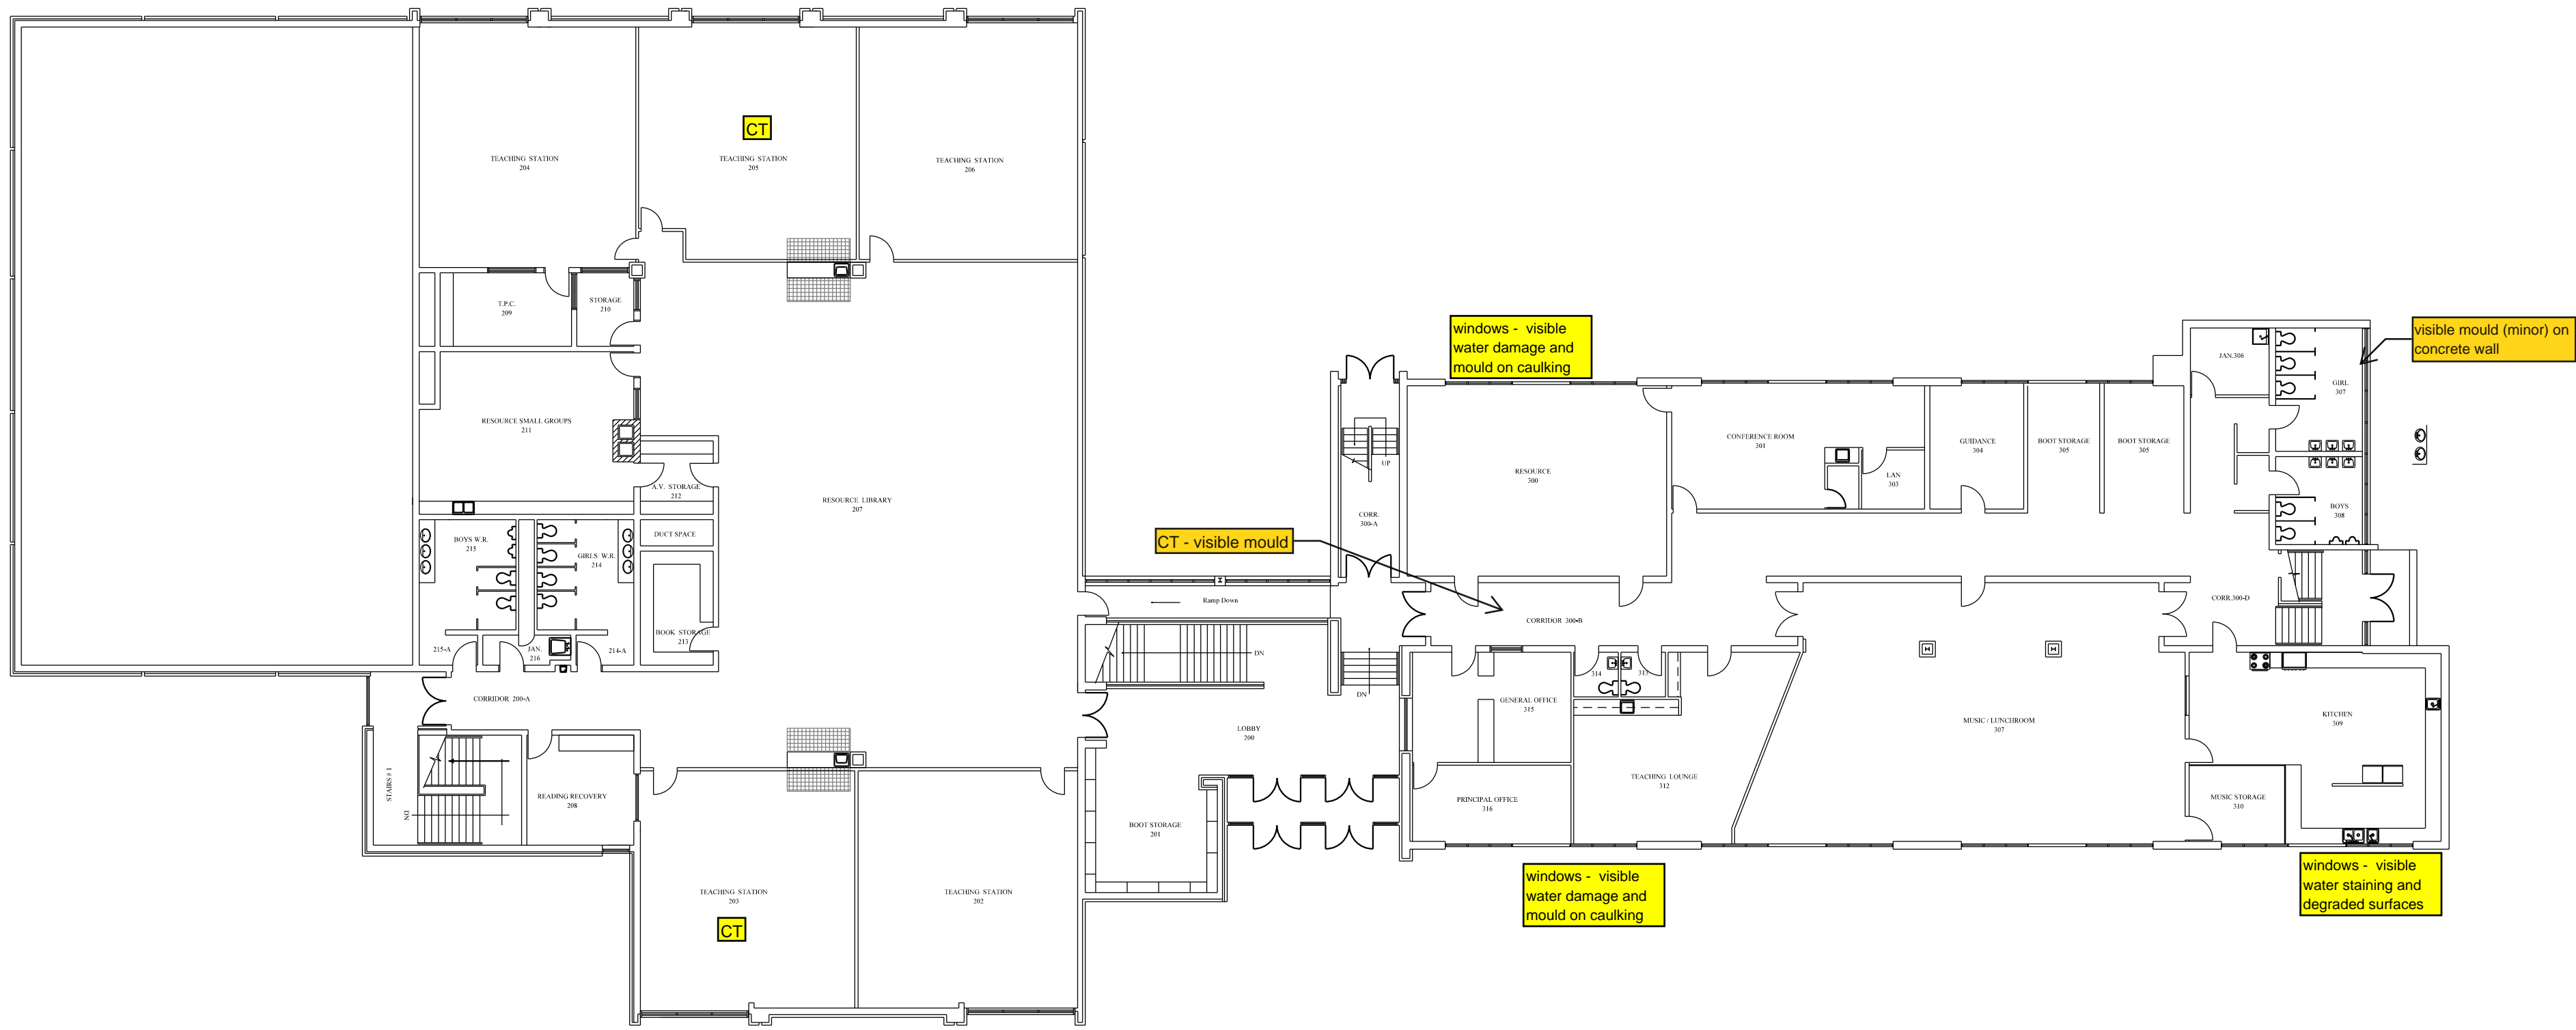
MAIN LEVEL

Table III Summary of Moisture affected areas		
Room No. / Description	Comments / Observations	Action required
Rms 120; 125; 203; 205; 300B corridor; 403	Stained ceiling tiles observed and reported throughout the building on all levels (see site floor plan - Appendix I for location markings).	Replace ceiling tiles as precautionary measure and to assist in detecting further water leaks. Some leaks were reported at the time of assessment.

CT - affected ceiling tile area
