Mould & Moisture Assessment Charlottetown Rural High School

Project No. 12620

Prepared for:

May 11, 2011

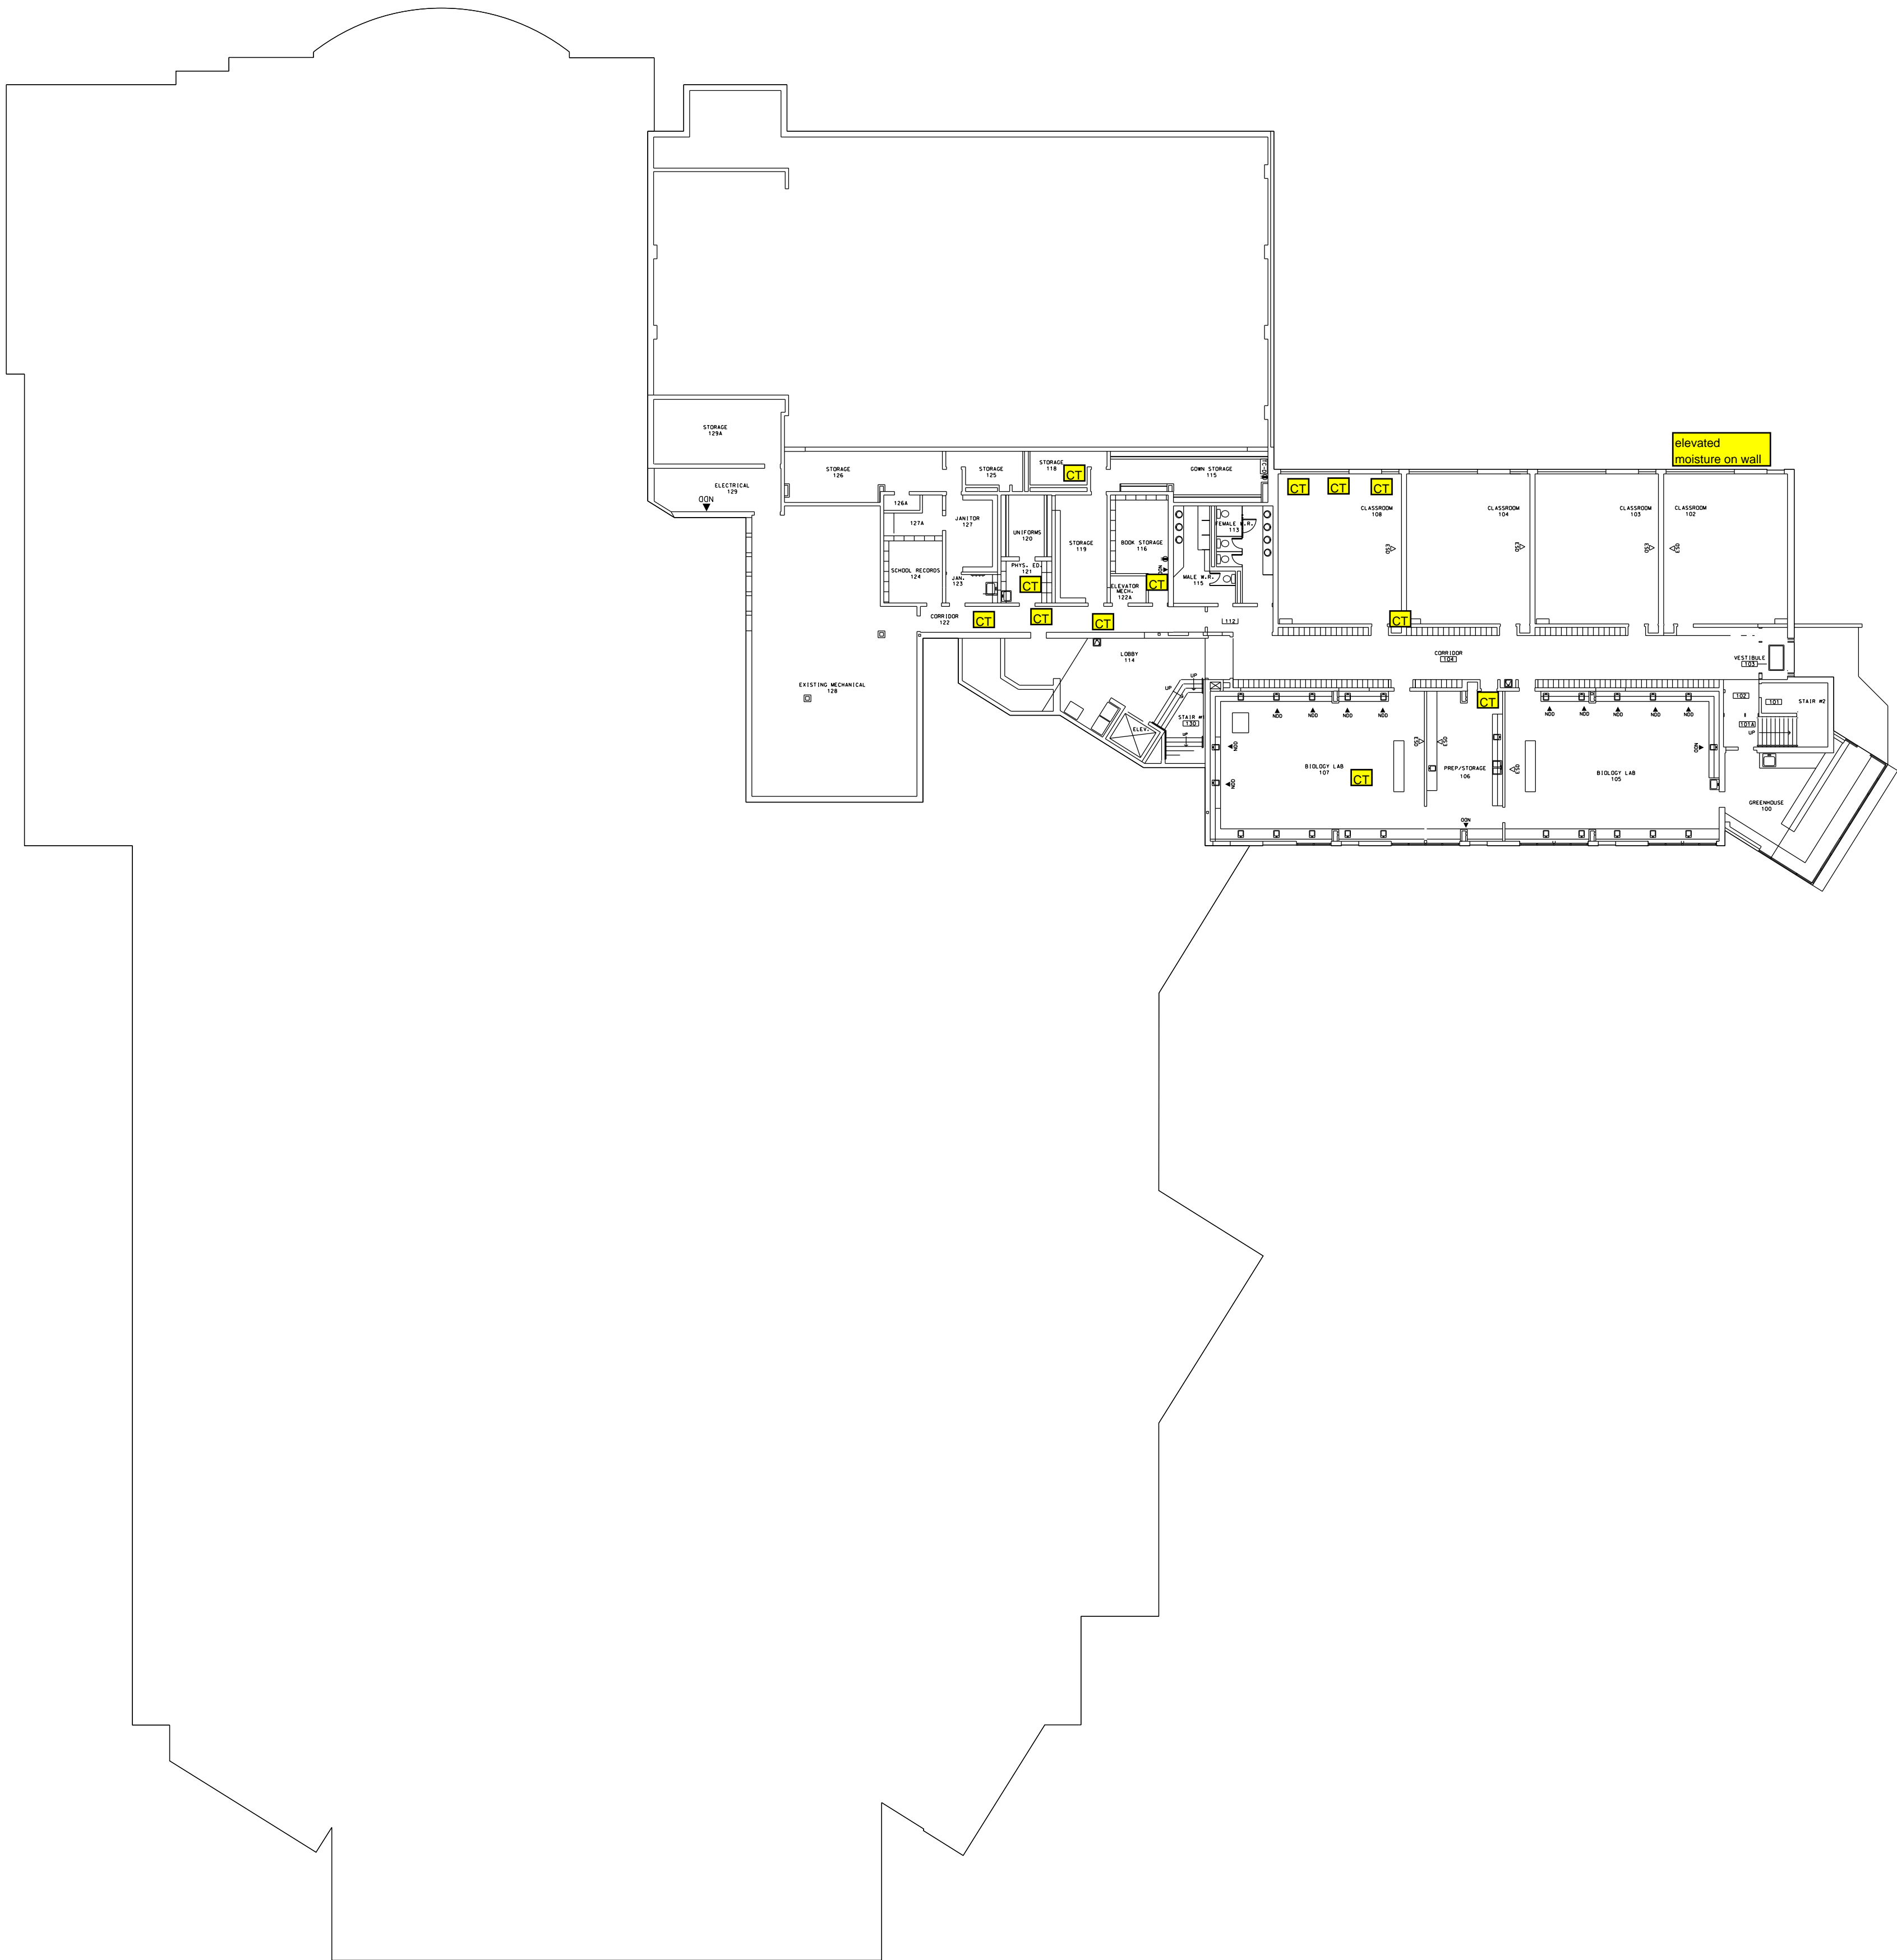
LOWER LEVEL PLAN

CT - affected ceiling tile area

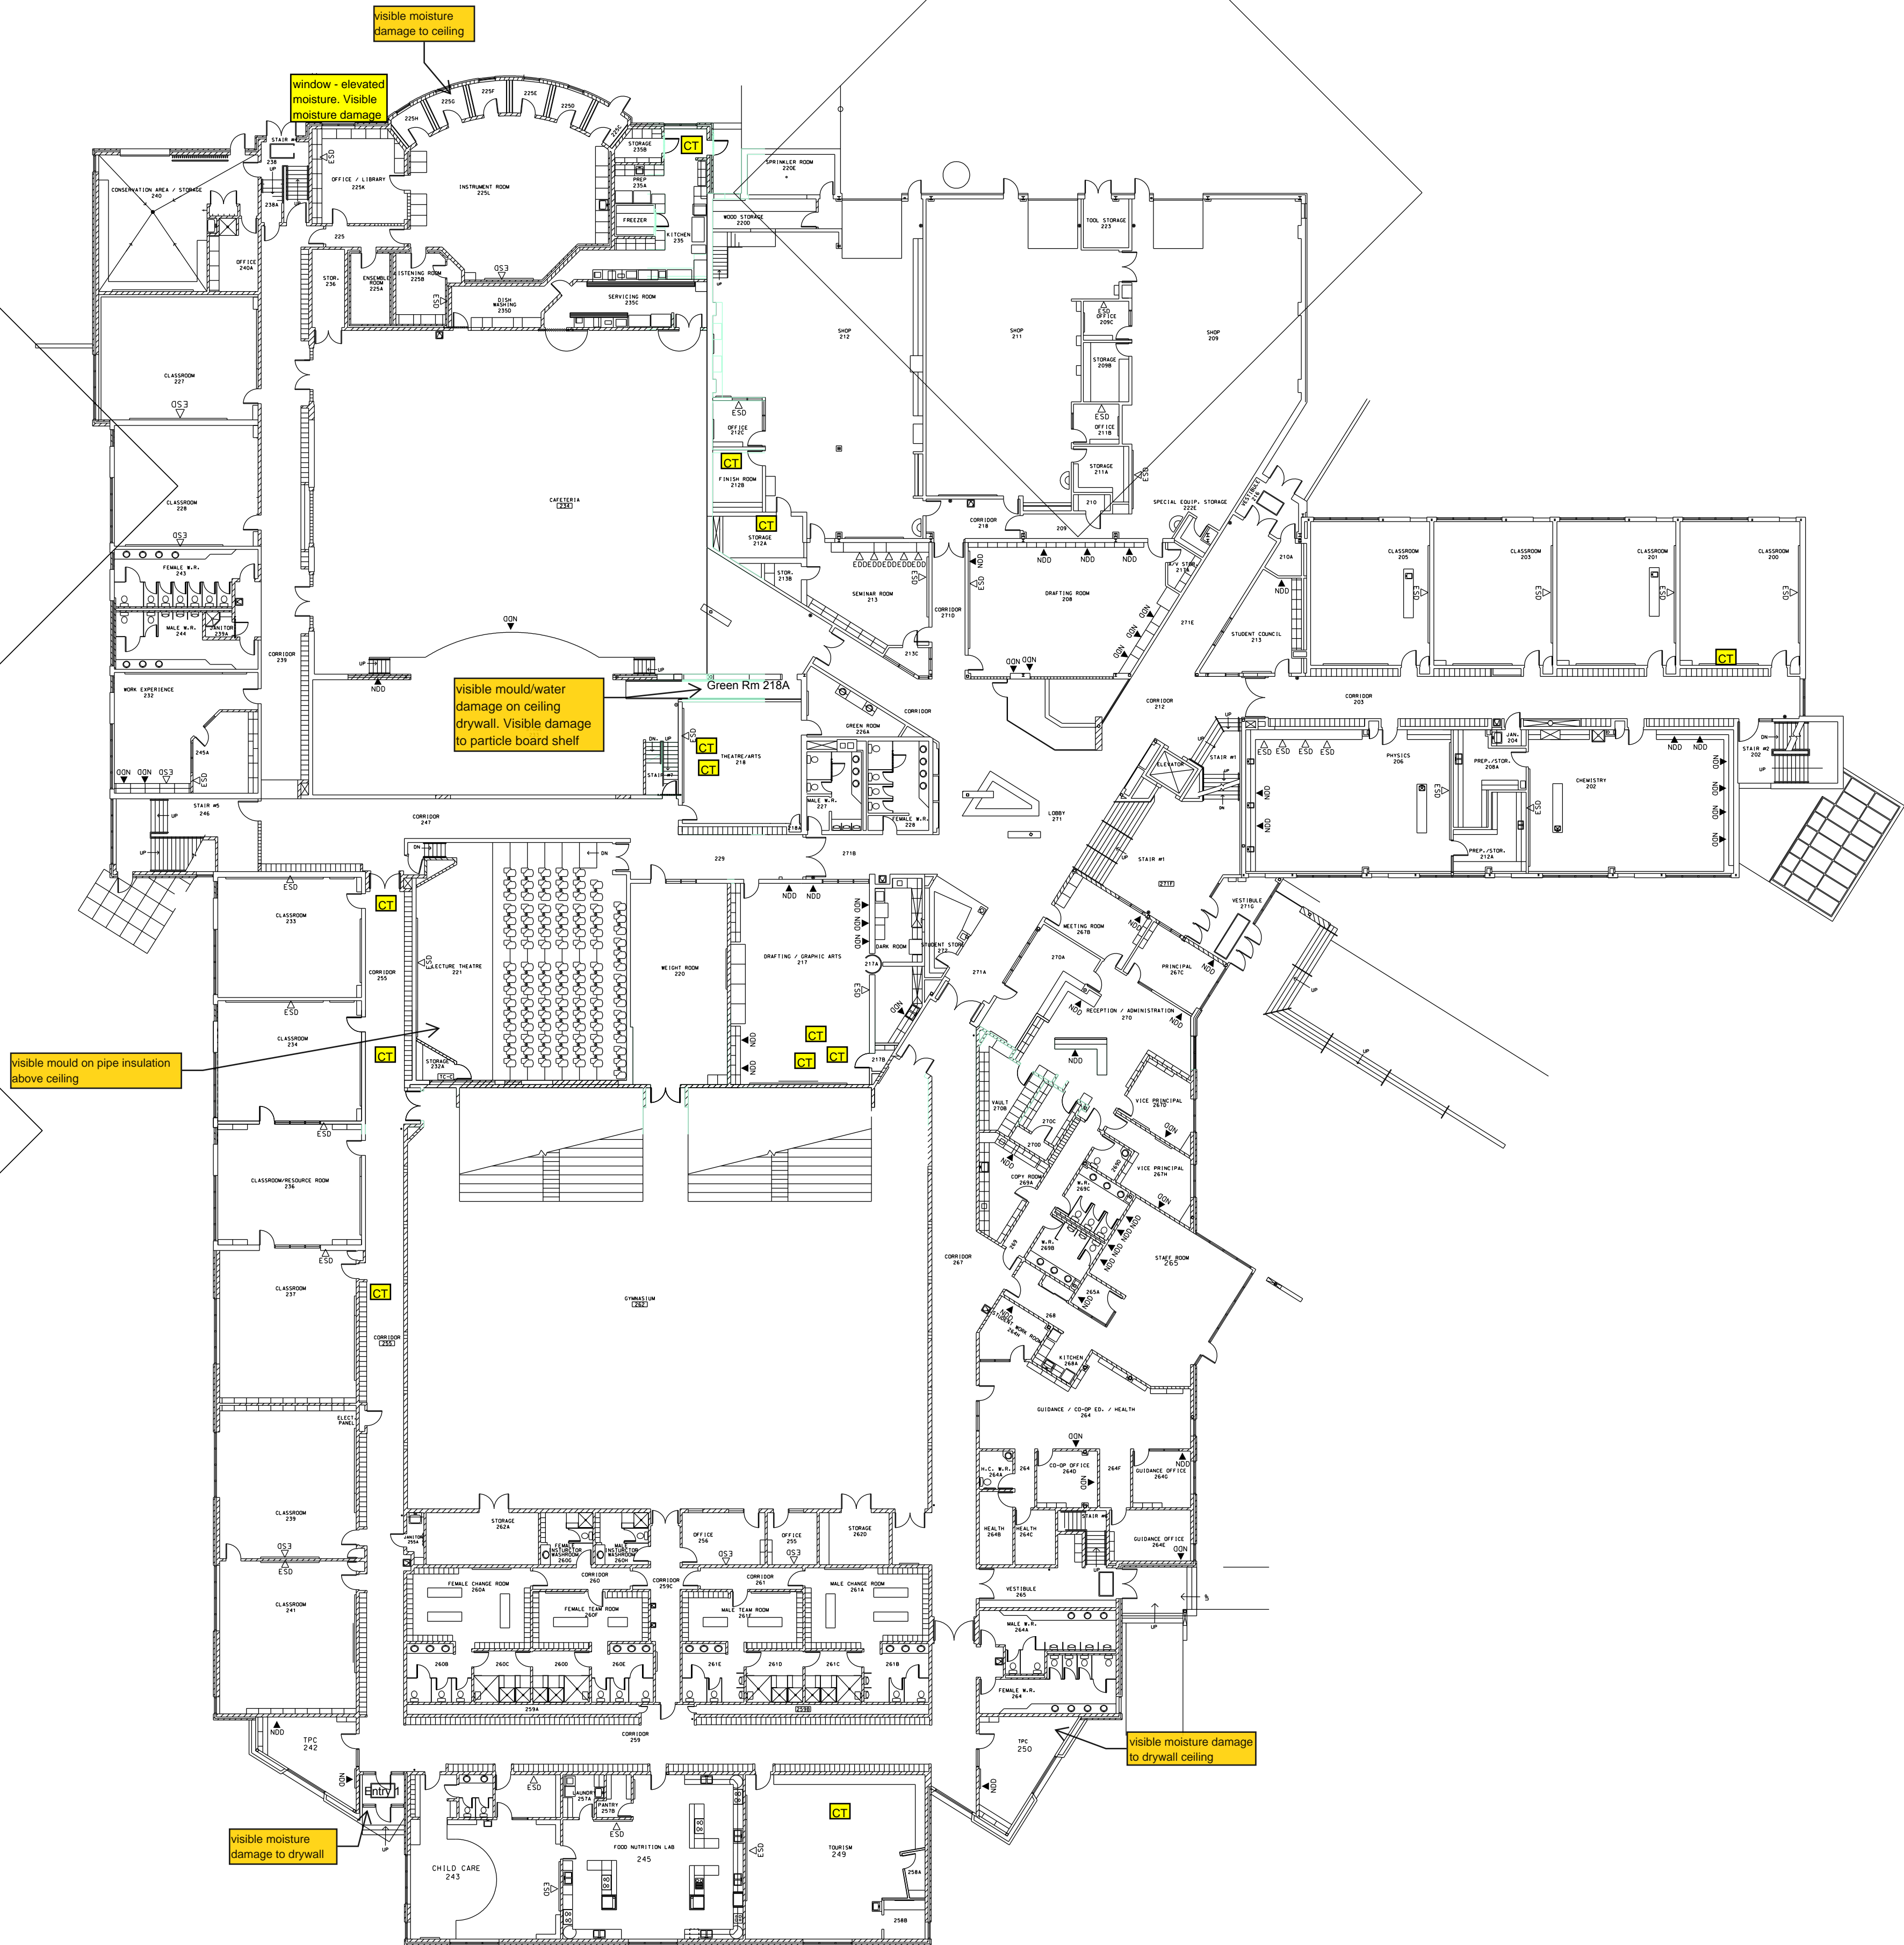
MAIN LEVEL PLAN

CT - affected ceiling tile area

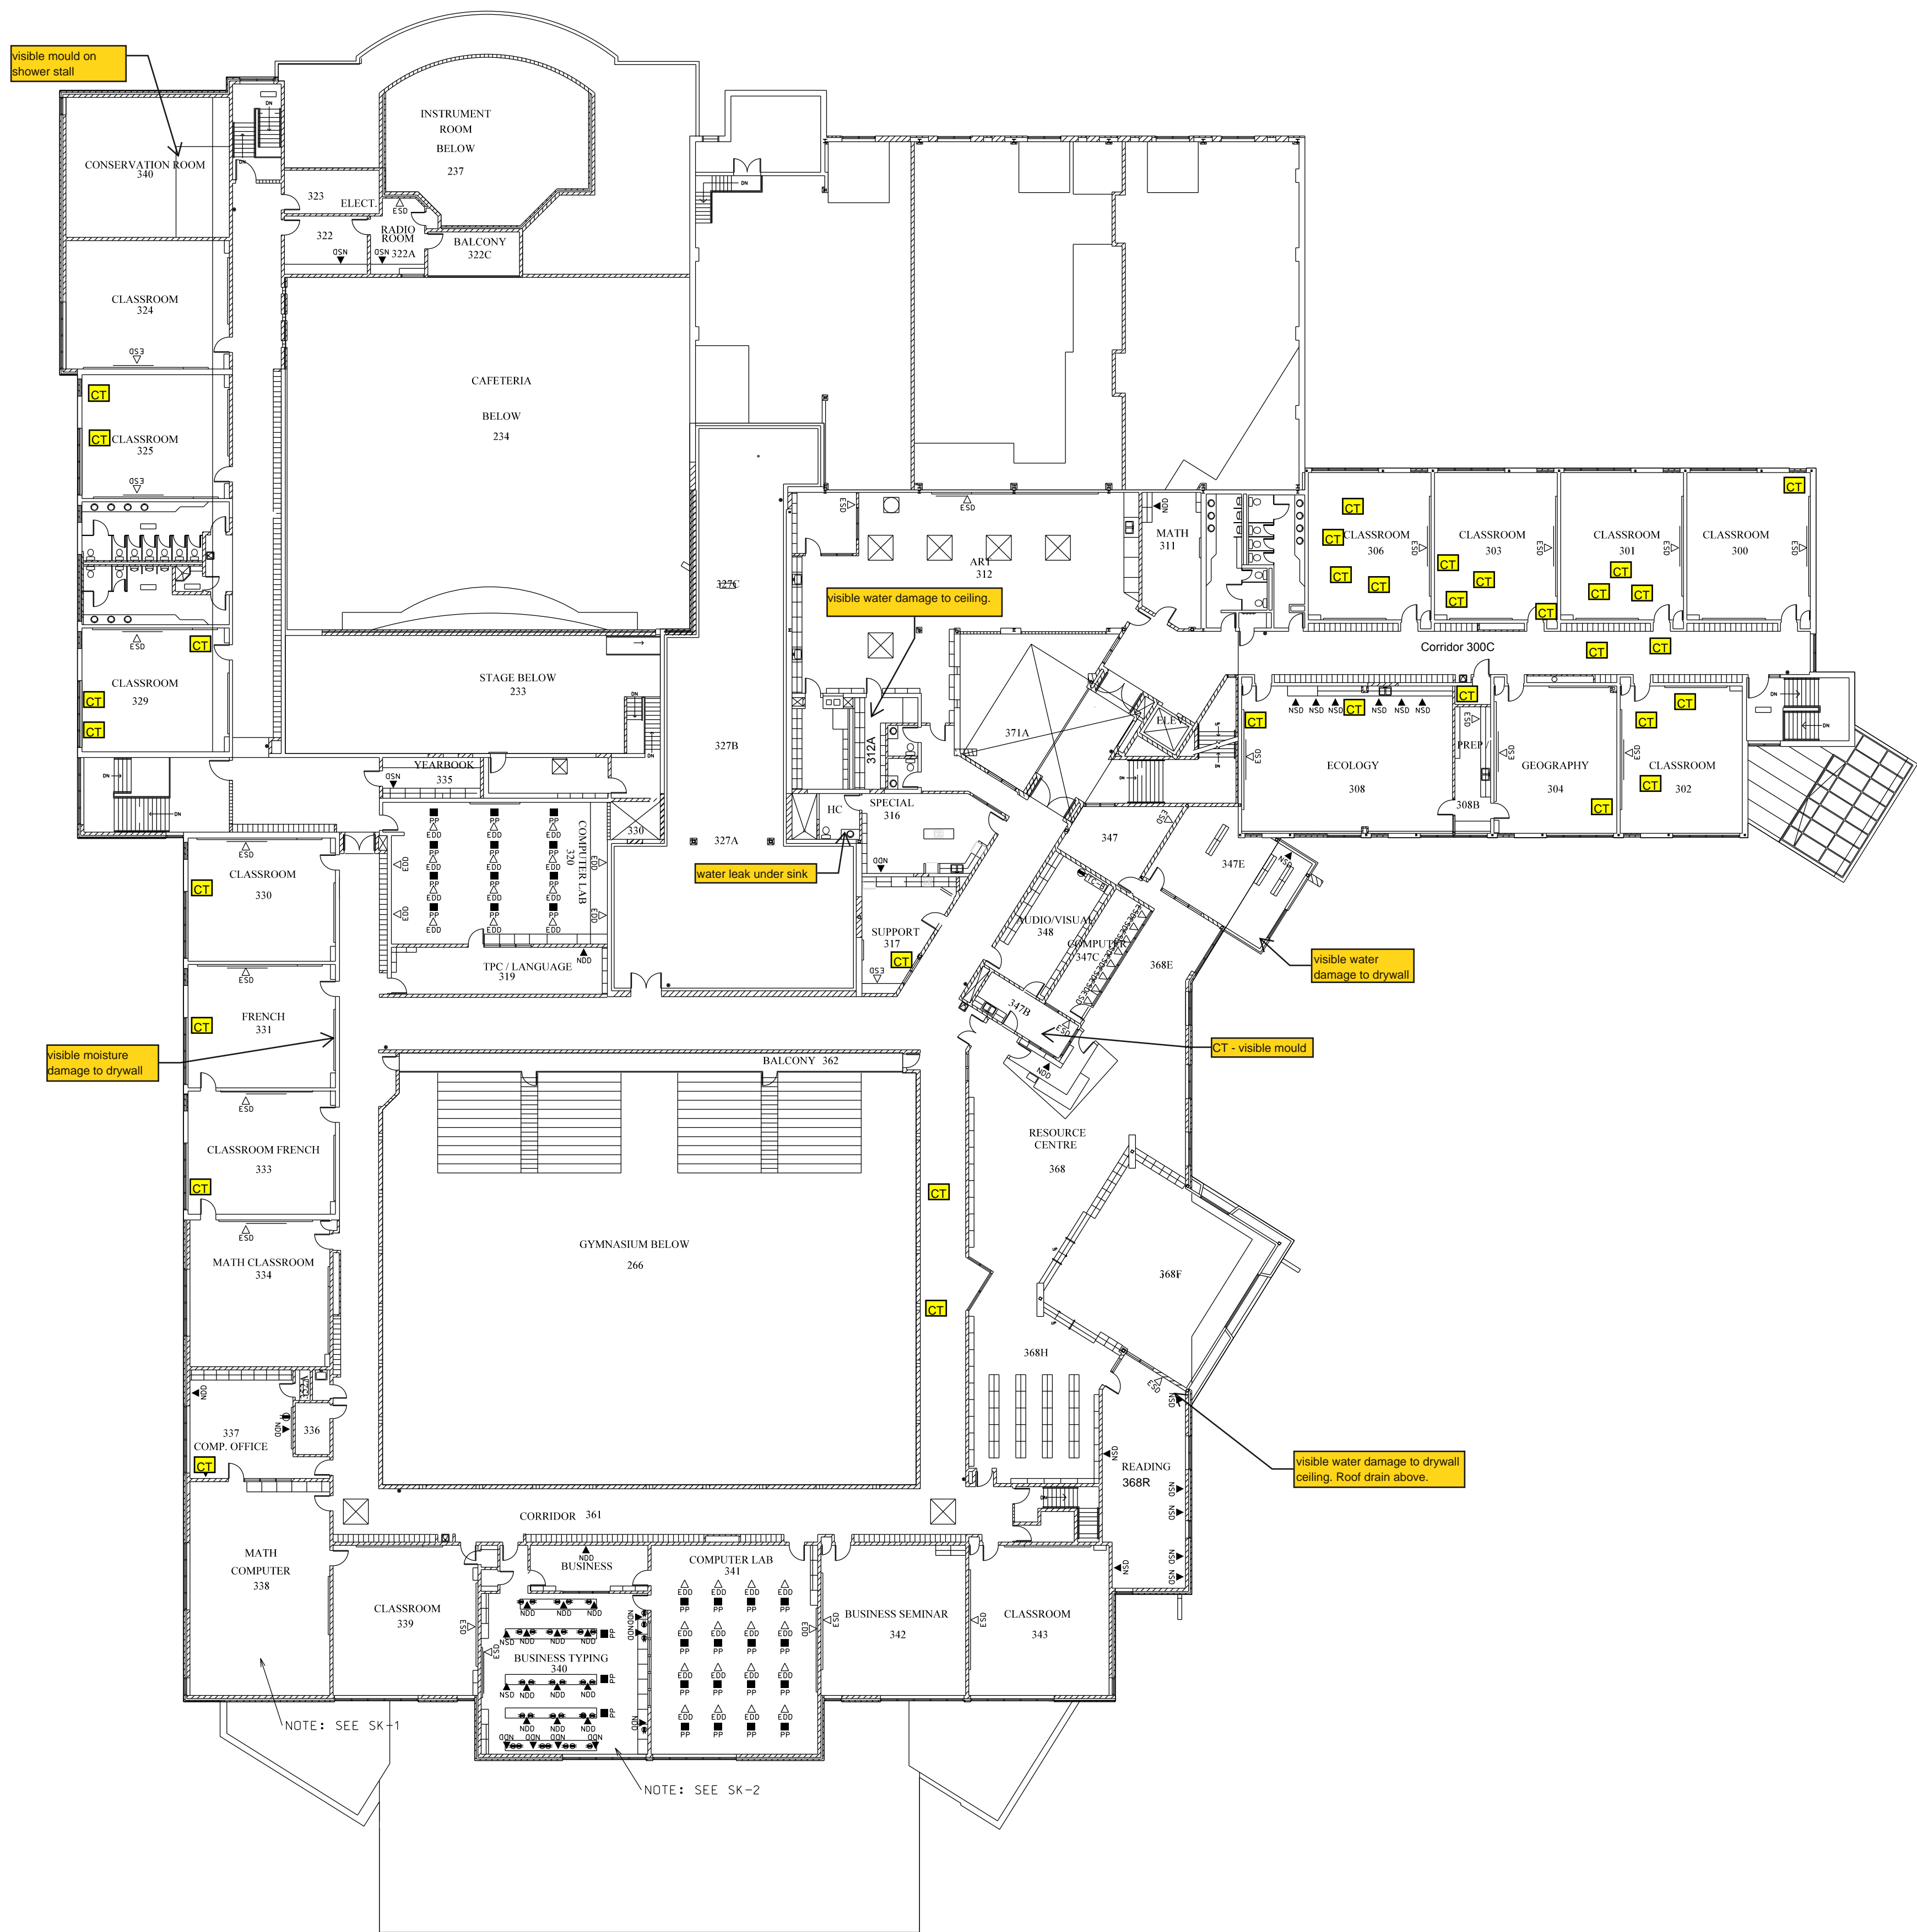
UPPER LEVEL PLAN

CT - affected ceiling tile area
