Mould & Moisture Assessment Colonel Gray High School

Project No. 12620

March 24, 2011

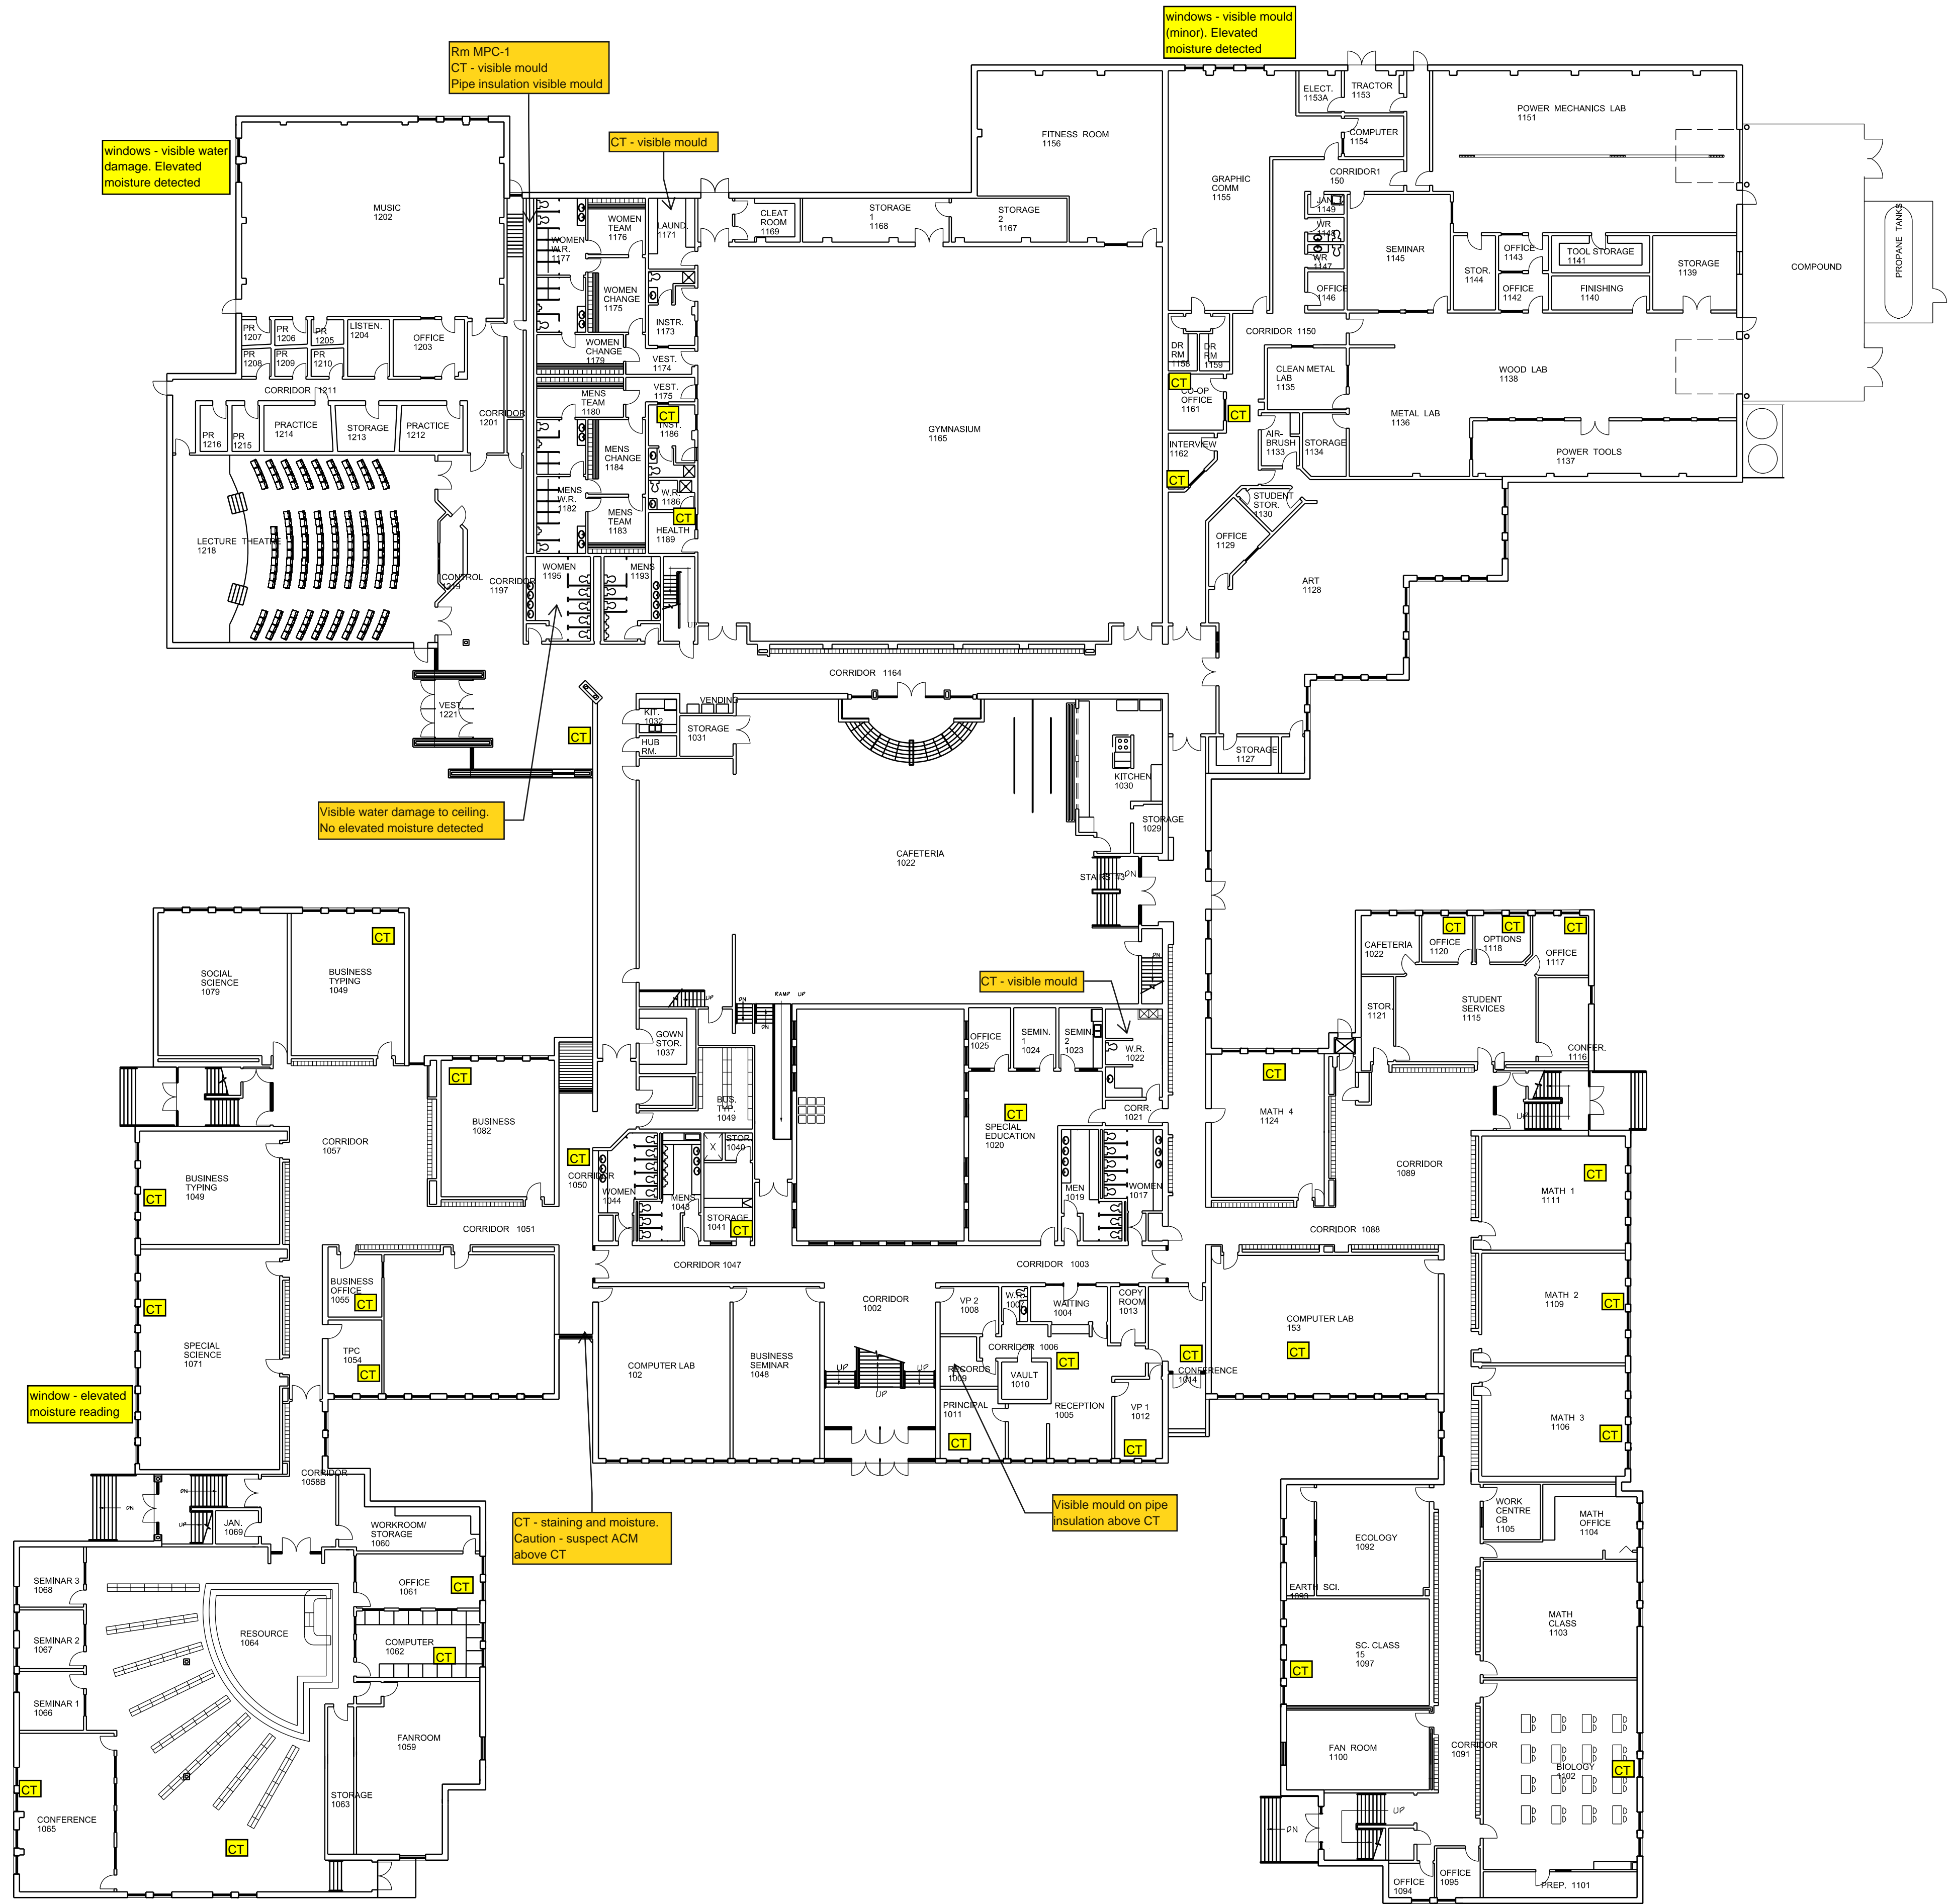
MAIN FLOOR

CT - affected ceiling tile area

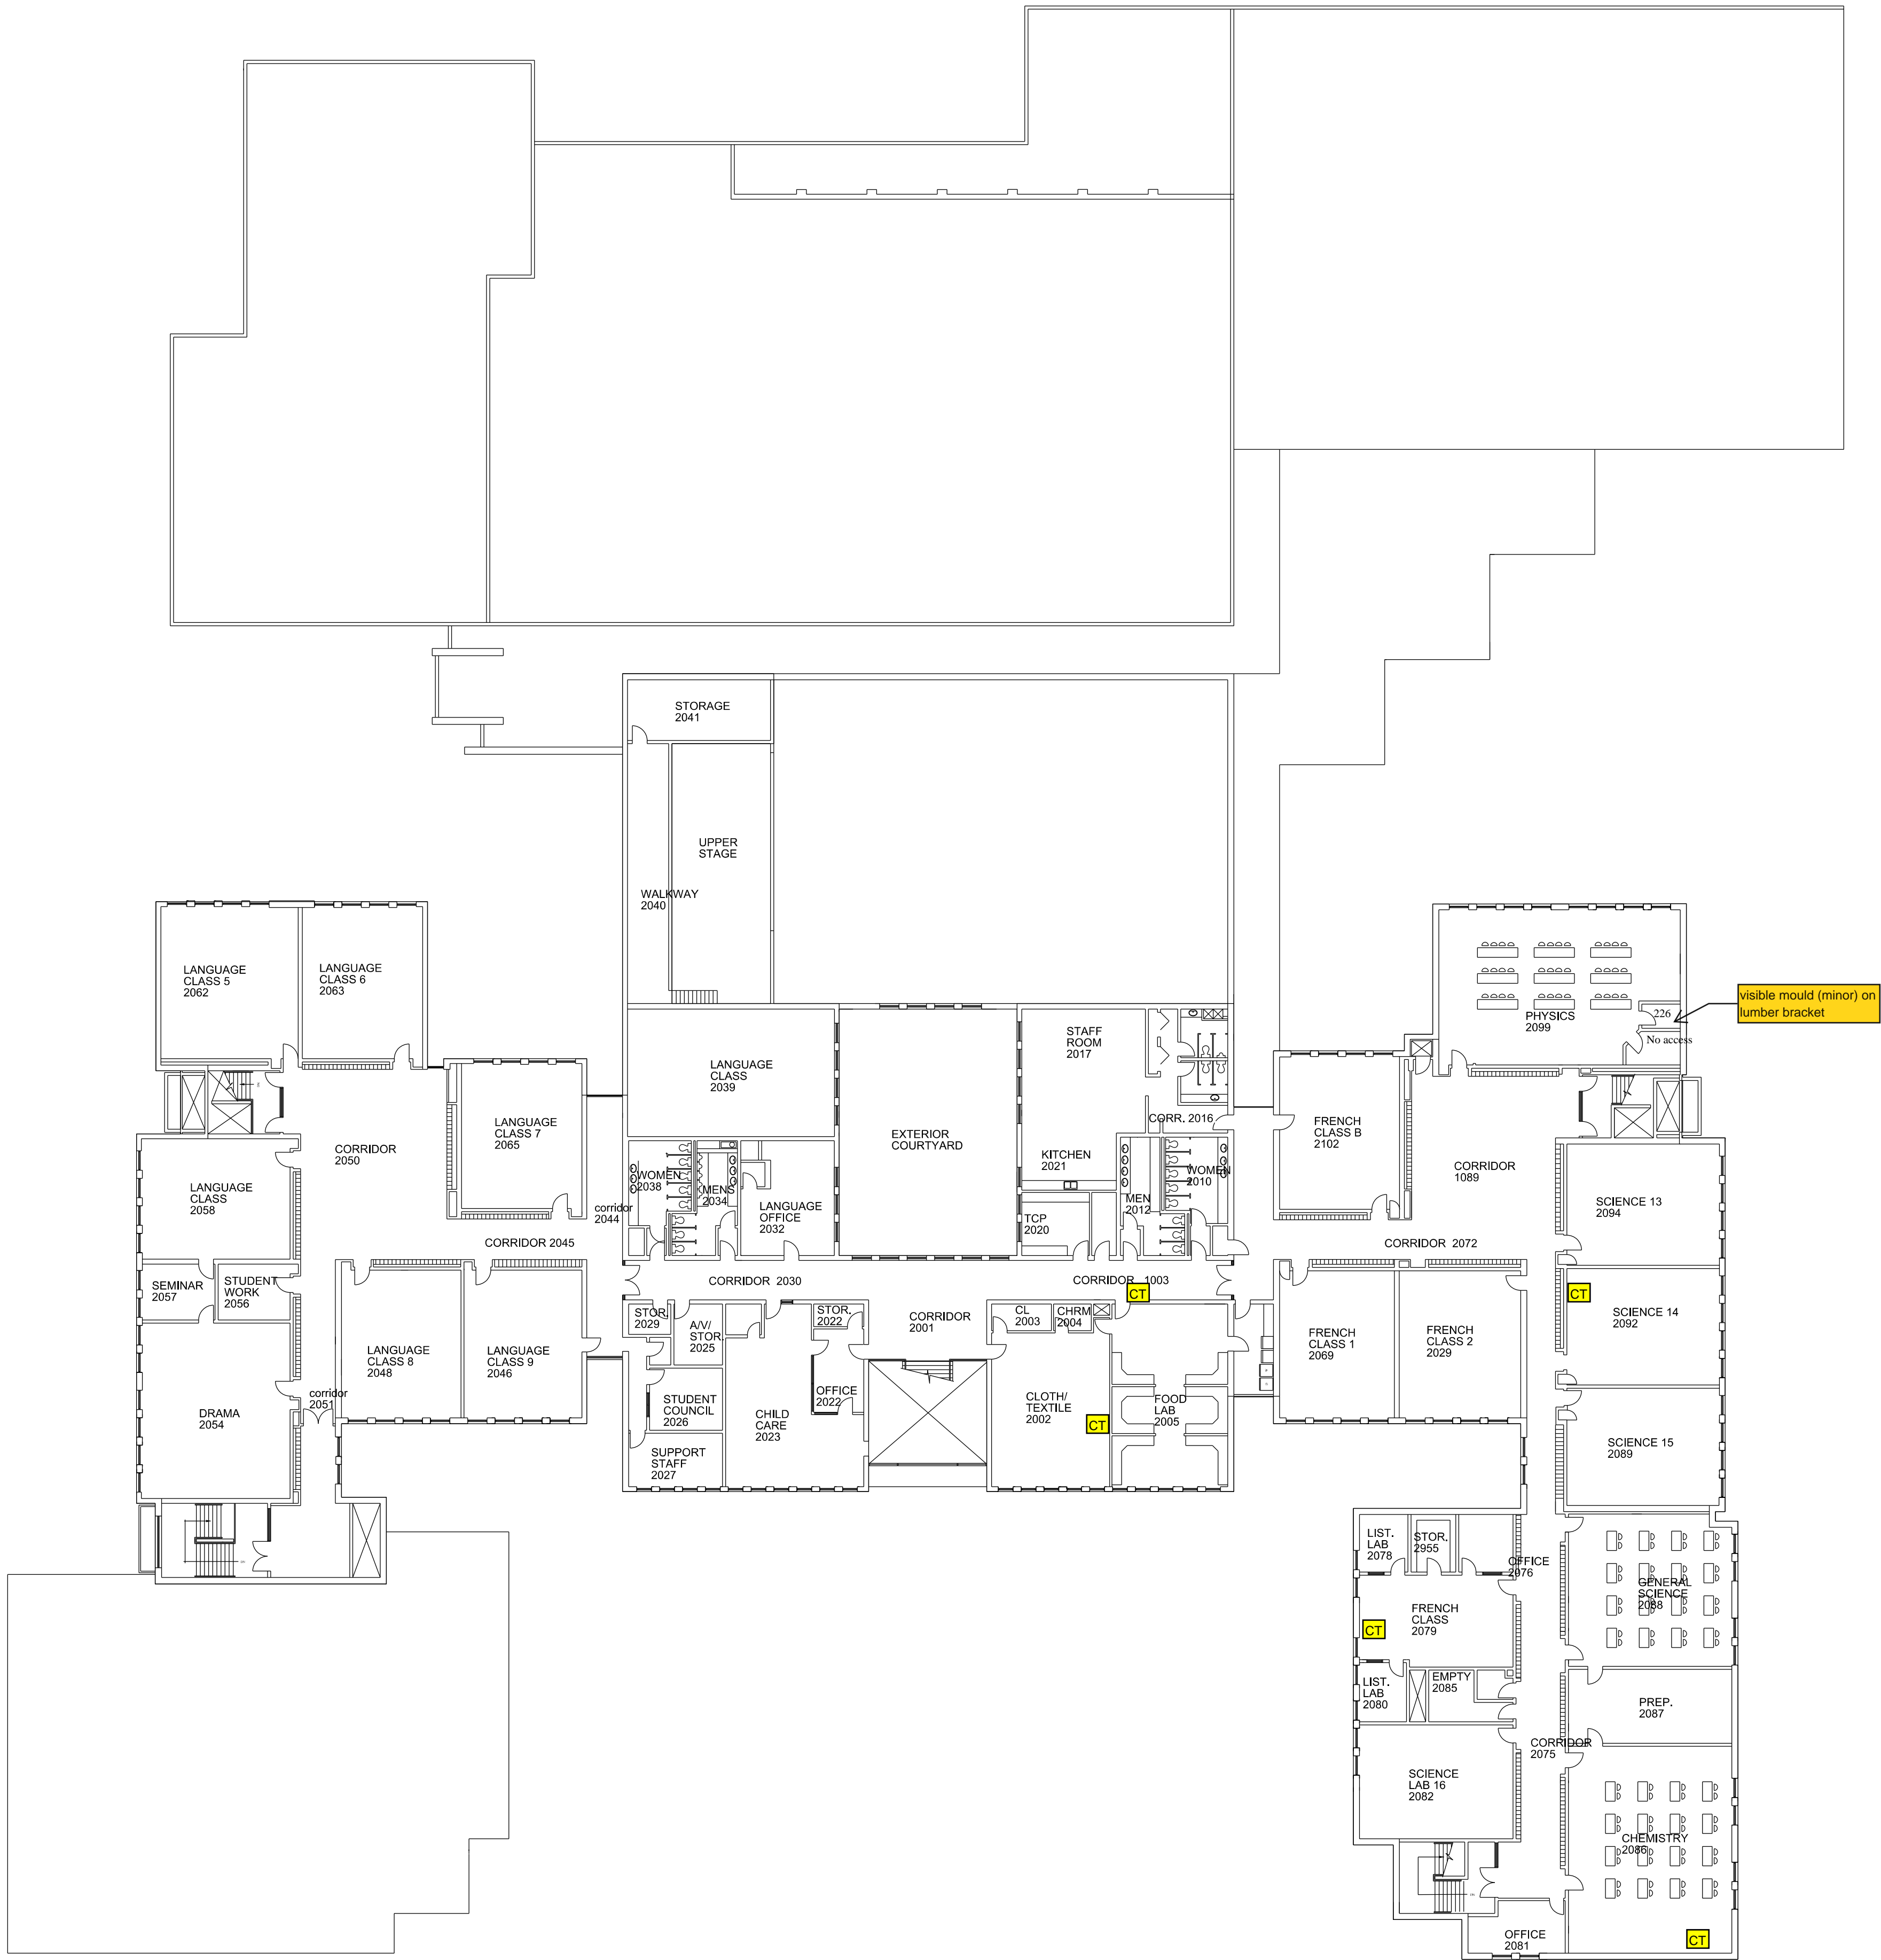
SECOND FLOOR

CT - affected ceiling tile area

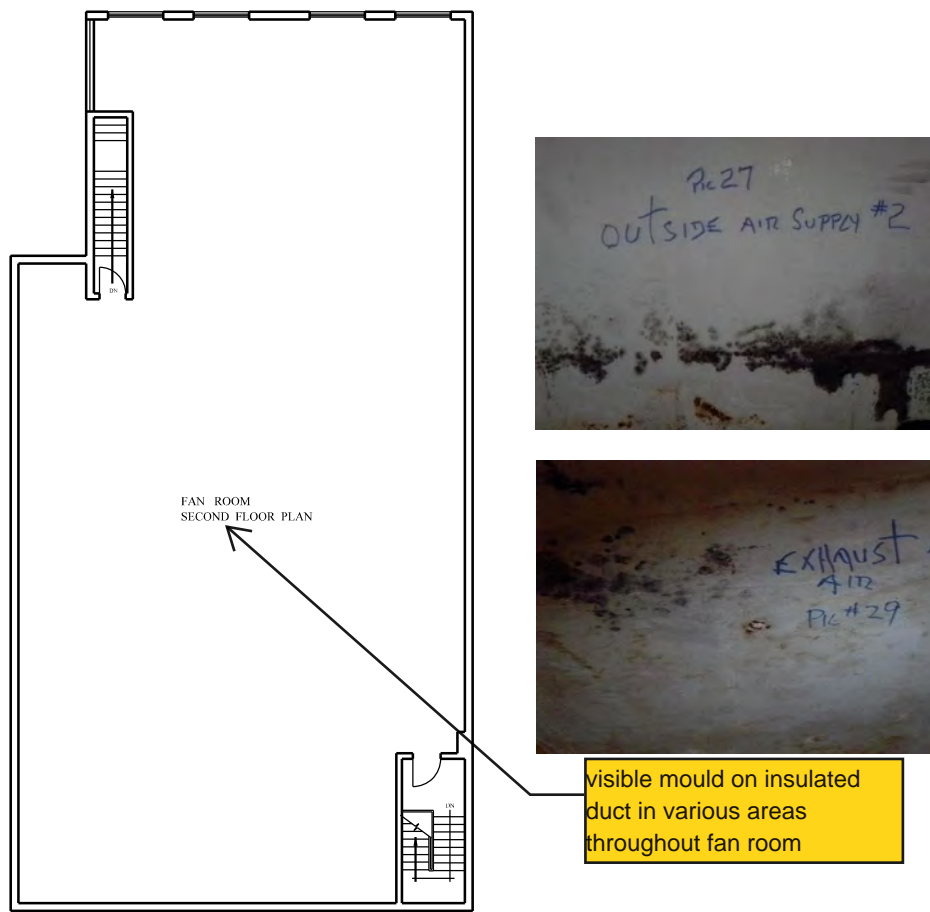
FAN ROOM

Visible mould was reported on mechanical air handling duct insulation in several areas throughout fan room. These materials should be considered suspect asbestos containing materials (ACM). Have materials tested for asbestos prior to disturbance work. Remediation work should be completed after hours. Air handling units should be shut off, critical openings and materials sealed/protected. Consult with Health & Safety professional for development of scope of work, remediation management and quality assurance as per CSA 82-04 mould guidelines for large scale mechanical rooms.

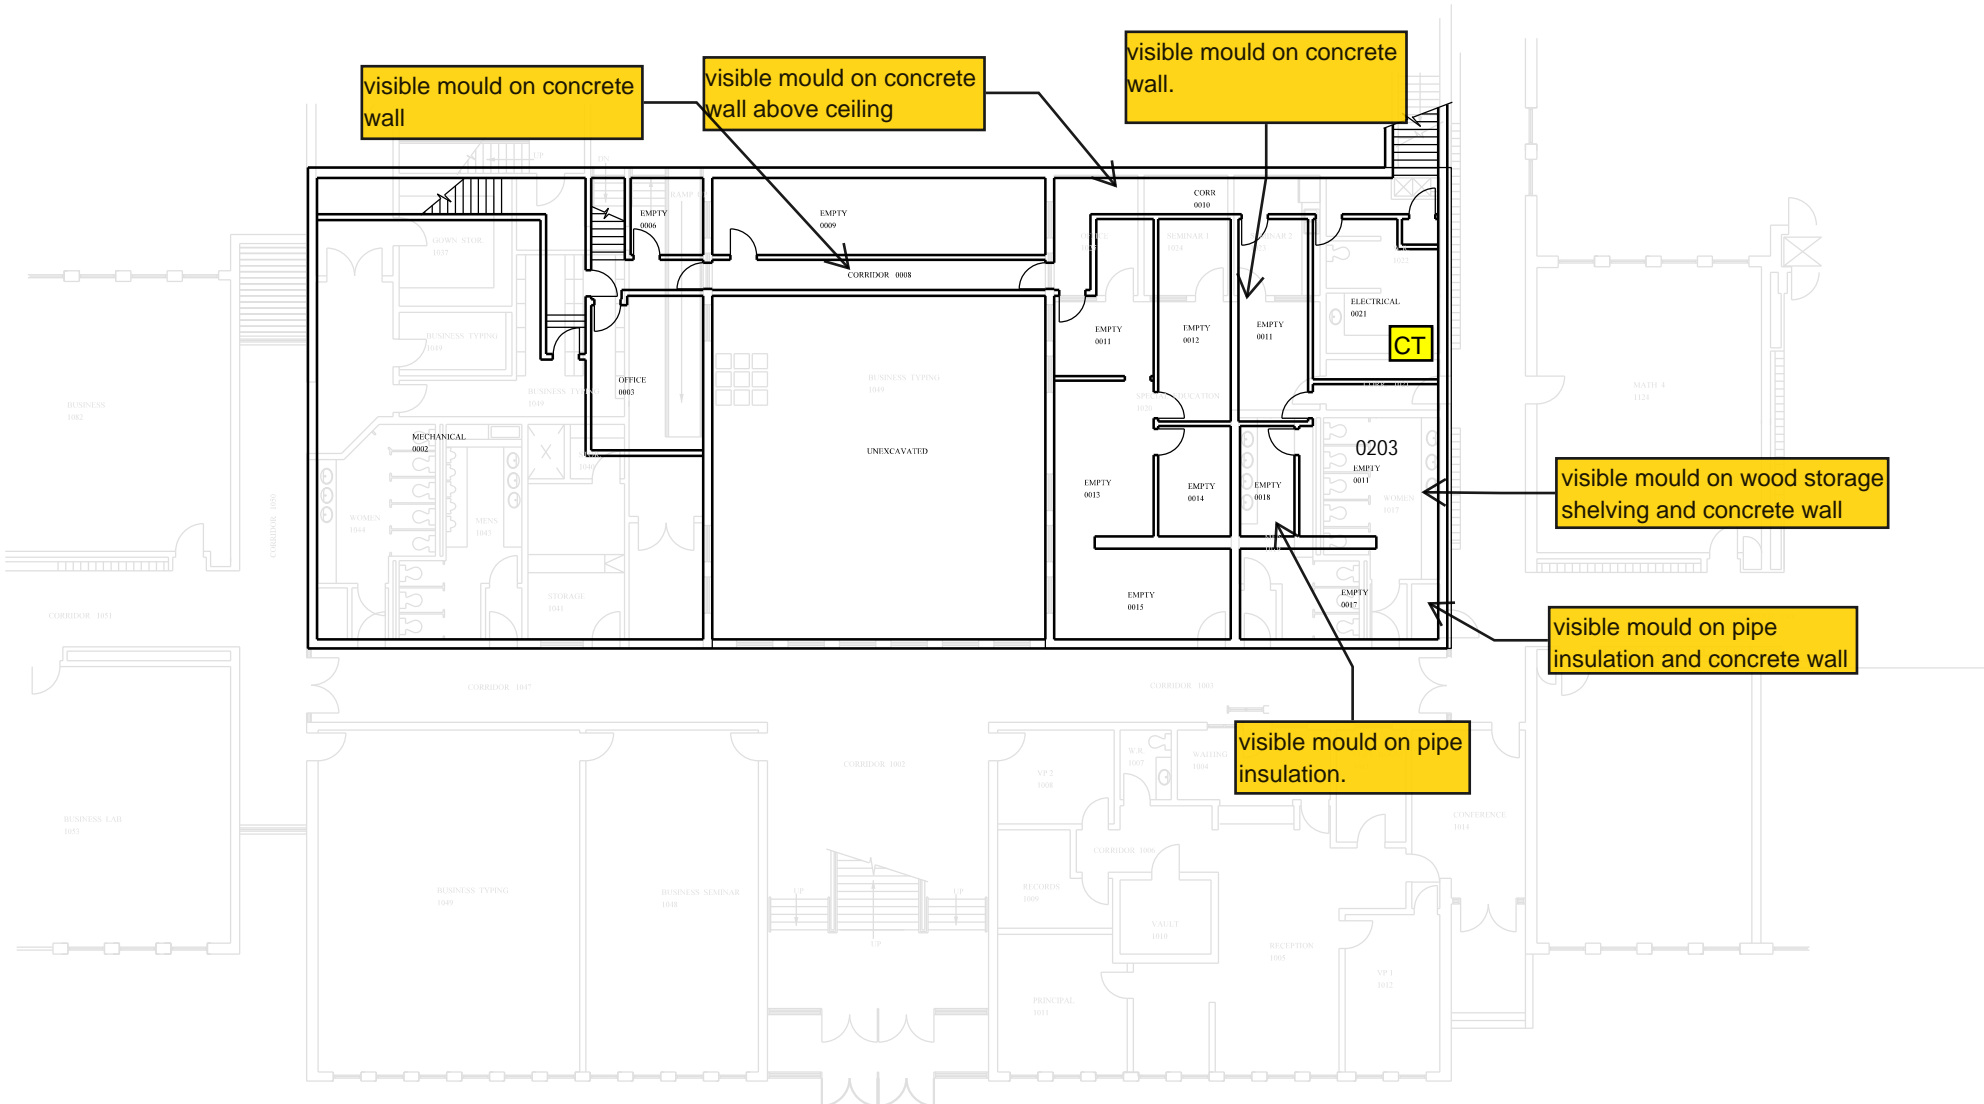
BASEMENT

It appears that the conditions noted for the basement are primarily the result of water intrusion through the building envelope (foundation) which, if left unattended, may result in more extensive water damage and further mould contamination in the future. Further assessment into identifying the source(s) of water infiltration into the basement level is the key quality assurance to avoid additional structural damage and mould amplification. Although no significant impact is anticipated for the remainder of the school, the basement level should not be used for occupancy or storage of books or the like. Access should be limited by all and restricted to people with asthma, allergies or compromised immune systems.
