Mould & Moisture Assessment Donagh Regional School

Project No. 12620

May 12, 2011

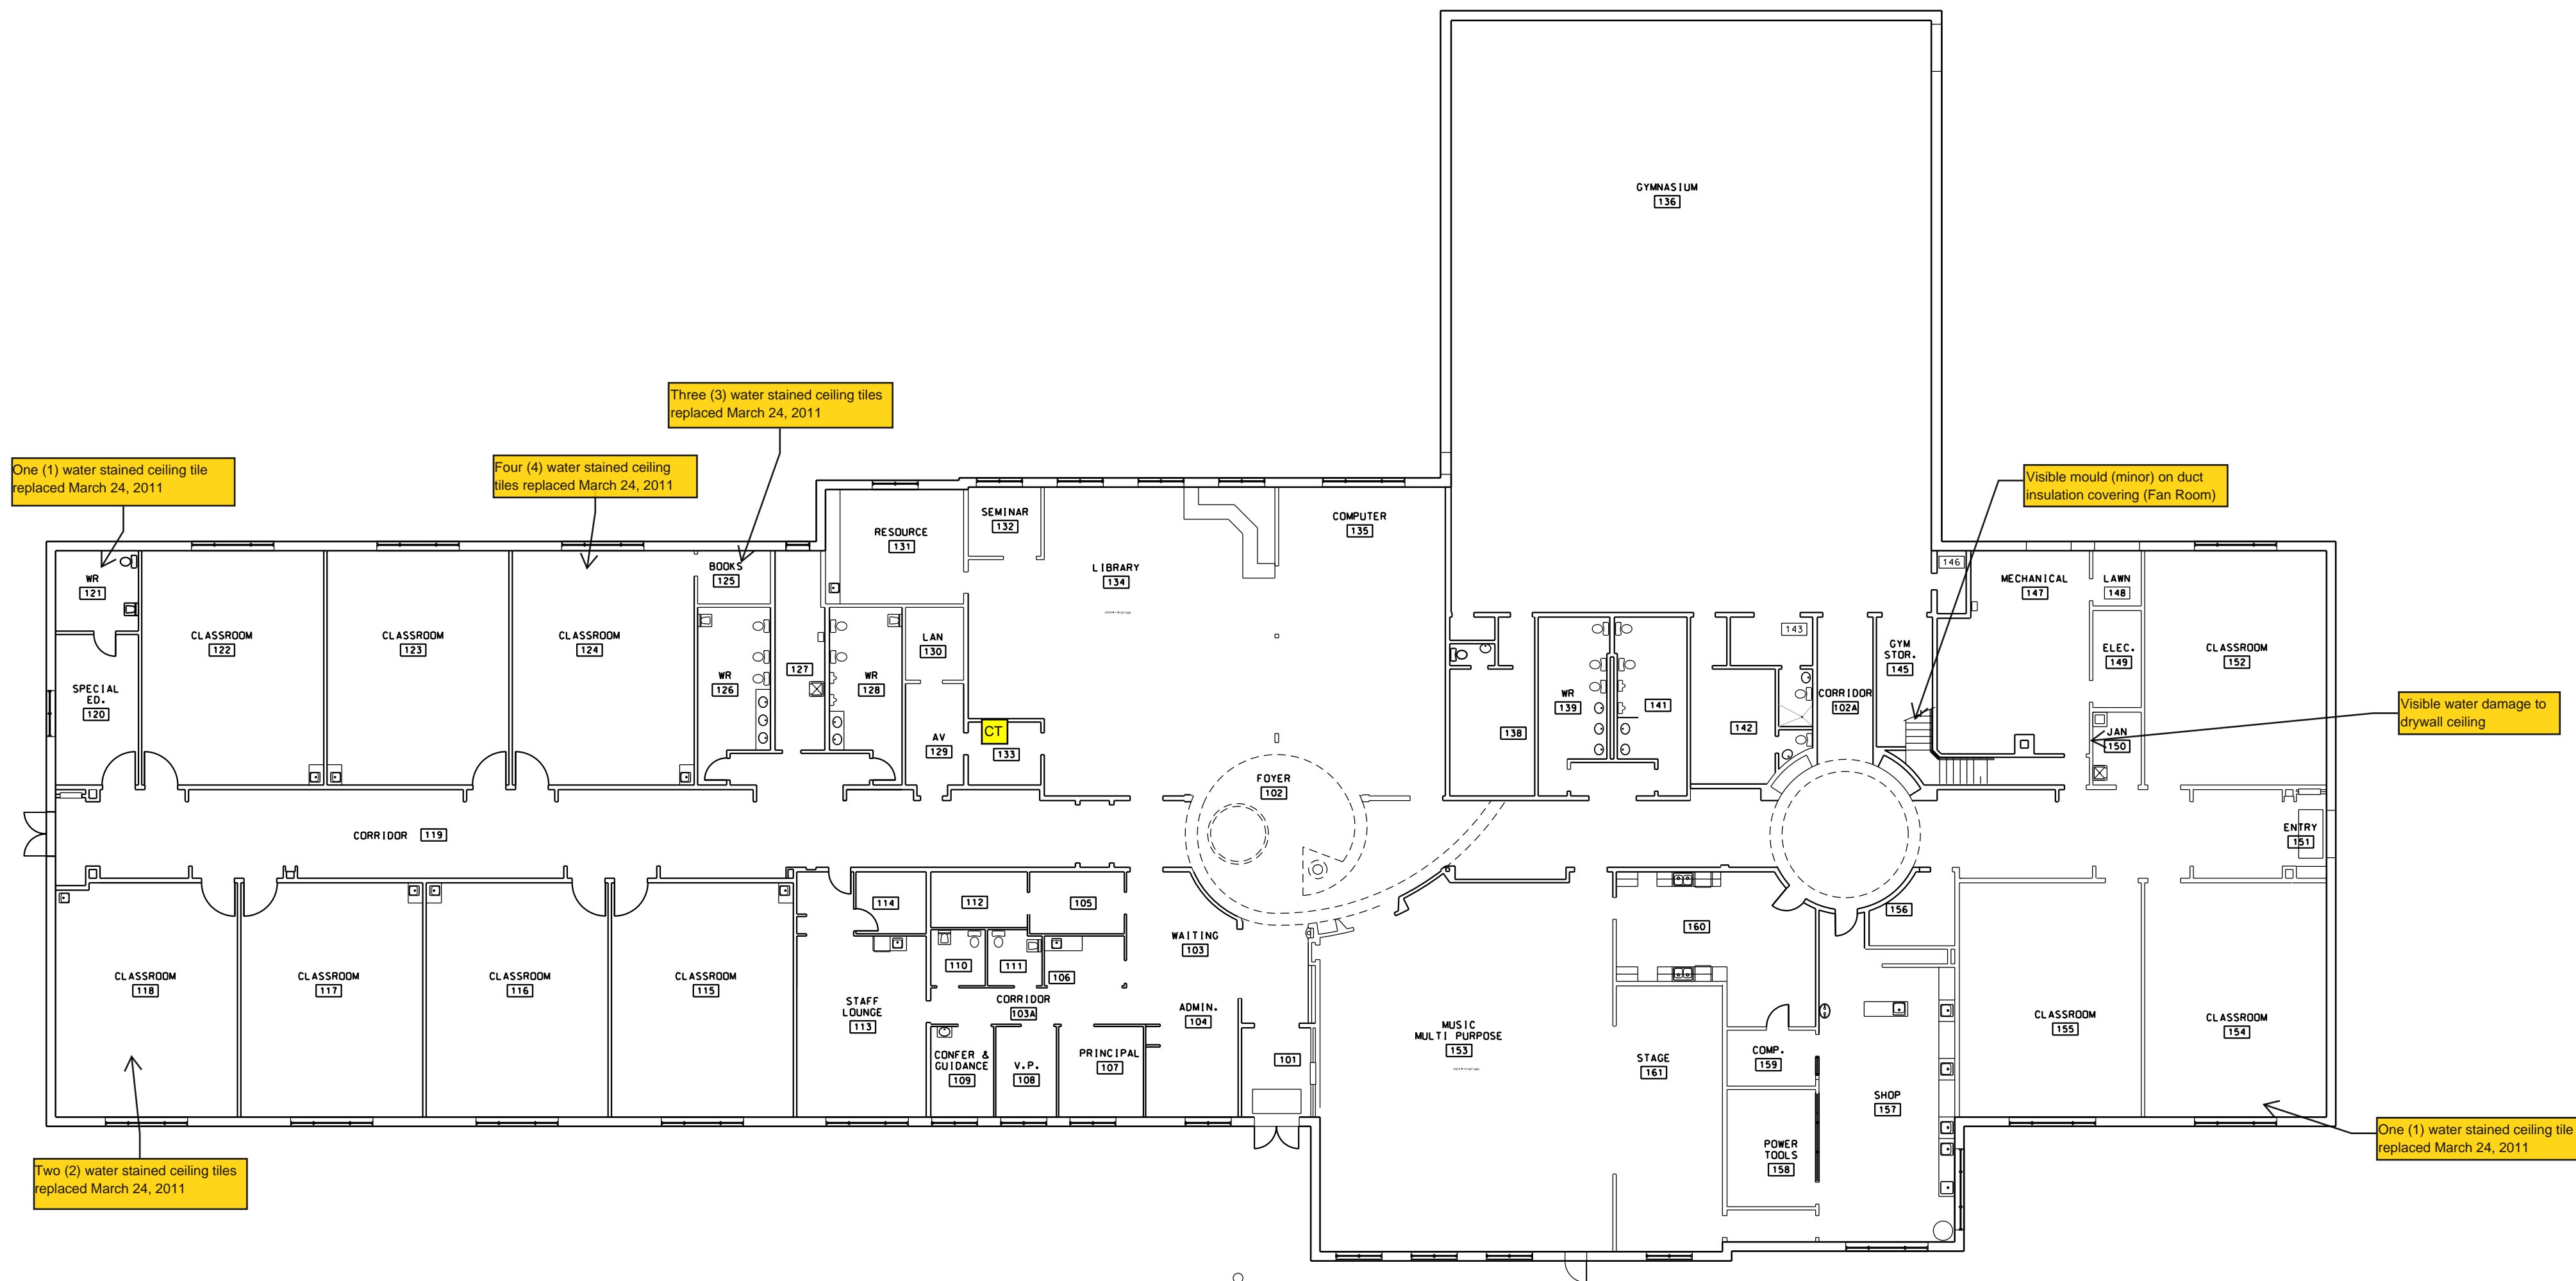
FLOOR PLAN

CT - affected ceiling tile area
