# Mould & Moisture Assessment Ellerslie Elementary School

**Project No. 12620**

**April 29, 2011**

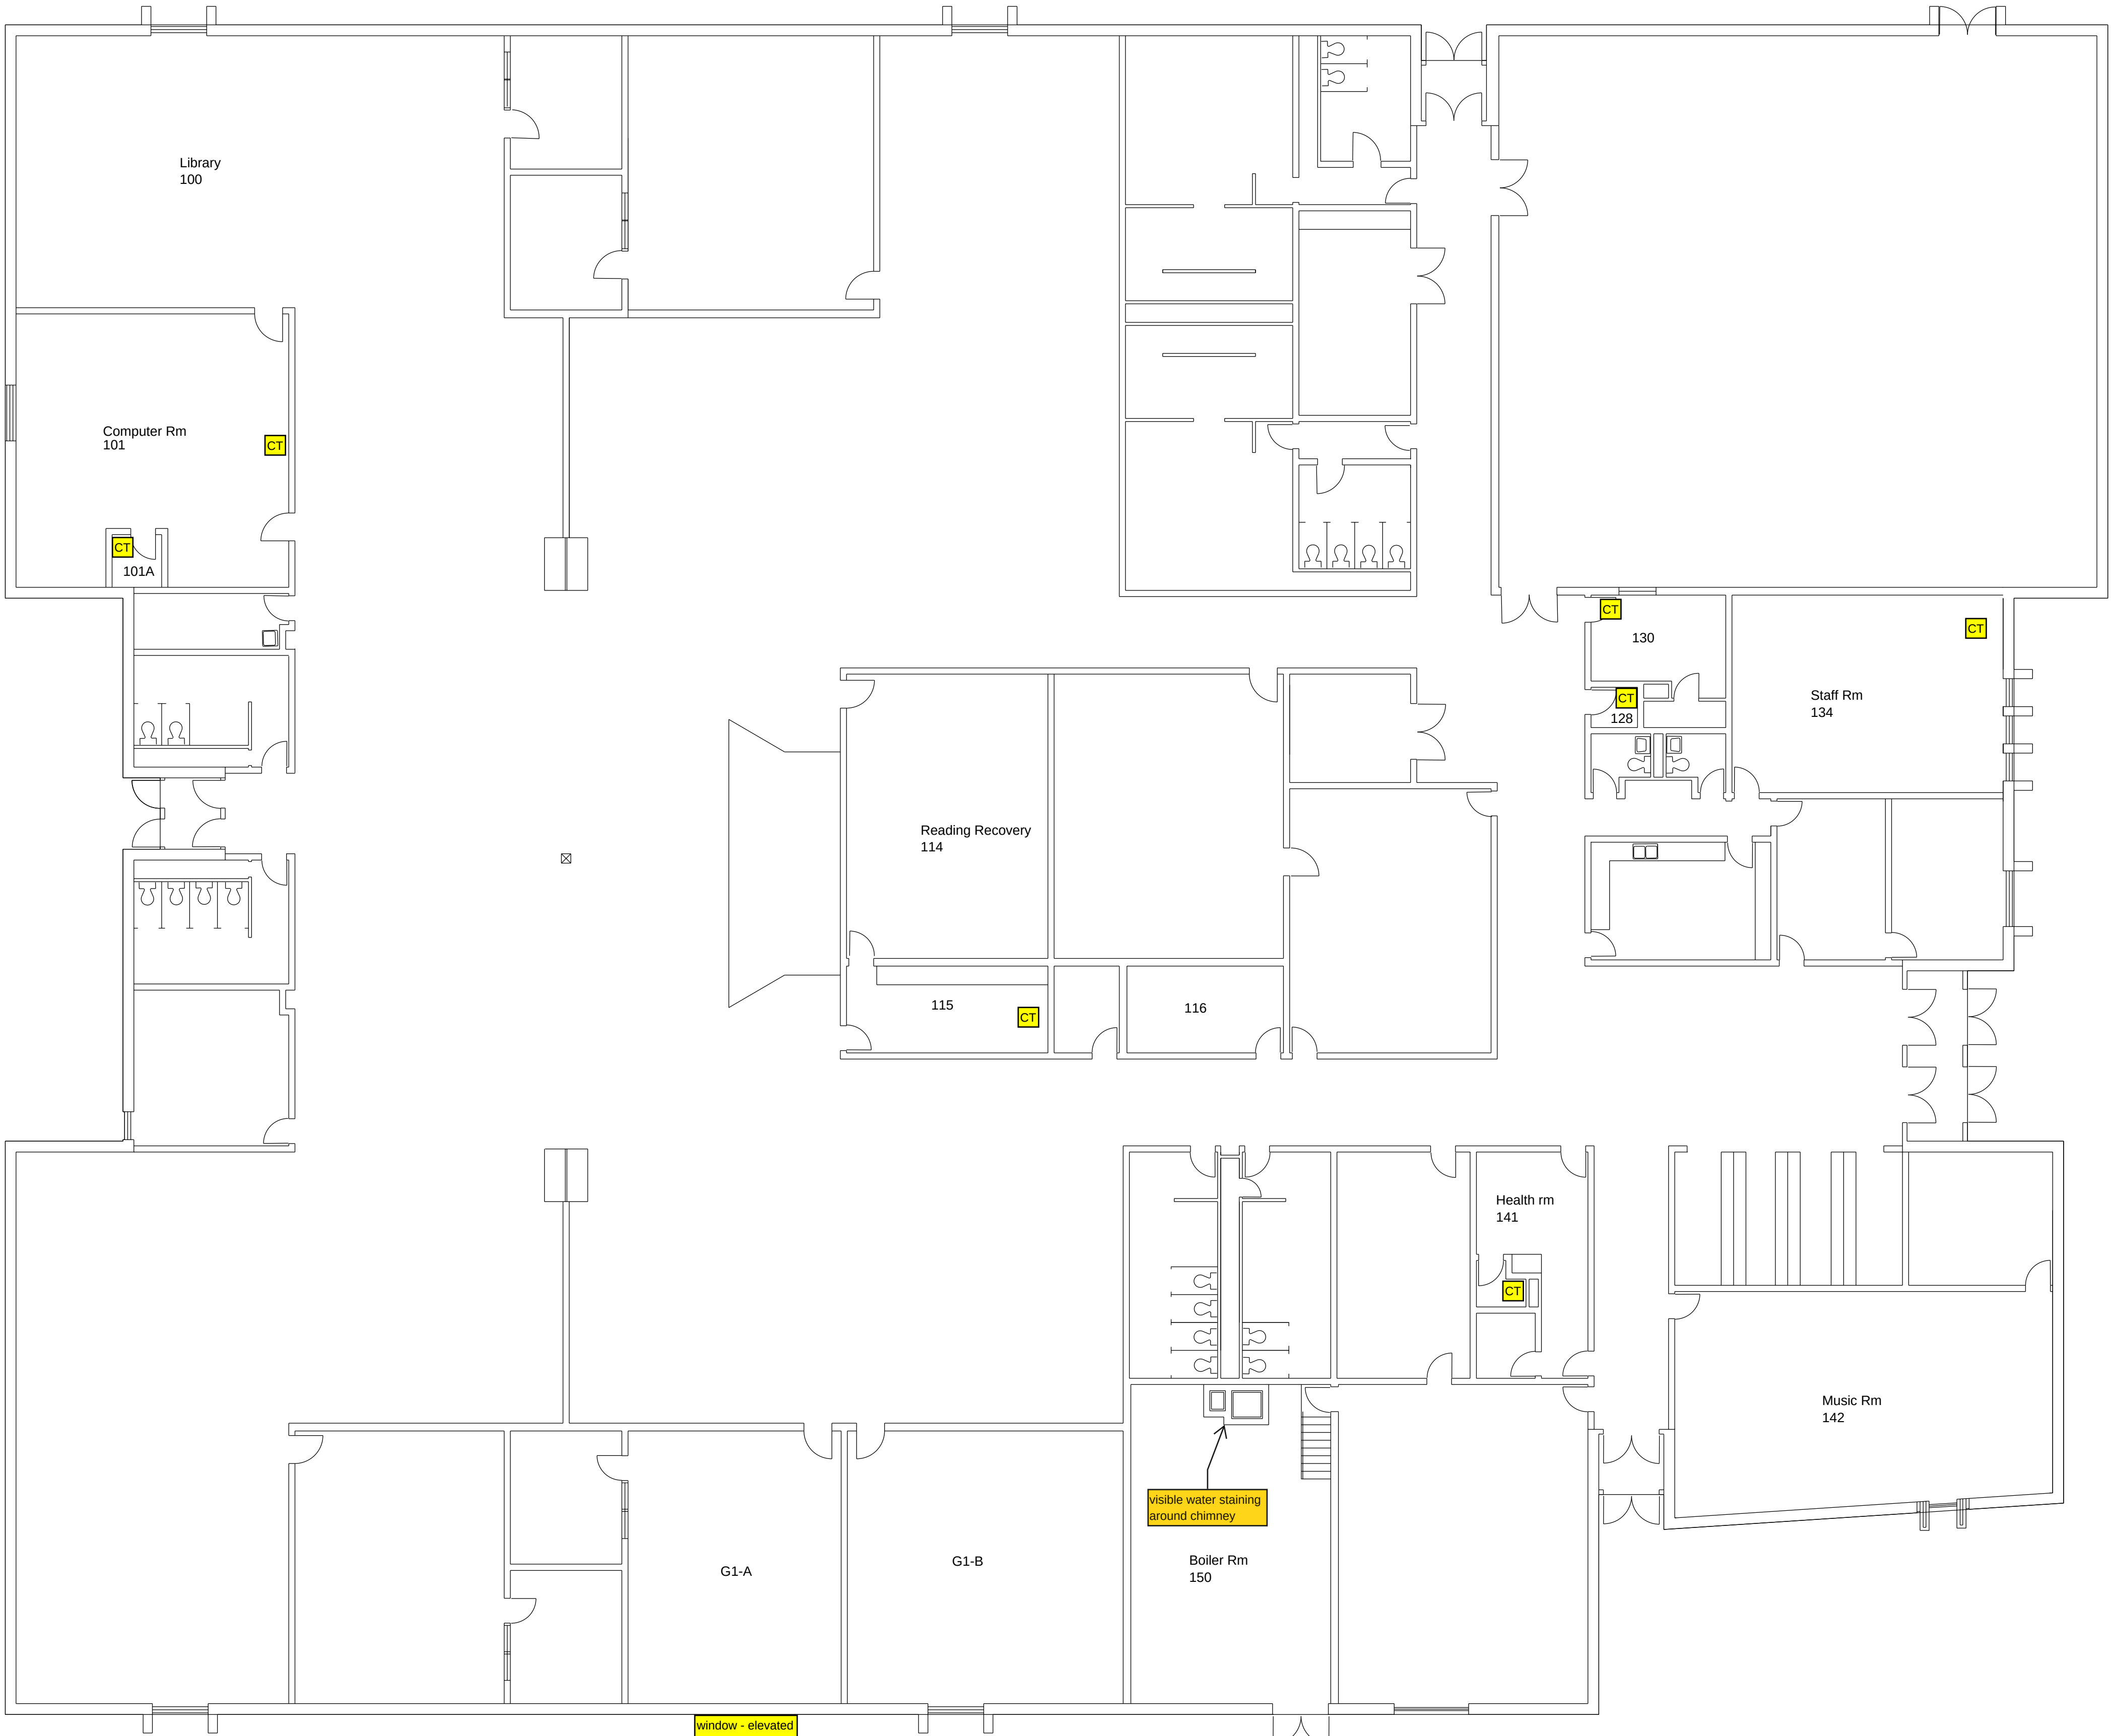
MAIN FLOOR PLAN  
SCALE = 1:125

| <b>Table II</b><br><b>Summary of Moisture affected areas</b> | | |
|---|---|---|
| Rm 128<br>also noted in Rms 101 (Computer Rm); 101A; 115; 130; 134; 141 | Stained ceiling tiles observed and reported in various areas throughout the building (see site floor plan - Appendix I for location markings) | Replace ceiling tiles as precautionary measure and to assist in detecting further water leaks. |
