Mould & Moisture Assessment Elm Street Elementary School

Project No. 12620

June 7, 2011

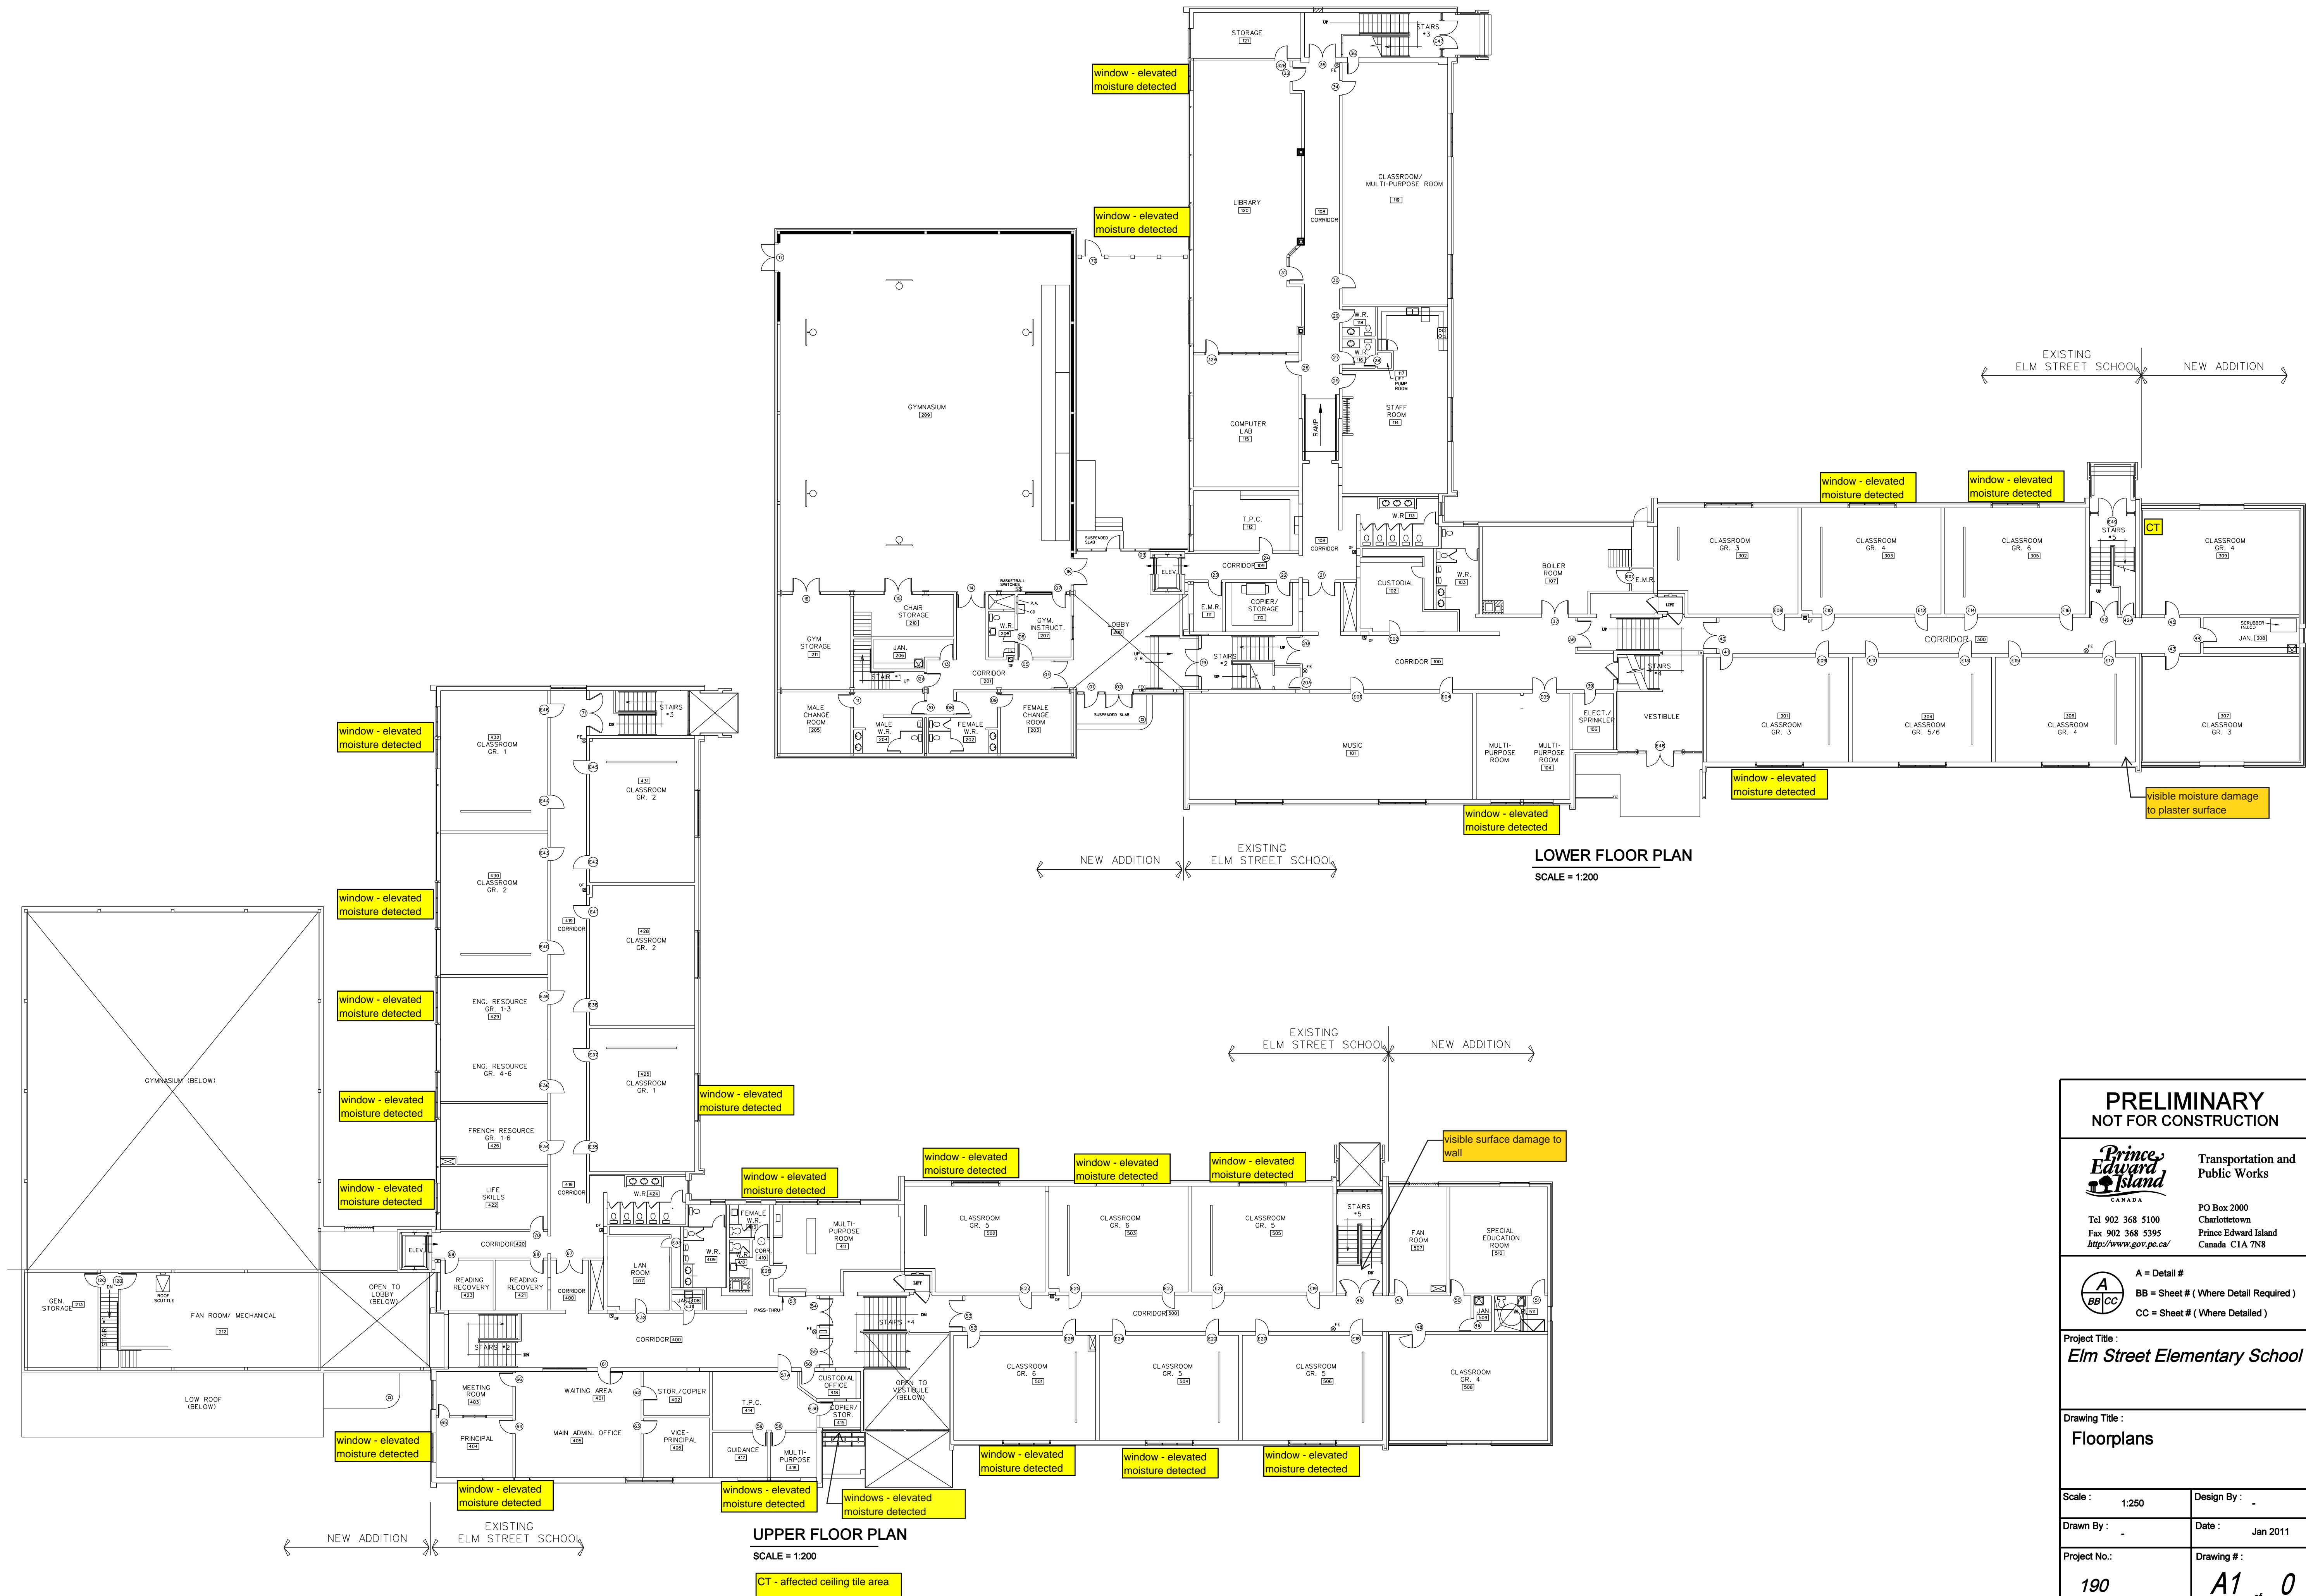
APPENDIX I
Site Floor Plans

Table II Summary of Moisture affected areas		
Room No. / Description	Comments / Observations	Action required
Rm 309	Stained ceiling tile observed and reported in noted area. (see site floor plan - Appendix I for location marking).	Replace ceiling tiles as precautionary measure and to assist in detecting further water leaks.
Rms 104 120; 301; 303; 305; 404; 405; 411; 415; 416; 417; 422; 425; 426; 430; 432; 501; 502; 503; 504; 505; 506.	Elevated moisture detected around windows. No visible mould observed.	Re-check windows components for moisture content. If elevated moisture persists, further investigation of select windows to assess for potential water infiltration or trapped moisture from installation.
Rm 306	Visible surface damage to plaster wall. No elevated moisture detected at the time of assessment.	Report any further water / moisture issues promptly to address potential infiltration issues.
