Mould & Moisture Assessment Englewood School

Project No. 12620

March 16, 2011

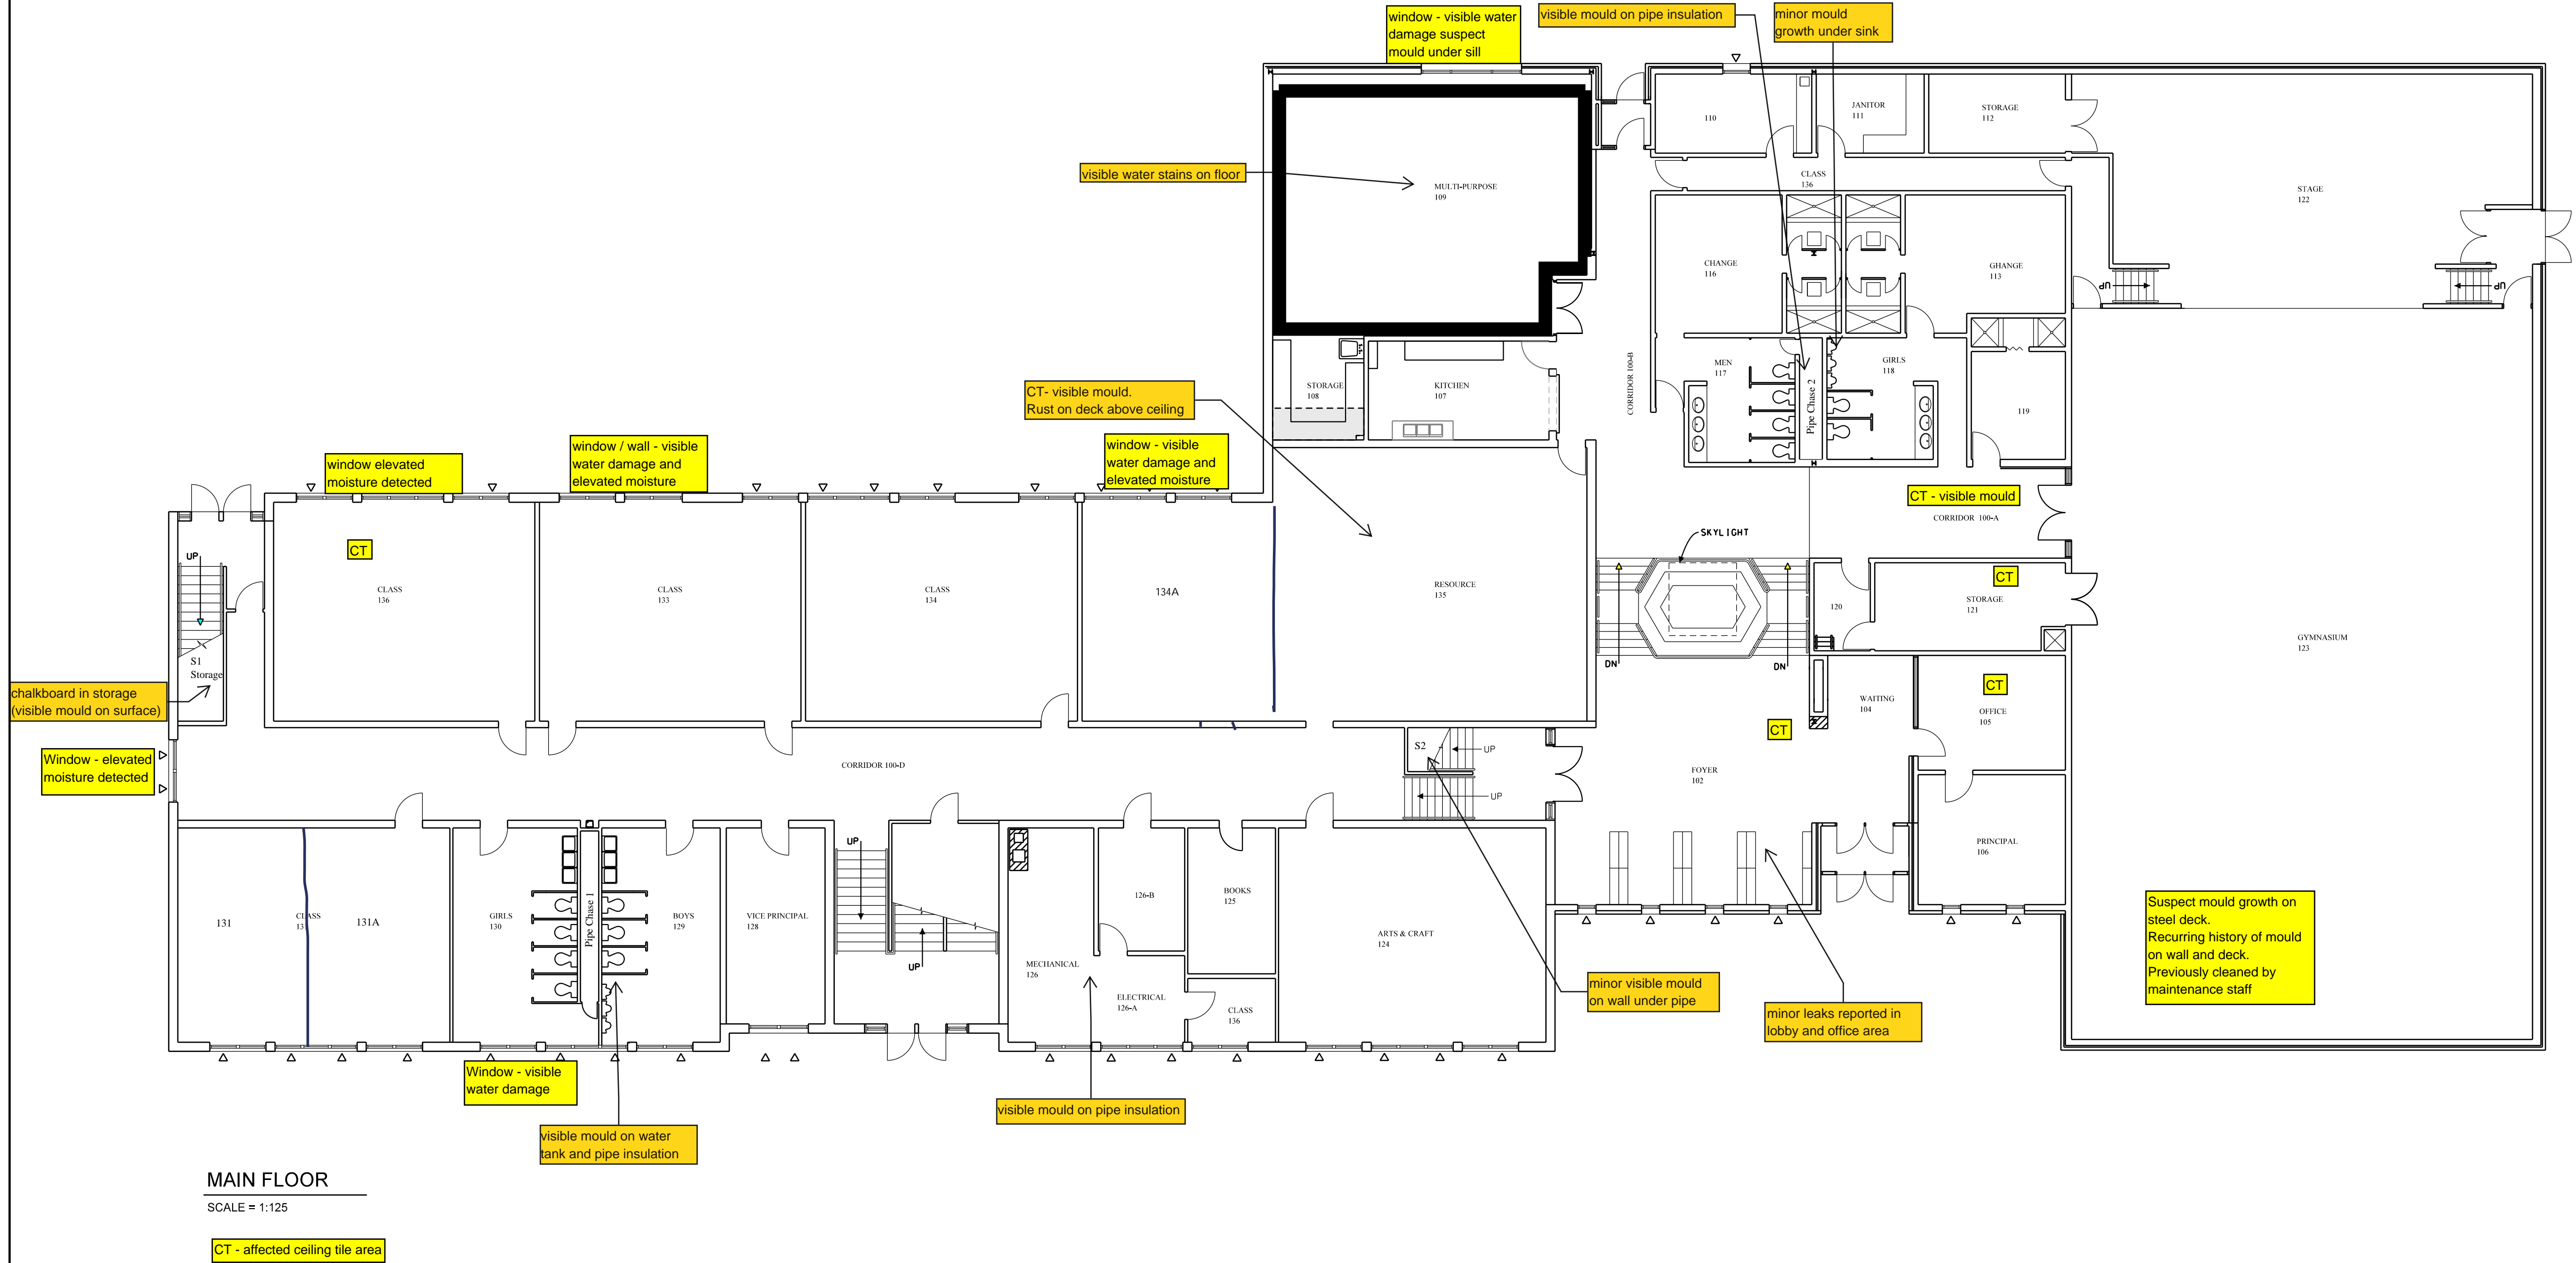
Drawing Title :
Main Floor Plan

Table II Summary of Visible Mould affected areas		
Room No. / Description	Comments / Observations	Level of Remediation
100A - Corridor 135 Library	Minor amount of visible mould on ceiling tile	Level 1 <10 ft ² (<1 m ²) (discard and replace)
Rm 118 Girls Washroom	Minor visible mould under sink base.	Level 1 <10 ft ² (<1 m ²) Clean up of affected area.
Rm 211 Staff Room As well as corridor outside room	Visible mould on wood framing above ceiling tile and suspect on ceiling grid. Roof repairs were reported to be completed and no recurring water. However, mould affected wood is present and should be properly decontaminated.	Level 2 10 - 100ft ² (1 - 10 m ²) Clean up of affected areas.
S2 Stairway	Minor visible mould on wall behind pipe.	Level 1 <10 ft ² (<1 m ²) Clean up of affected area.
S1 Storage	Visible mould on stored chalkboard.	Level 1 <10 ft ² (<1 m ²) Clean up of affected area
Pipe Chase 2; Rm 126 Mechanical Rm	Visible mould on mechanical pipe insulation	Have suspect materials tested for asbestos and treated accordingly. Mould remediation should follow Level 1 procedures of affected areas.

Rm 129 – Boys Washroom	Visible mould on water tank & mechanical pipe insulation	Have suspect materials tested for asbestos and treated accordingly. Mould remediation should follow Level 1 procedures of affected areas.
Rm 123 Gymnasium	Suspect visual mould on steel deck of Gymnasium.	Level 2 10 - 100 ft ² (1 - 10 m ²) Cleaning of affected areas

Table III Summary of Moisture affected areas		
Room No. / Description	Comments / Observations	Action required
Rms 100A corridor; 102; 105; 121; 135; 136 (fixed tiles); 211; 215	Stained in lay ceiling tiles observed and reported throughout the building on both levels (see site floor plan - Appendix I for location markings).	Replace ceiling tiles as precautionary measure and to assist in detecting further water leaks. Some leaks were reported at the time of assessment.
Rm 100D corridor; 109; 130; 133; 134A; 136	Visible water damage and elevated moisture detected around windows.	Further investigation required into addressing water infiltration and possible hidden mould
Rm 2A Janitor Room	High humidity area. Mould odours detected. No visible mould.	Have area cleaned and decontaminated using Level 1 precautions. Report any recurring odours to assist in identifying contributors.

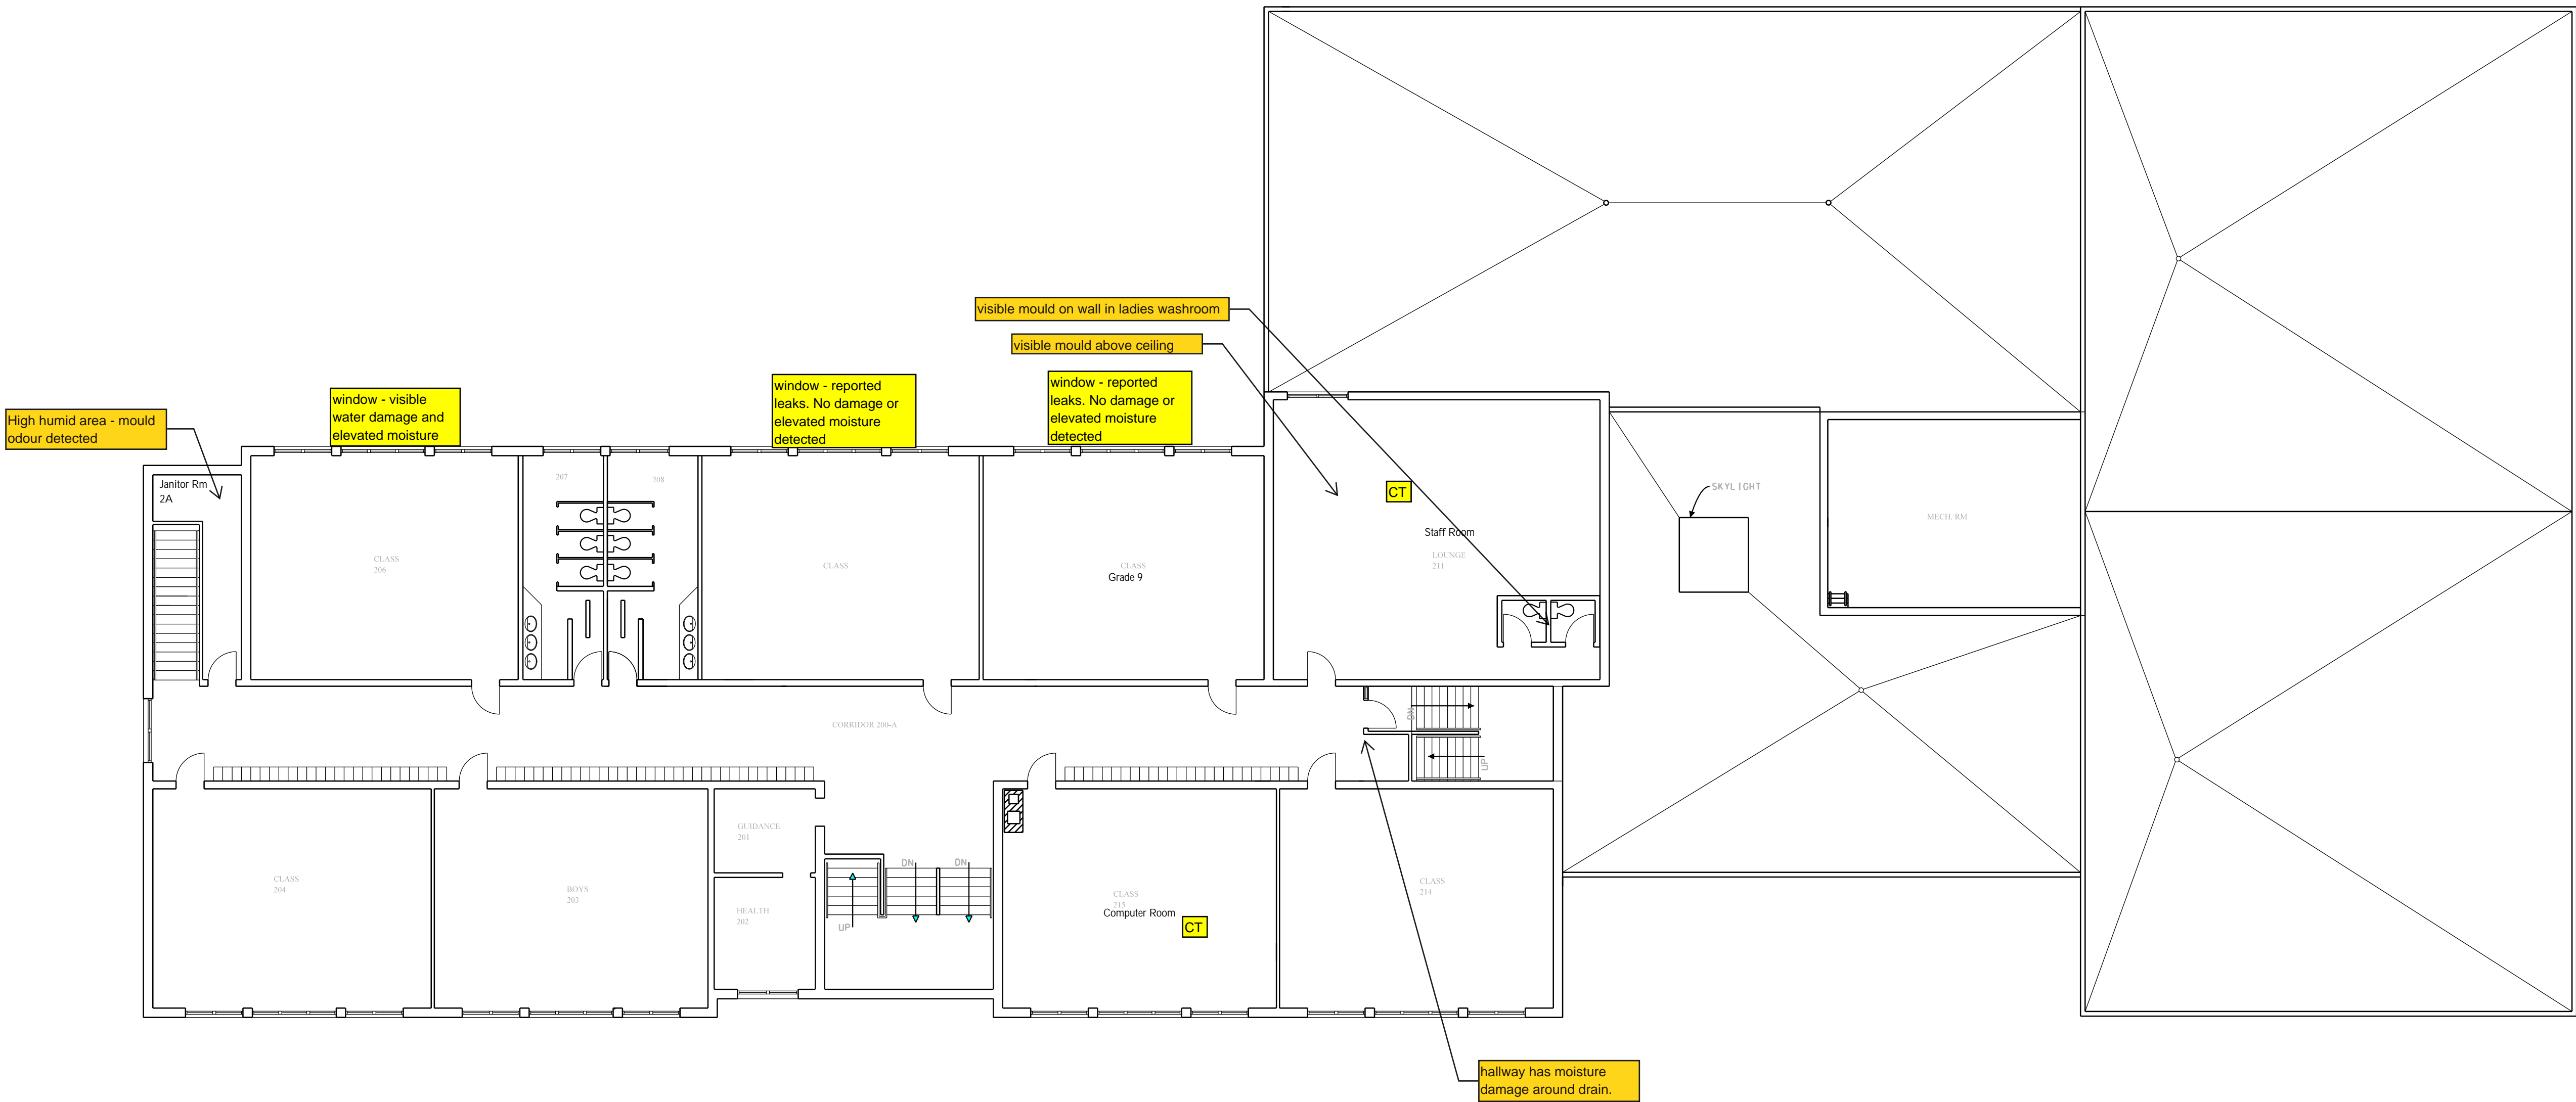
Drawing Title :
Second Floor Plan

CT - affected ceiling tile area
