# Mould & Moisture Assessment East Wiltshire Junior High School

**Project No. 12620**

**March 9, 2011**

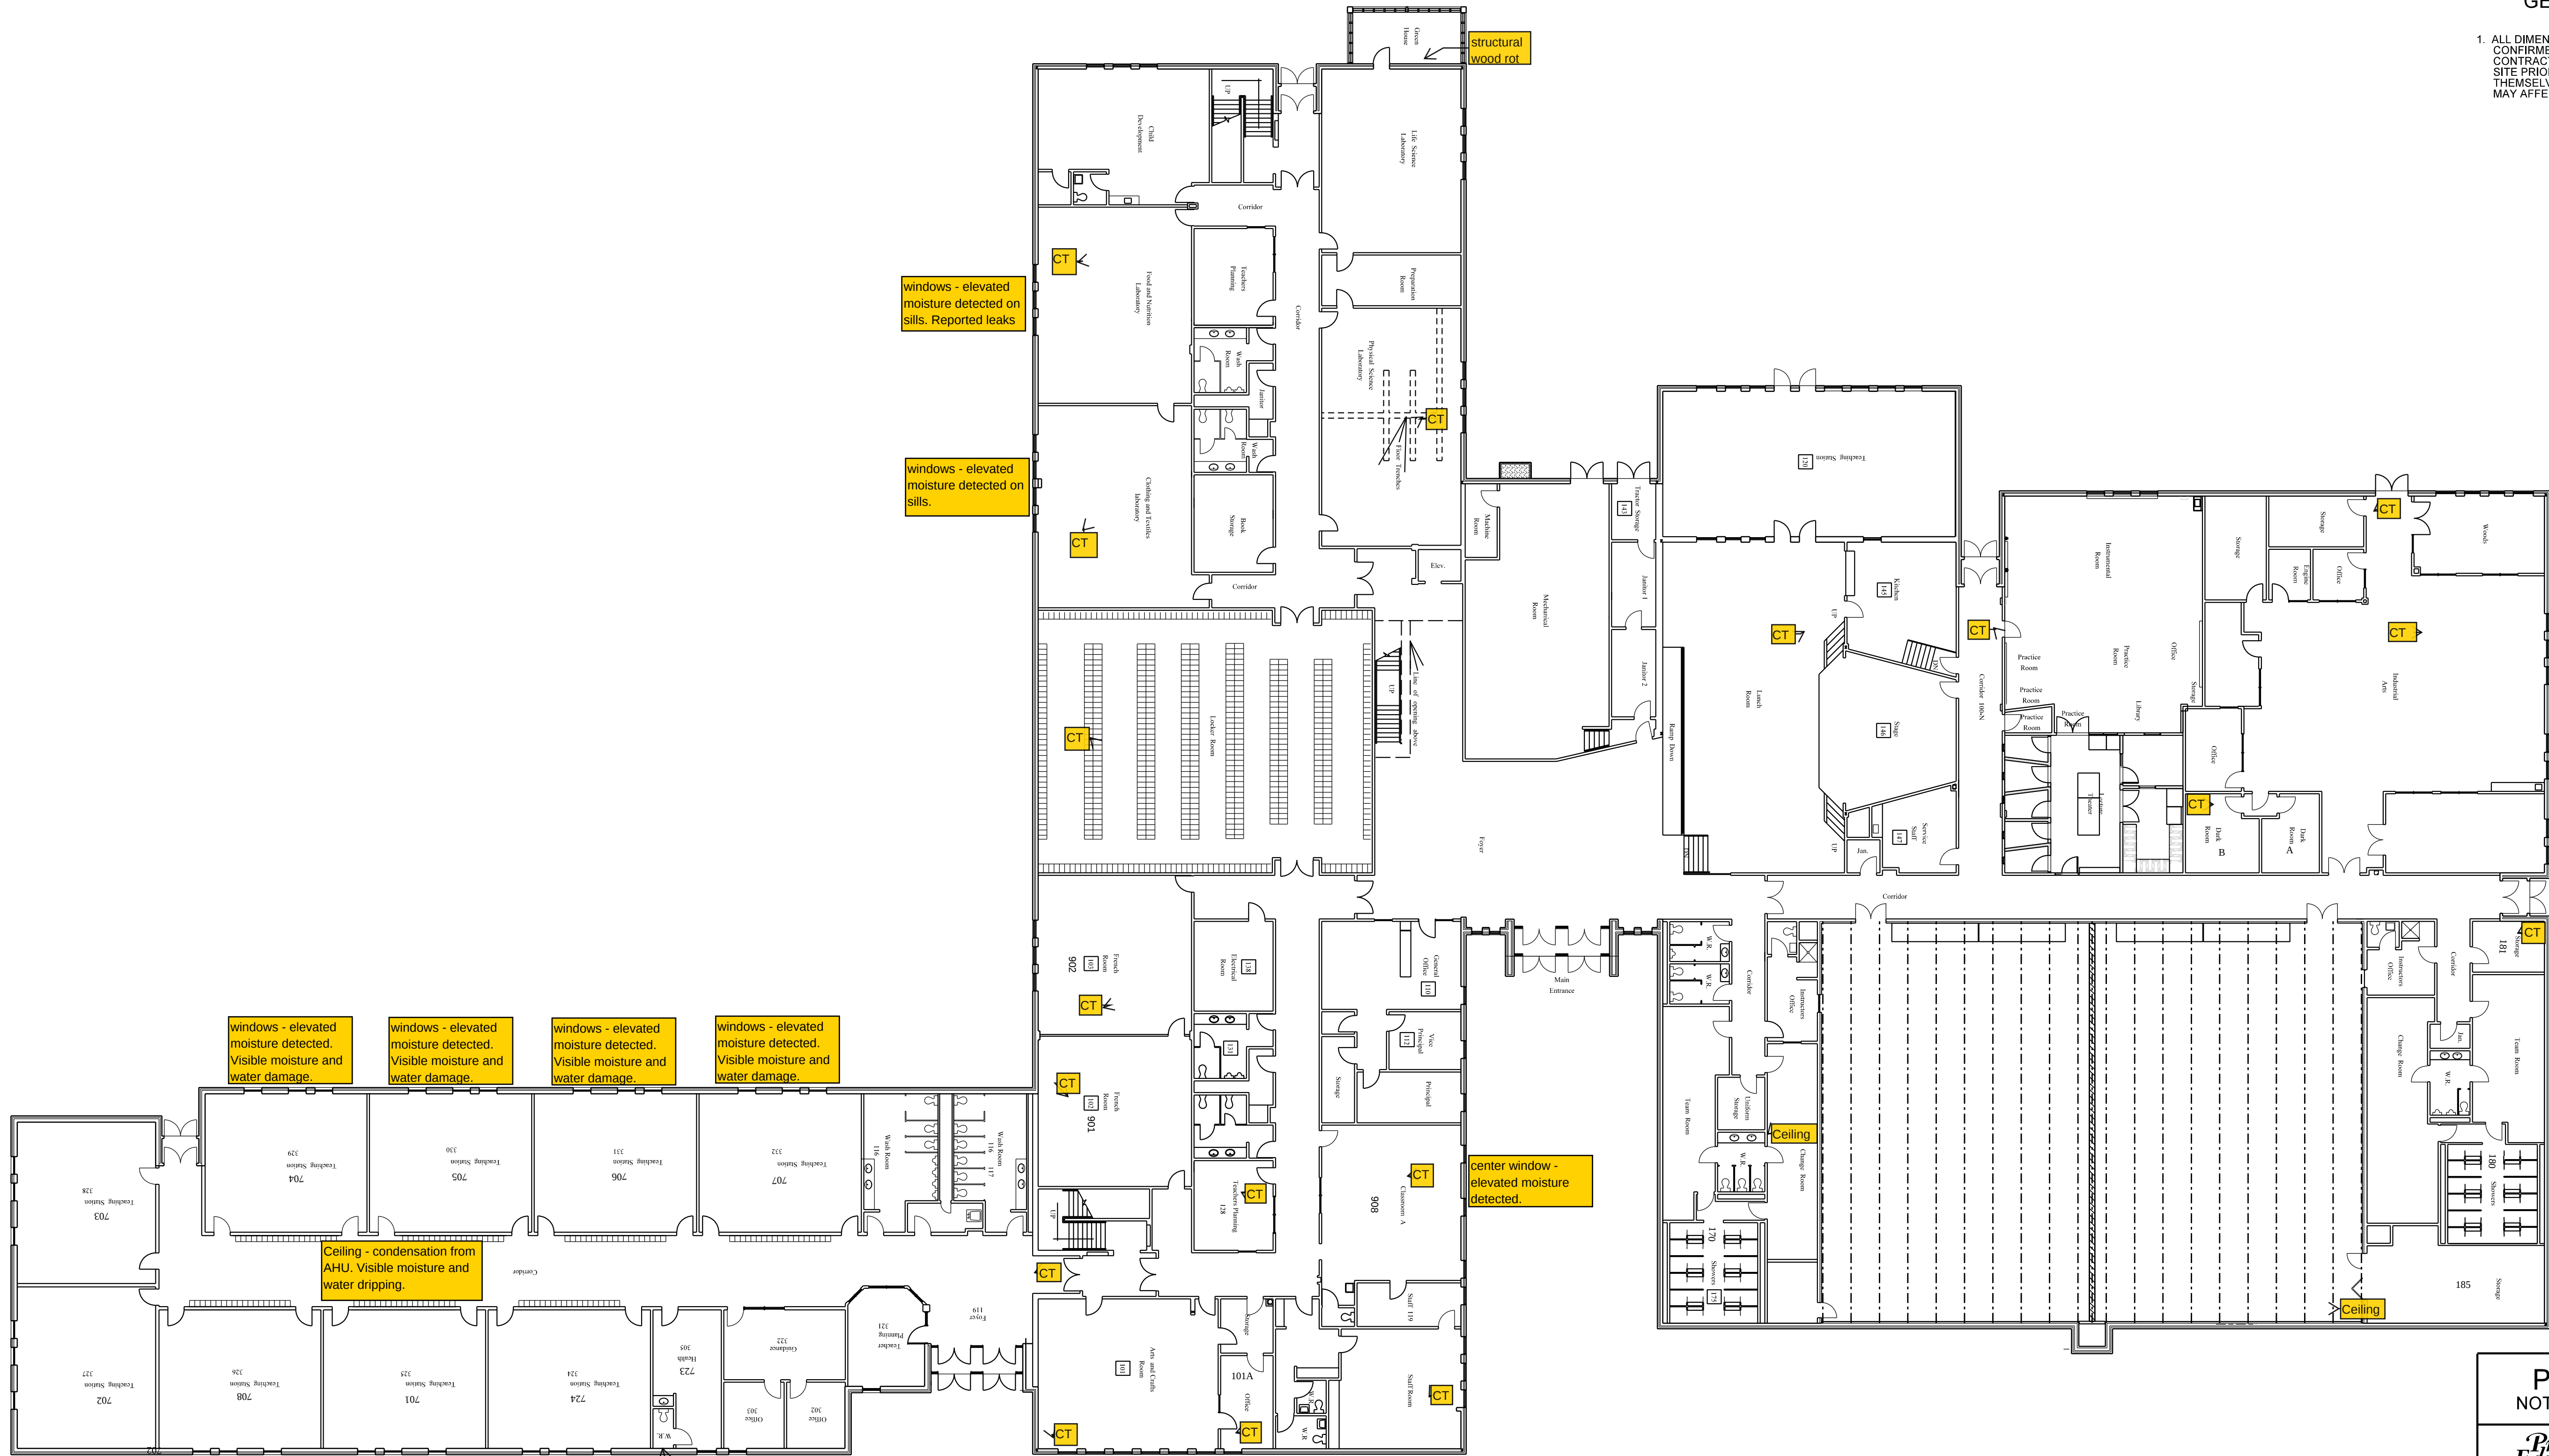
MAIN FLOOR

Several windows throughout the school were found to have elevated moisture and/or minor visible mould growth in or around windows sills. These locations are noted in Table III and are identified on the site floor plan (Appendix I). Remediation of these locations is recommended to consist of surface cleaning and/or removal of the wooden window sill (depending on the extent of water damage/mould contamination) following Level 1 mould remediation protocols.

areas are noted in Table III and are identified on the site floor plan (Appendix I). Some visible mould was observed on some ceiling tiles as noted in Table II. It was also reported on the background mould investigation form (Appendix II), that some water damaged ceiling tiles were removed prior to the assessment. Therefore, all areas of potential roof leaks may not have been identified during our assessment since there may not have been any signs of damage at locations where ceiling tiles had been replaced prior to our site visit. All ceiling tiles exhibiting evidence of water damage are recommended to be removed and replaced as a precautionary measure while those ceiling tiles identified and/or exhibiting evidence of suspect mould contamination are recommended to be removed following Level 1 mould remediation protocols.

CT - affected ceiling tile area
