# Mould & Moisture Assessment Georgetown Elementary School

**Project No. 12620**

**May 17, 2011**

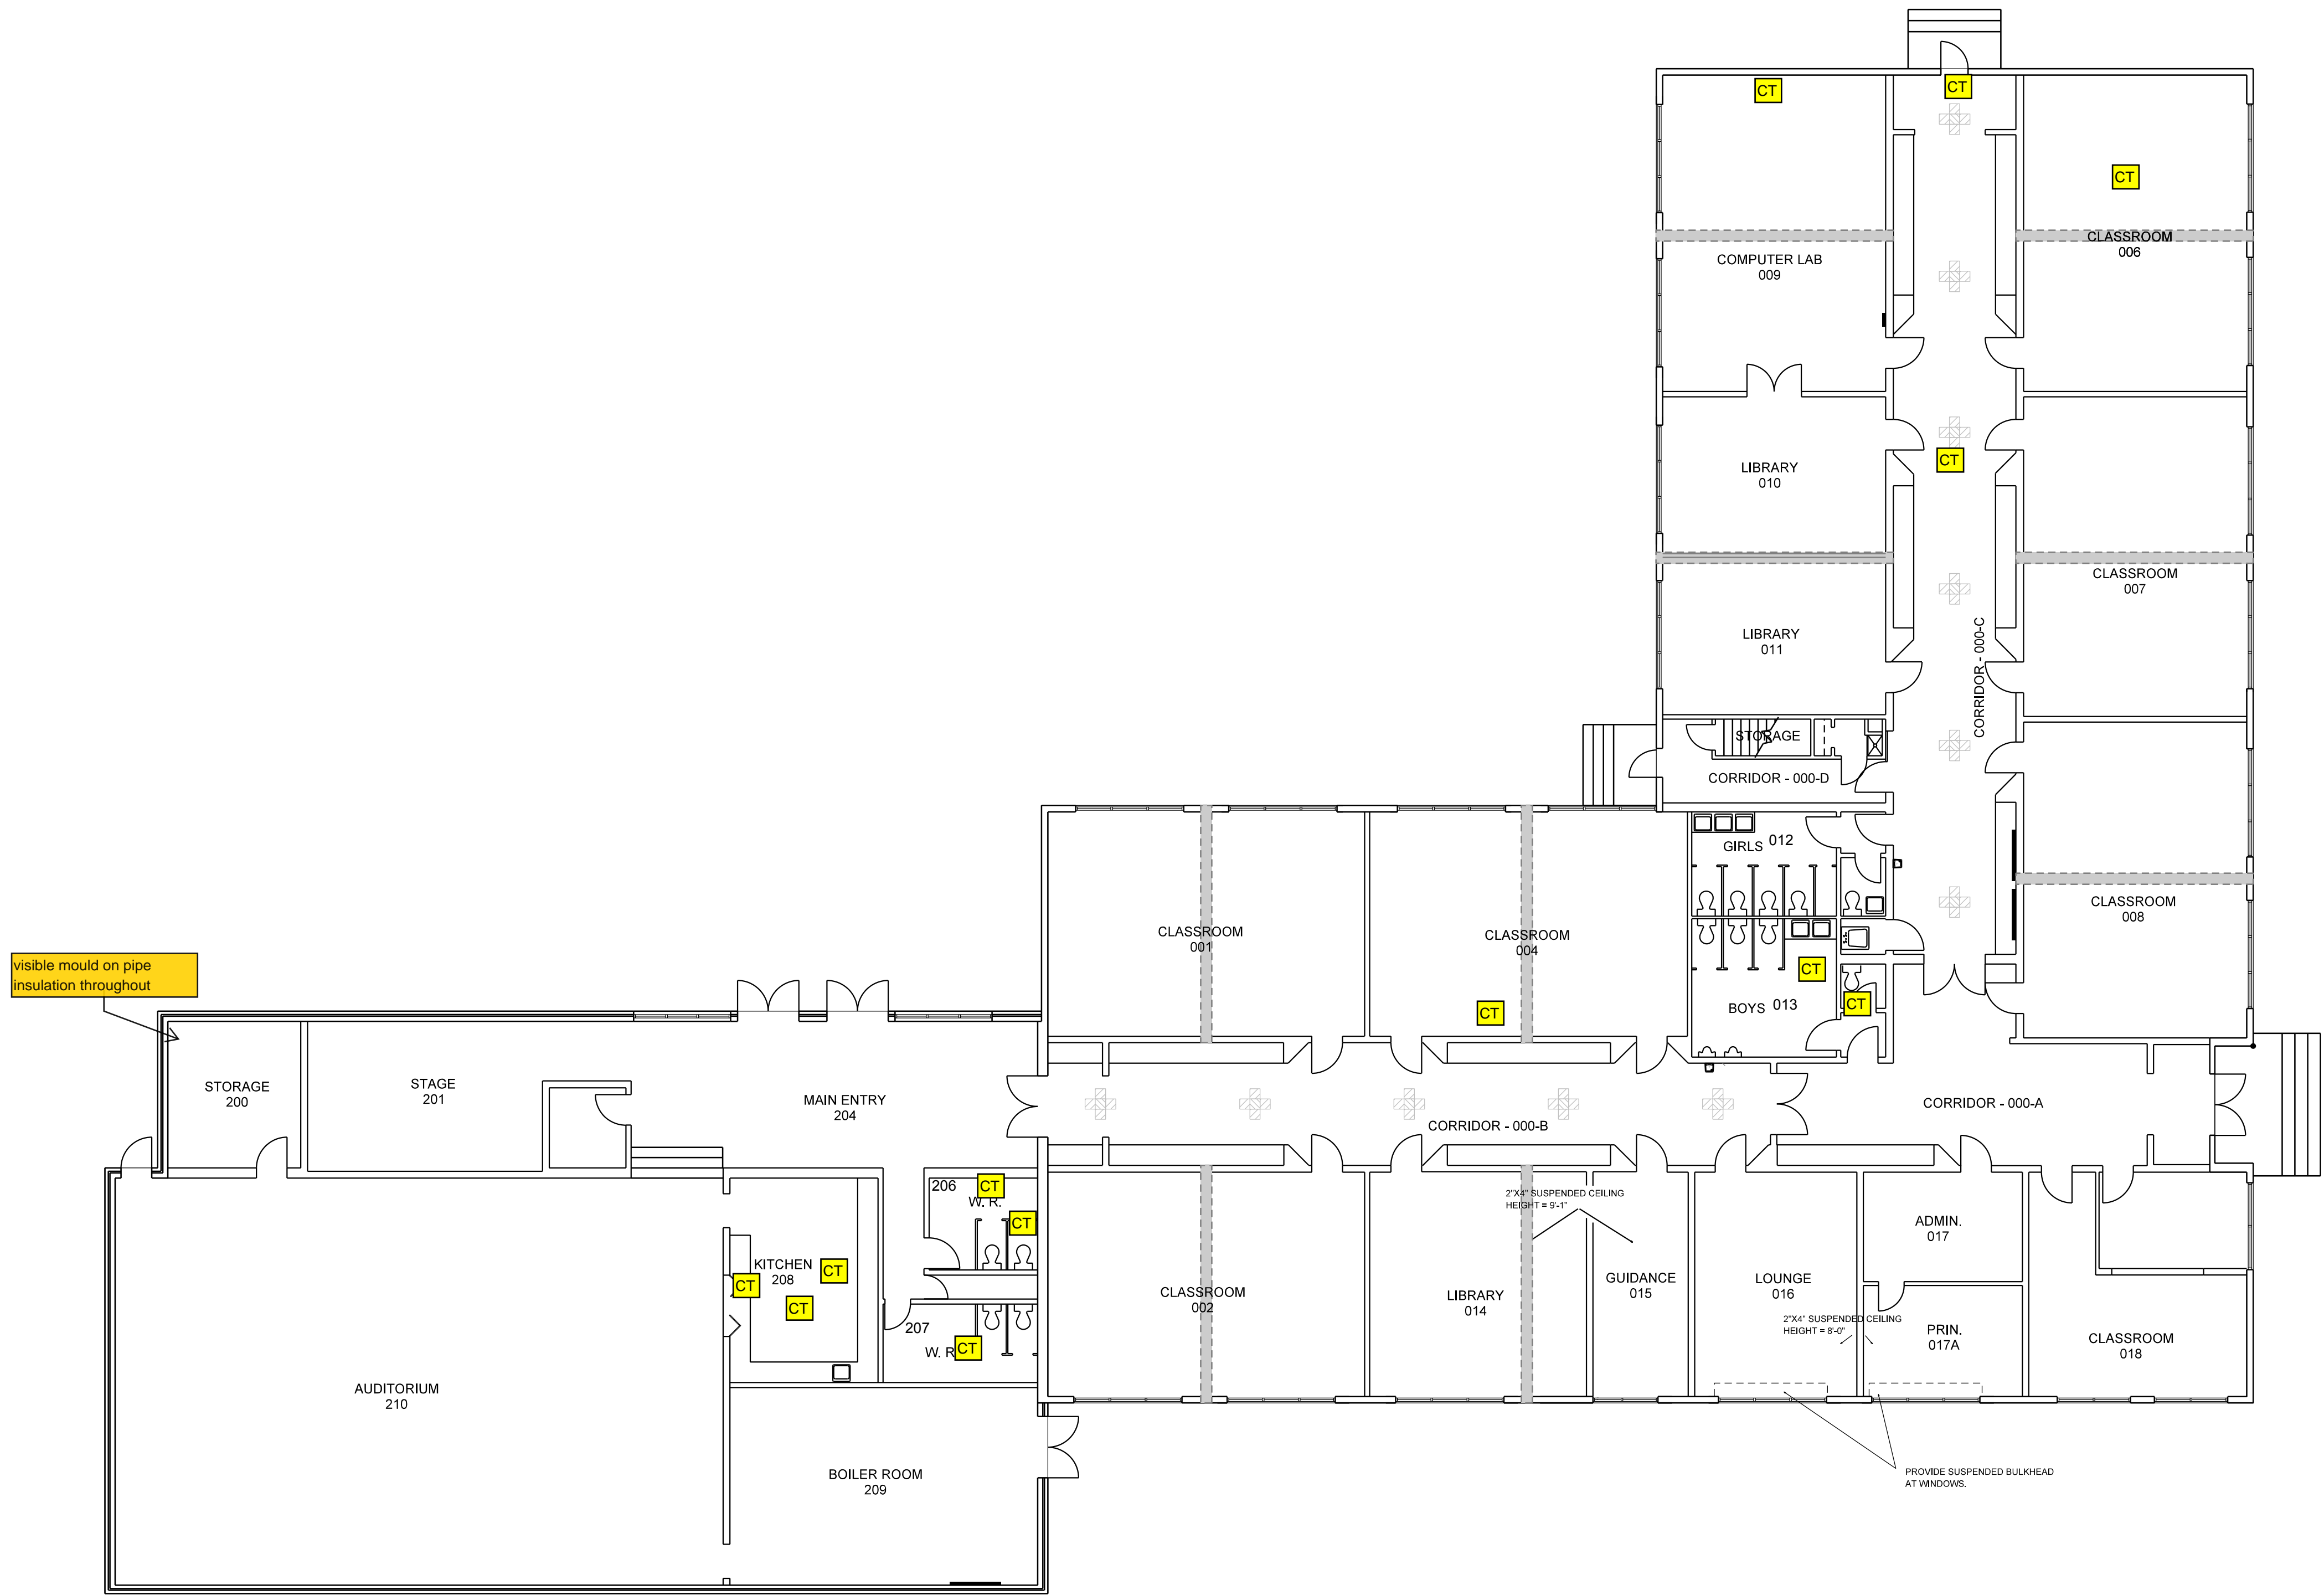
*Floor Plan*

<b>Table III</b> <b>Summary of Moisture affected areas</b>		
<b>Room No. / Description</b>	<b>Comments / Observations</b>	<b>Action required</b>
Rms 000-C; 004; 006; 009; 013; 014; 206; 207; 208	Stained ceiling tiles observed and reported throughout the building (see site floor plan - Appendix I for location markings).	Some roof leaks were reported at the time of assessment and roof repairs were reportedly in progress. Fixed ceiling tiles were reported above any suspended ceilings. No access in to these areas. Therefore, it is recommended that further investigation be conducted above these ceiling spaces to assess for potential hidden mould.

CT - affected ceiling tile area
