**GREENFIELD  
ELEMENTARY SCHOOL**

# Mould & Moisture Assessment Greenfield Elementary School

**Project No. 12620**

**April 29, 2011**

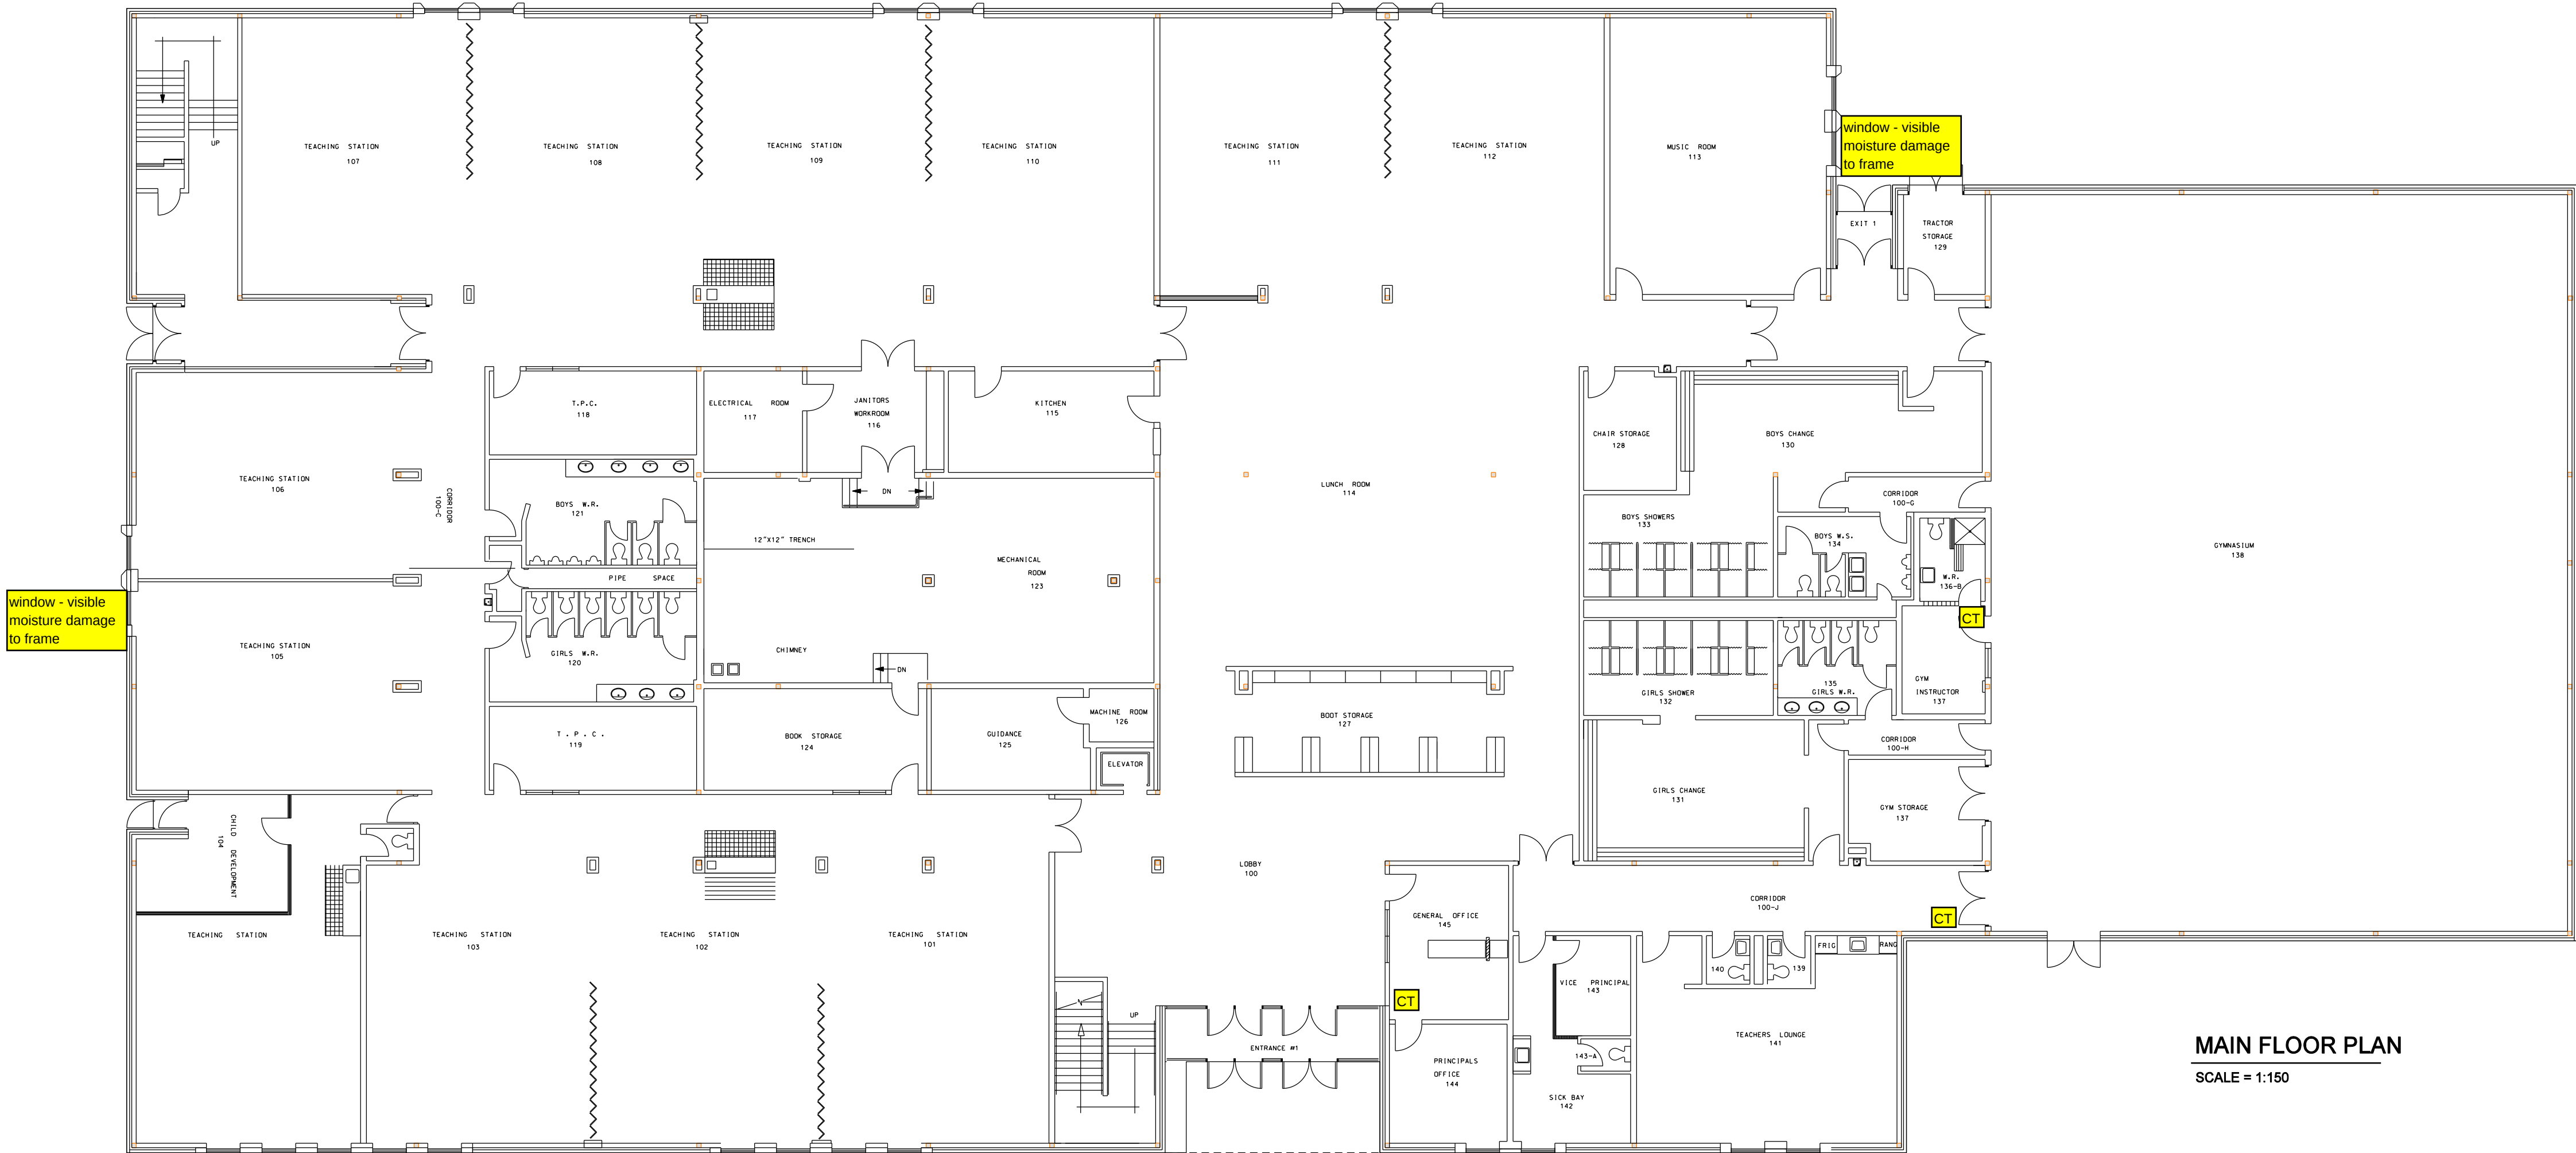
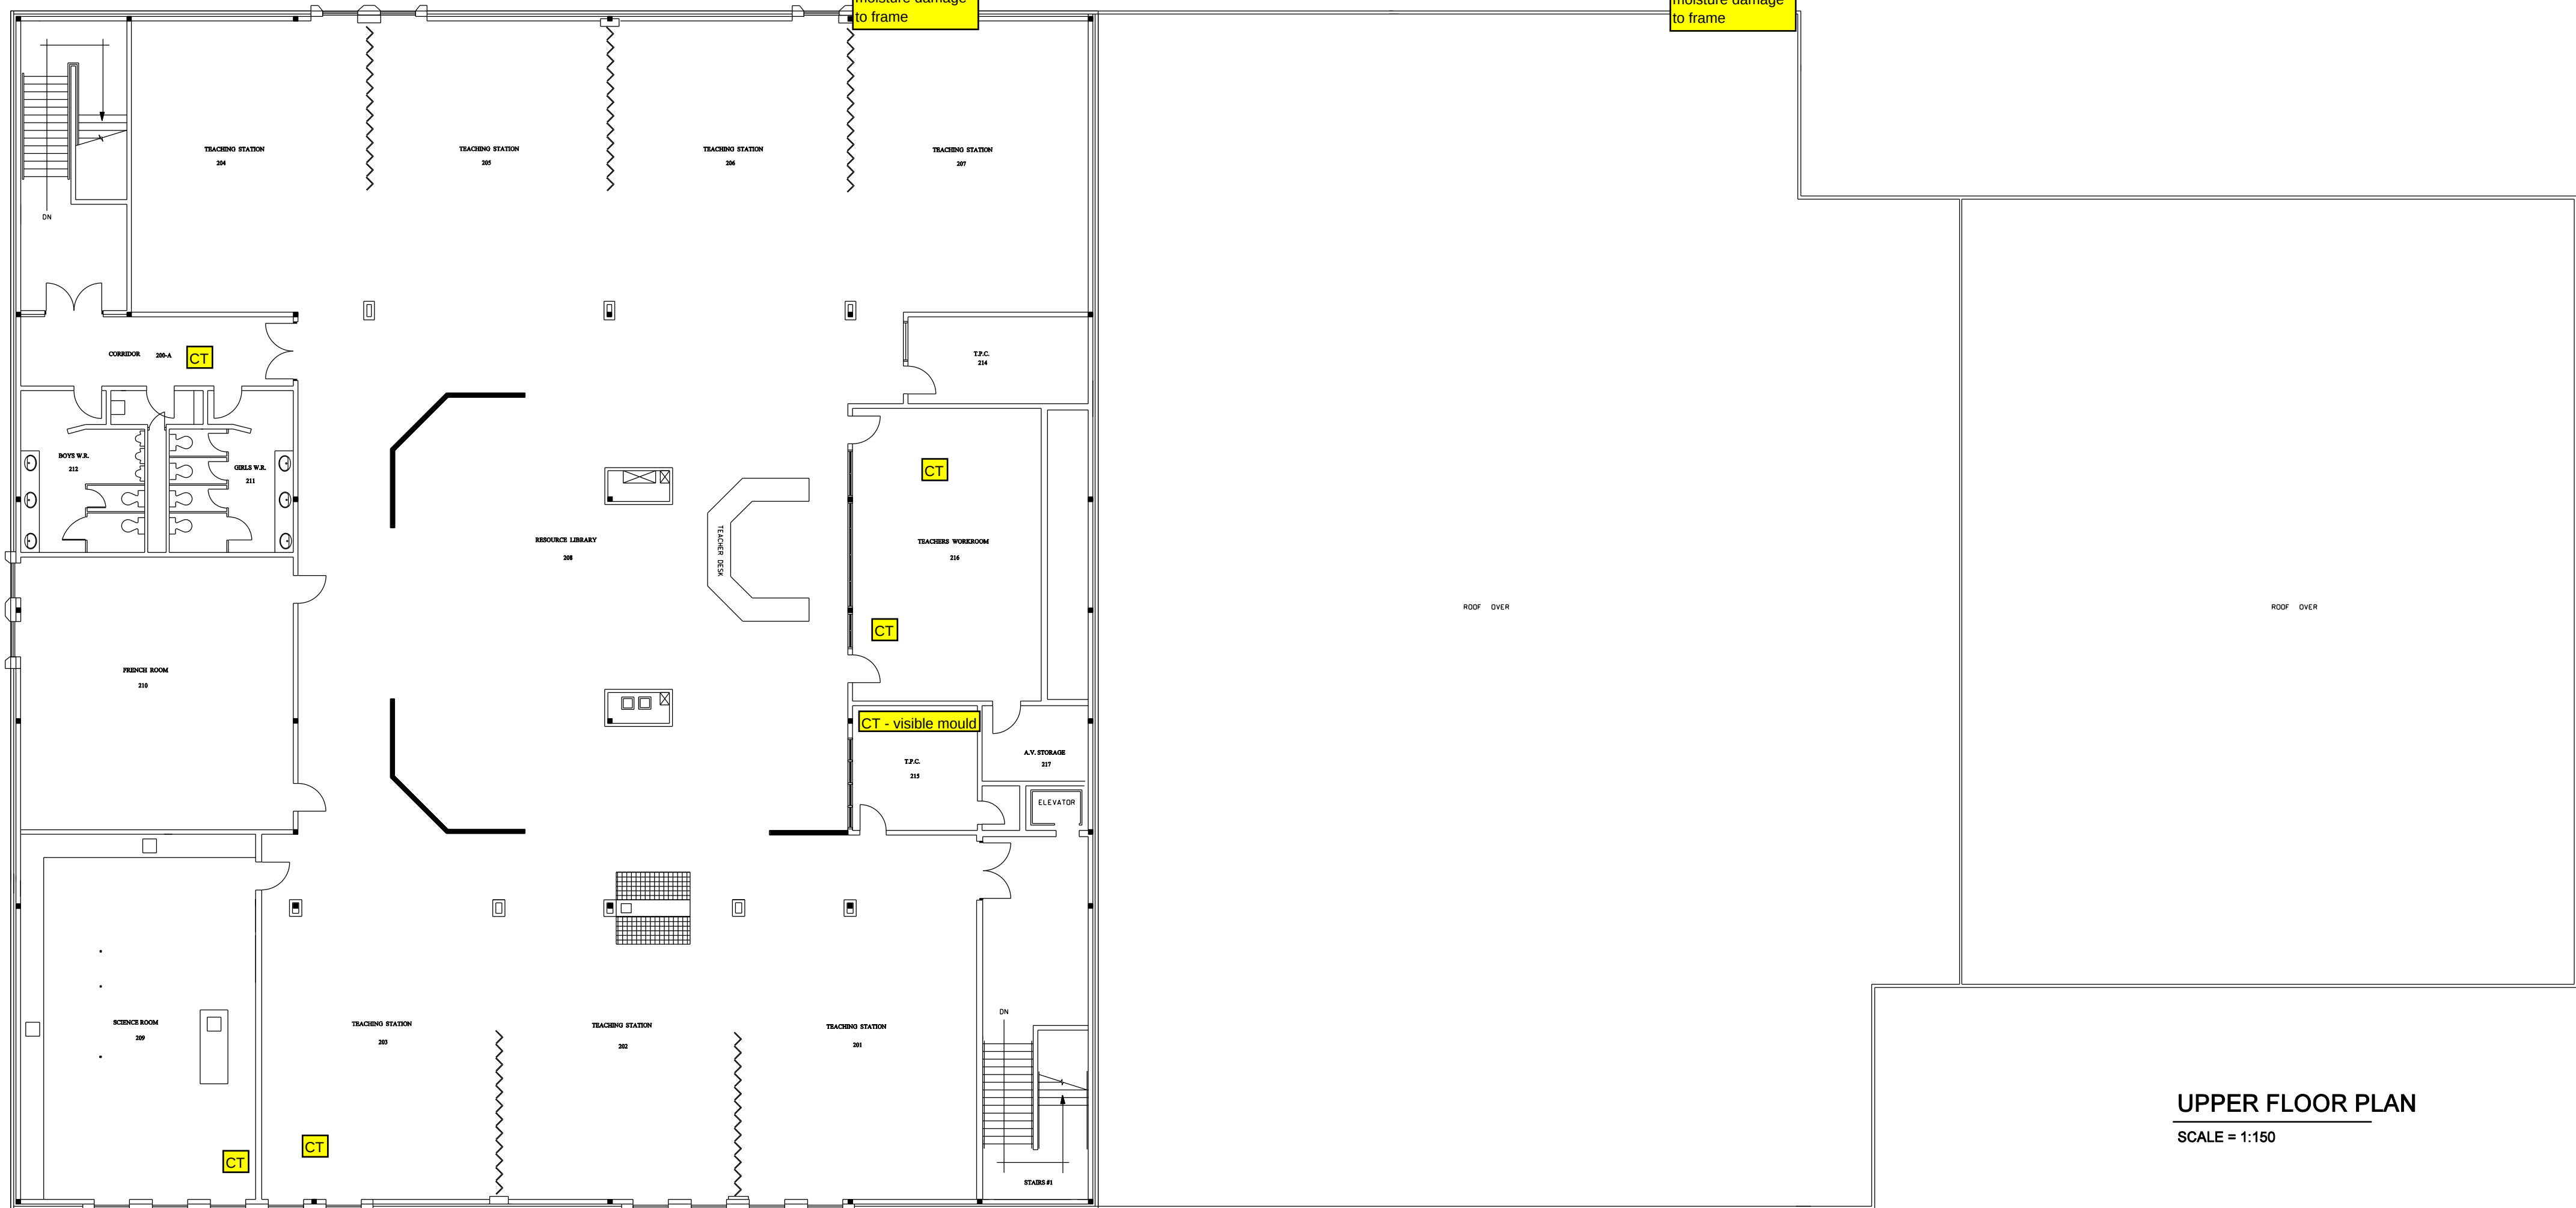
| <b>Table III</b><br><b>Summary of Moisture affected areas</b> | | |
|---|---|---|
| Corridor 100J<br>137; 145;<br>Corridor 200A;<br>203; 209; 215;<br>216 | Stained ceiling tiles observed and reported in various areas noted throughout the building.<br>(see site floor plan - Appendix I for location markings). | Replace ceiling tiles as precautionary measure and to assist in detecting further water leaks. Some mechanical leaks reported at the time of assessment. |
