Hernewood
Intermediate School

Mould & Moisture Assessment Hernewood Intermediate School

Project No. 12620

May 2, 2011

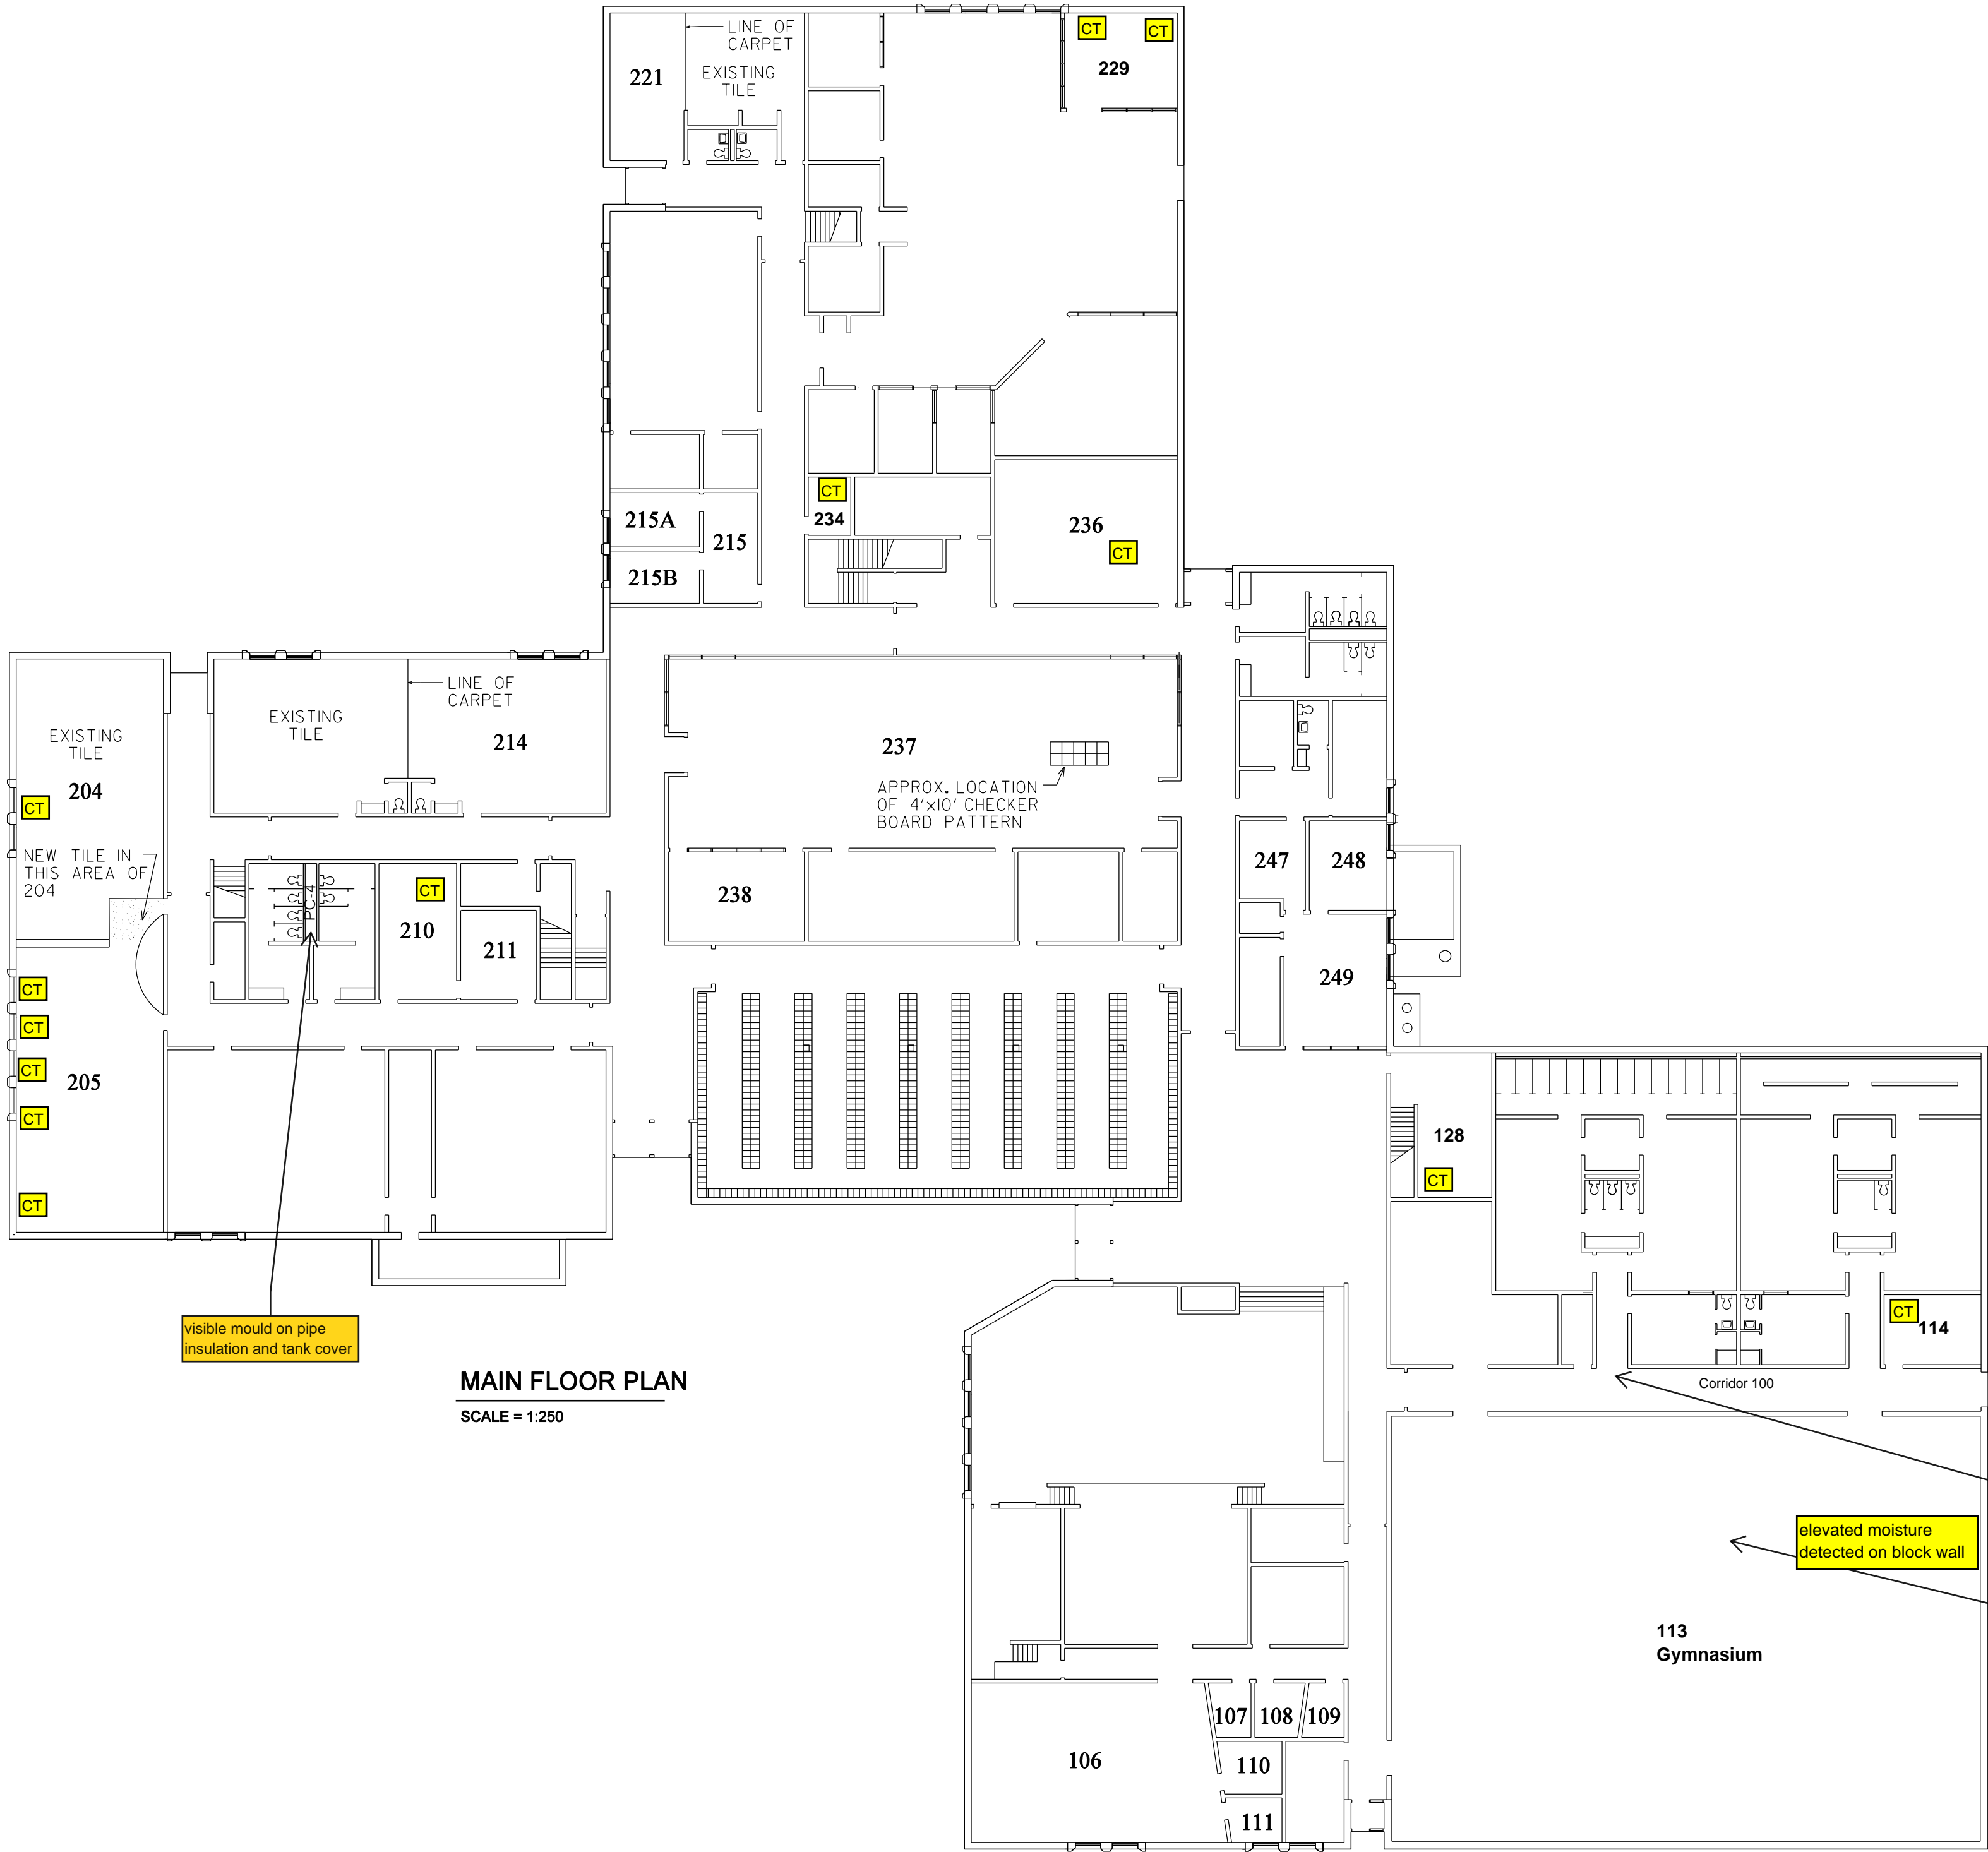
MAIN FLOOR PLAN
SCALE = 1:250

Table III Summary of Moisture affected areas		
Room No. / Description	Comments / Observations	Action required
Rms 114; 128; 204; 205; 210; 229; 234; 236; 304; 306; 313; 324	Stained ceiling tiles observed and reported throughout the building (see site floor plan - Appendix I for location markings).	Replace ceiling tiles as precautionary measure and to assist in detecting further water leaks. Some leaks were reported at the time of assessment.
Gymnasium 113	Elevated moisture content in cinder block wall.	School Background Questionnaire suggests work carried out on exterior of Gymnasium wall.

Areas exhibiting water staining on ceiling tiles , as noted in Table III, should be replaced as a precautionary measure and to assist in detecting further water leaks. Some areas have mechanical systems above them which are contributing to condensation or minor leaks which should be repaired to avoid excess moisture and subsequent mould growth.
