# Mould & Moisture Assessment Kinkora Regional High School

**Project No. 12620**

**May 19, 2011**

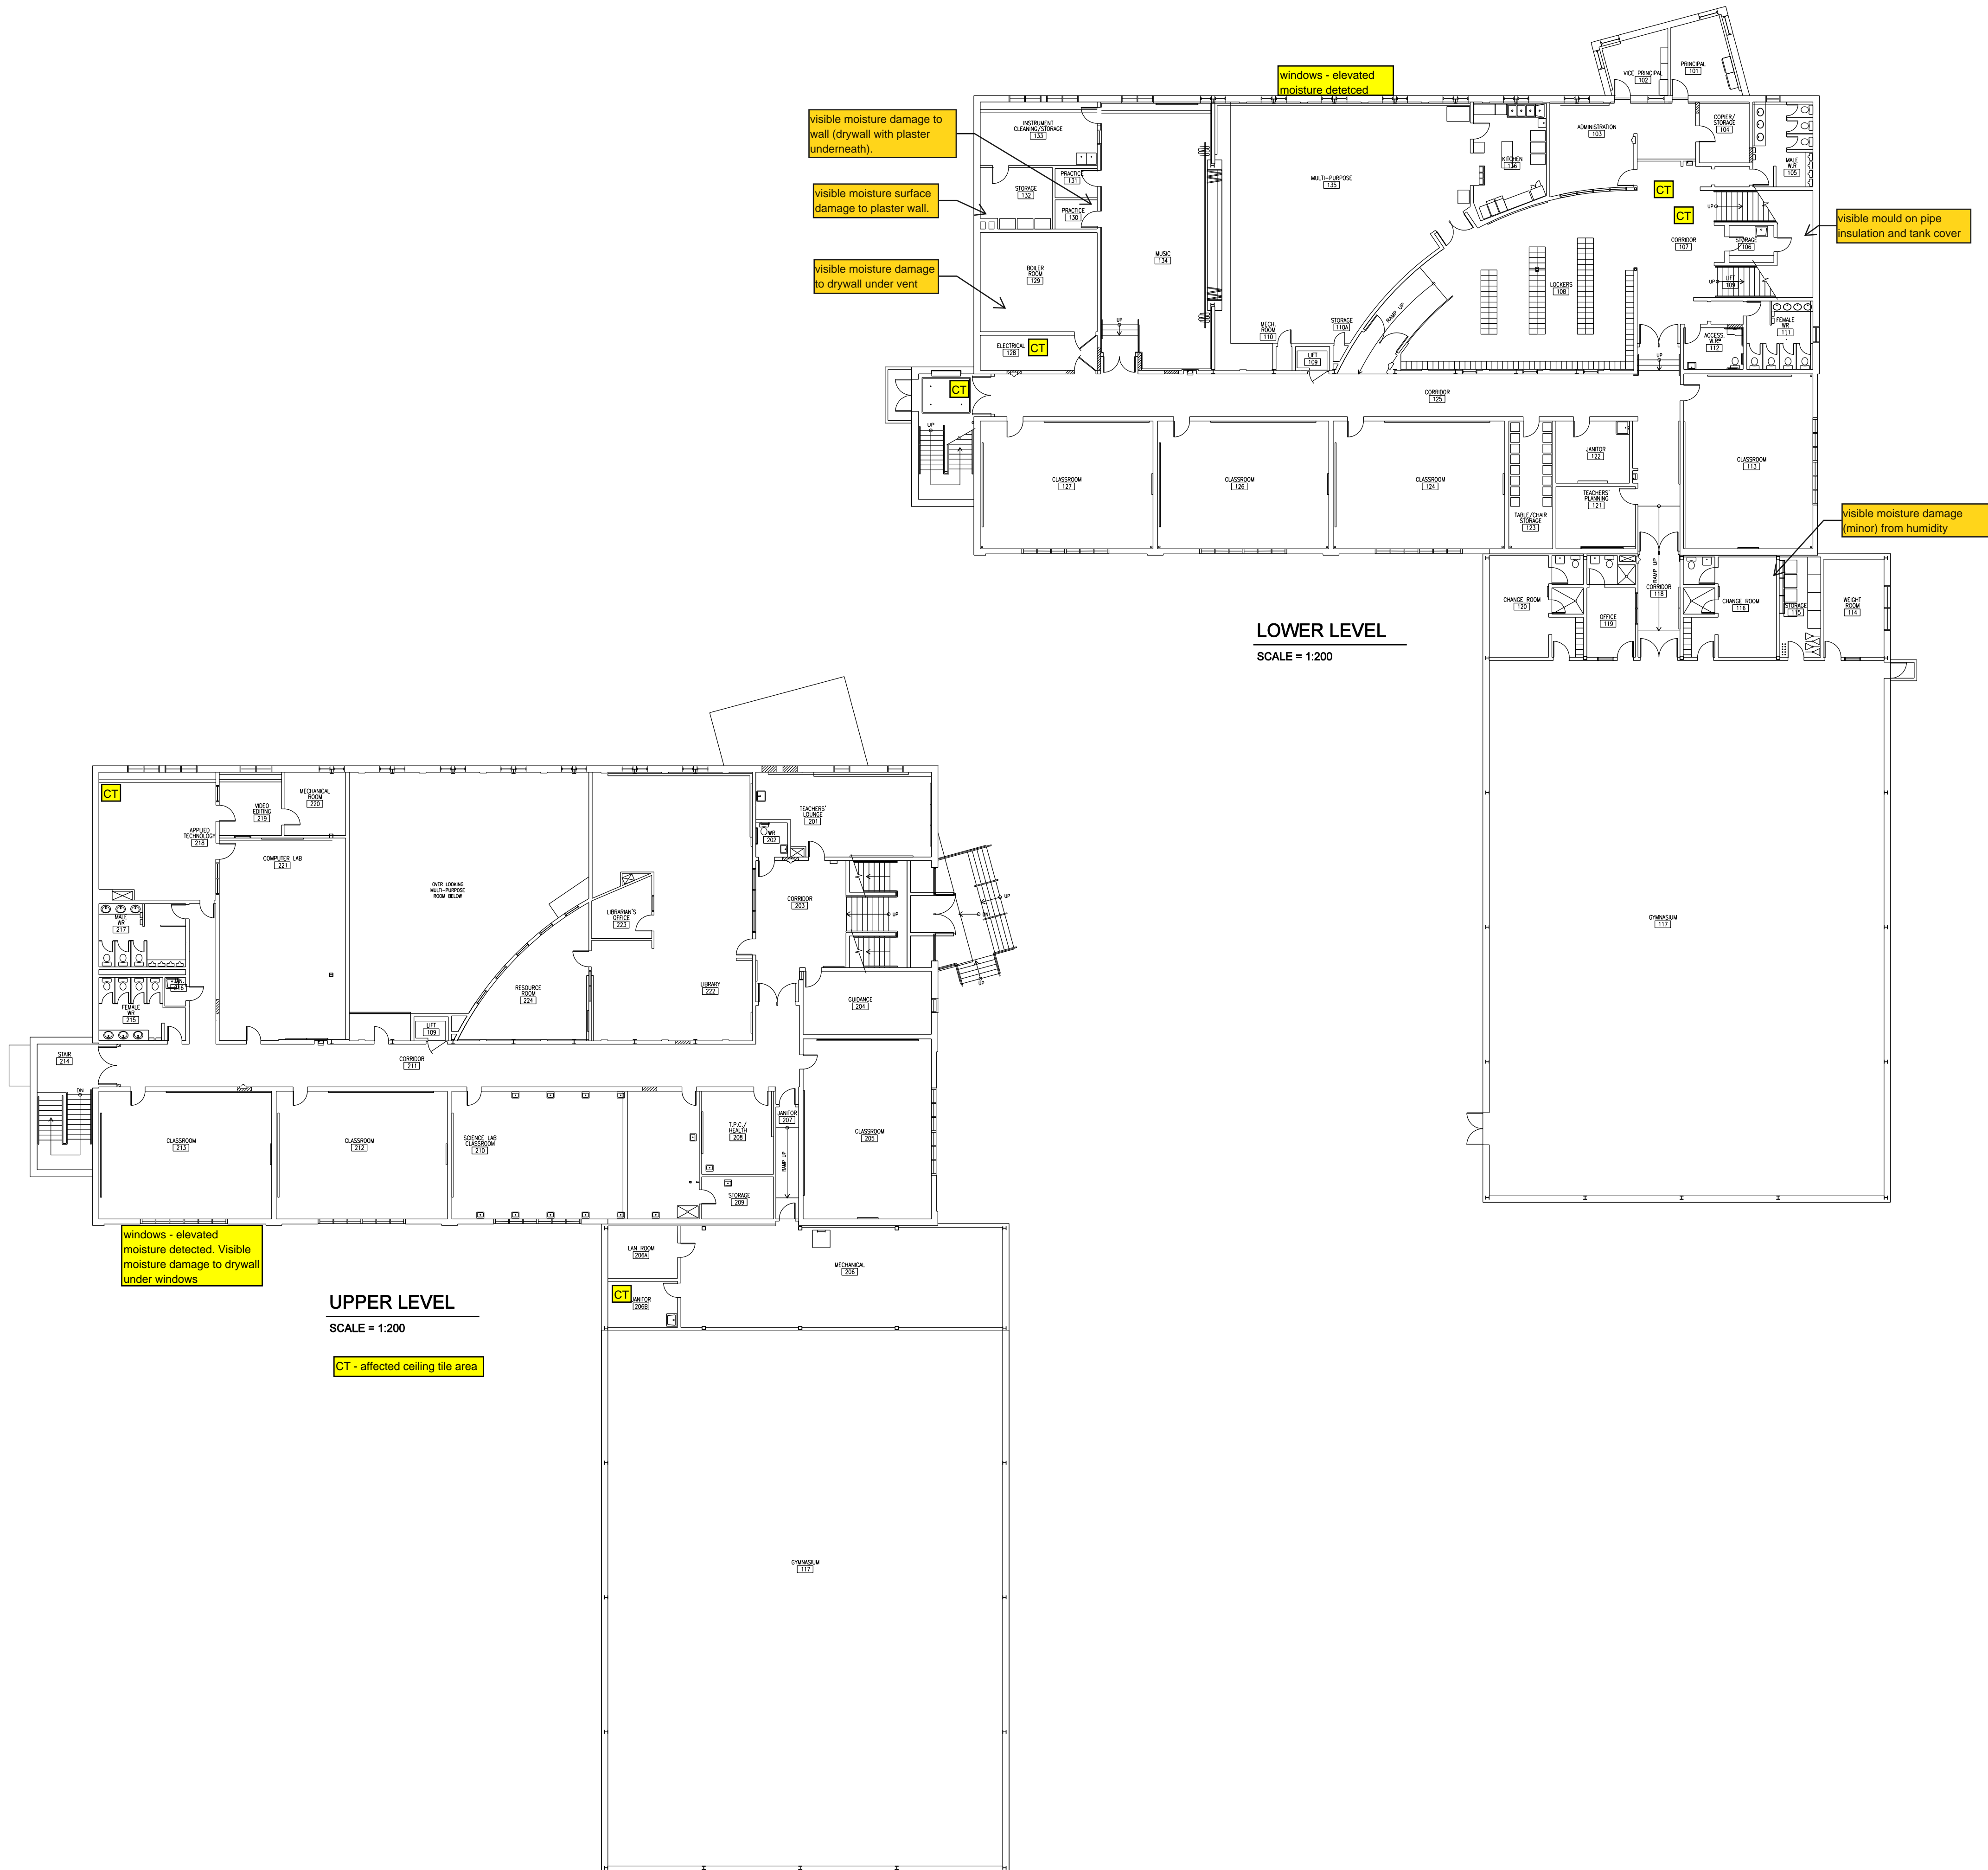
**APPENDIX I**  
**Site Floor Plans**

| Rms 107; 125 entry; 128; 206B; 218 | Stained ceiling tiles observed and reported in noted locations (see site floor plan - Appendix I for location markings). | Replace ceiling tiles as precautionary measure and to assist in detecting further water leaks. Mechanical condensation reported in various locations at the time of assessment. |
