# Mould & Moisture Assessment Merritt E. Callaghan Intermediate School

**Project No. 12620**

**Prepared for:**

**May 3, 2011**

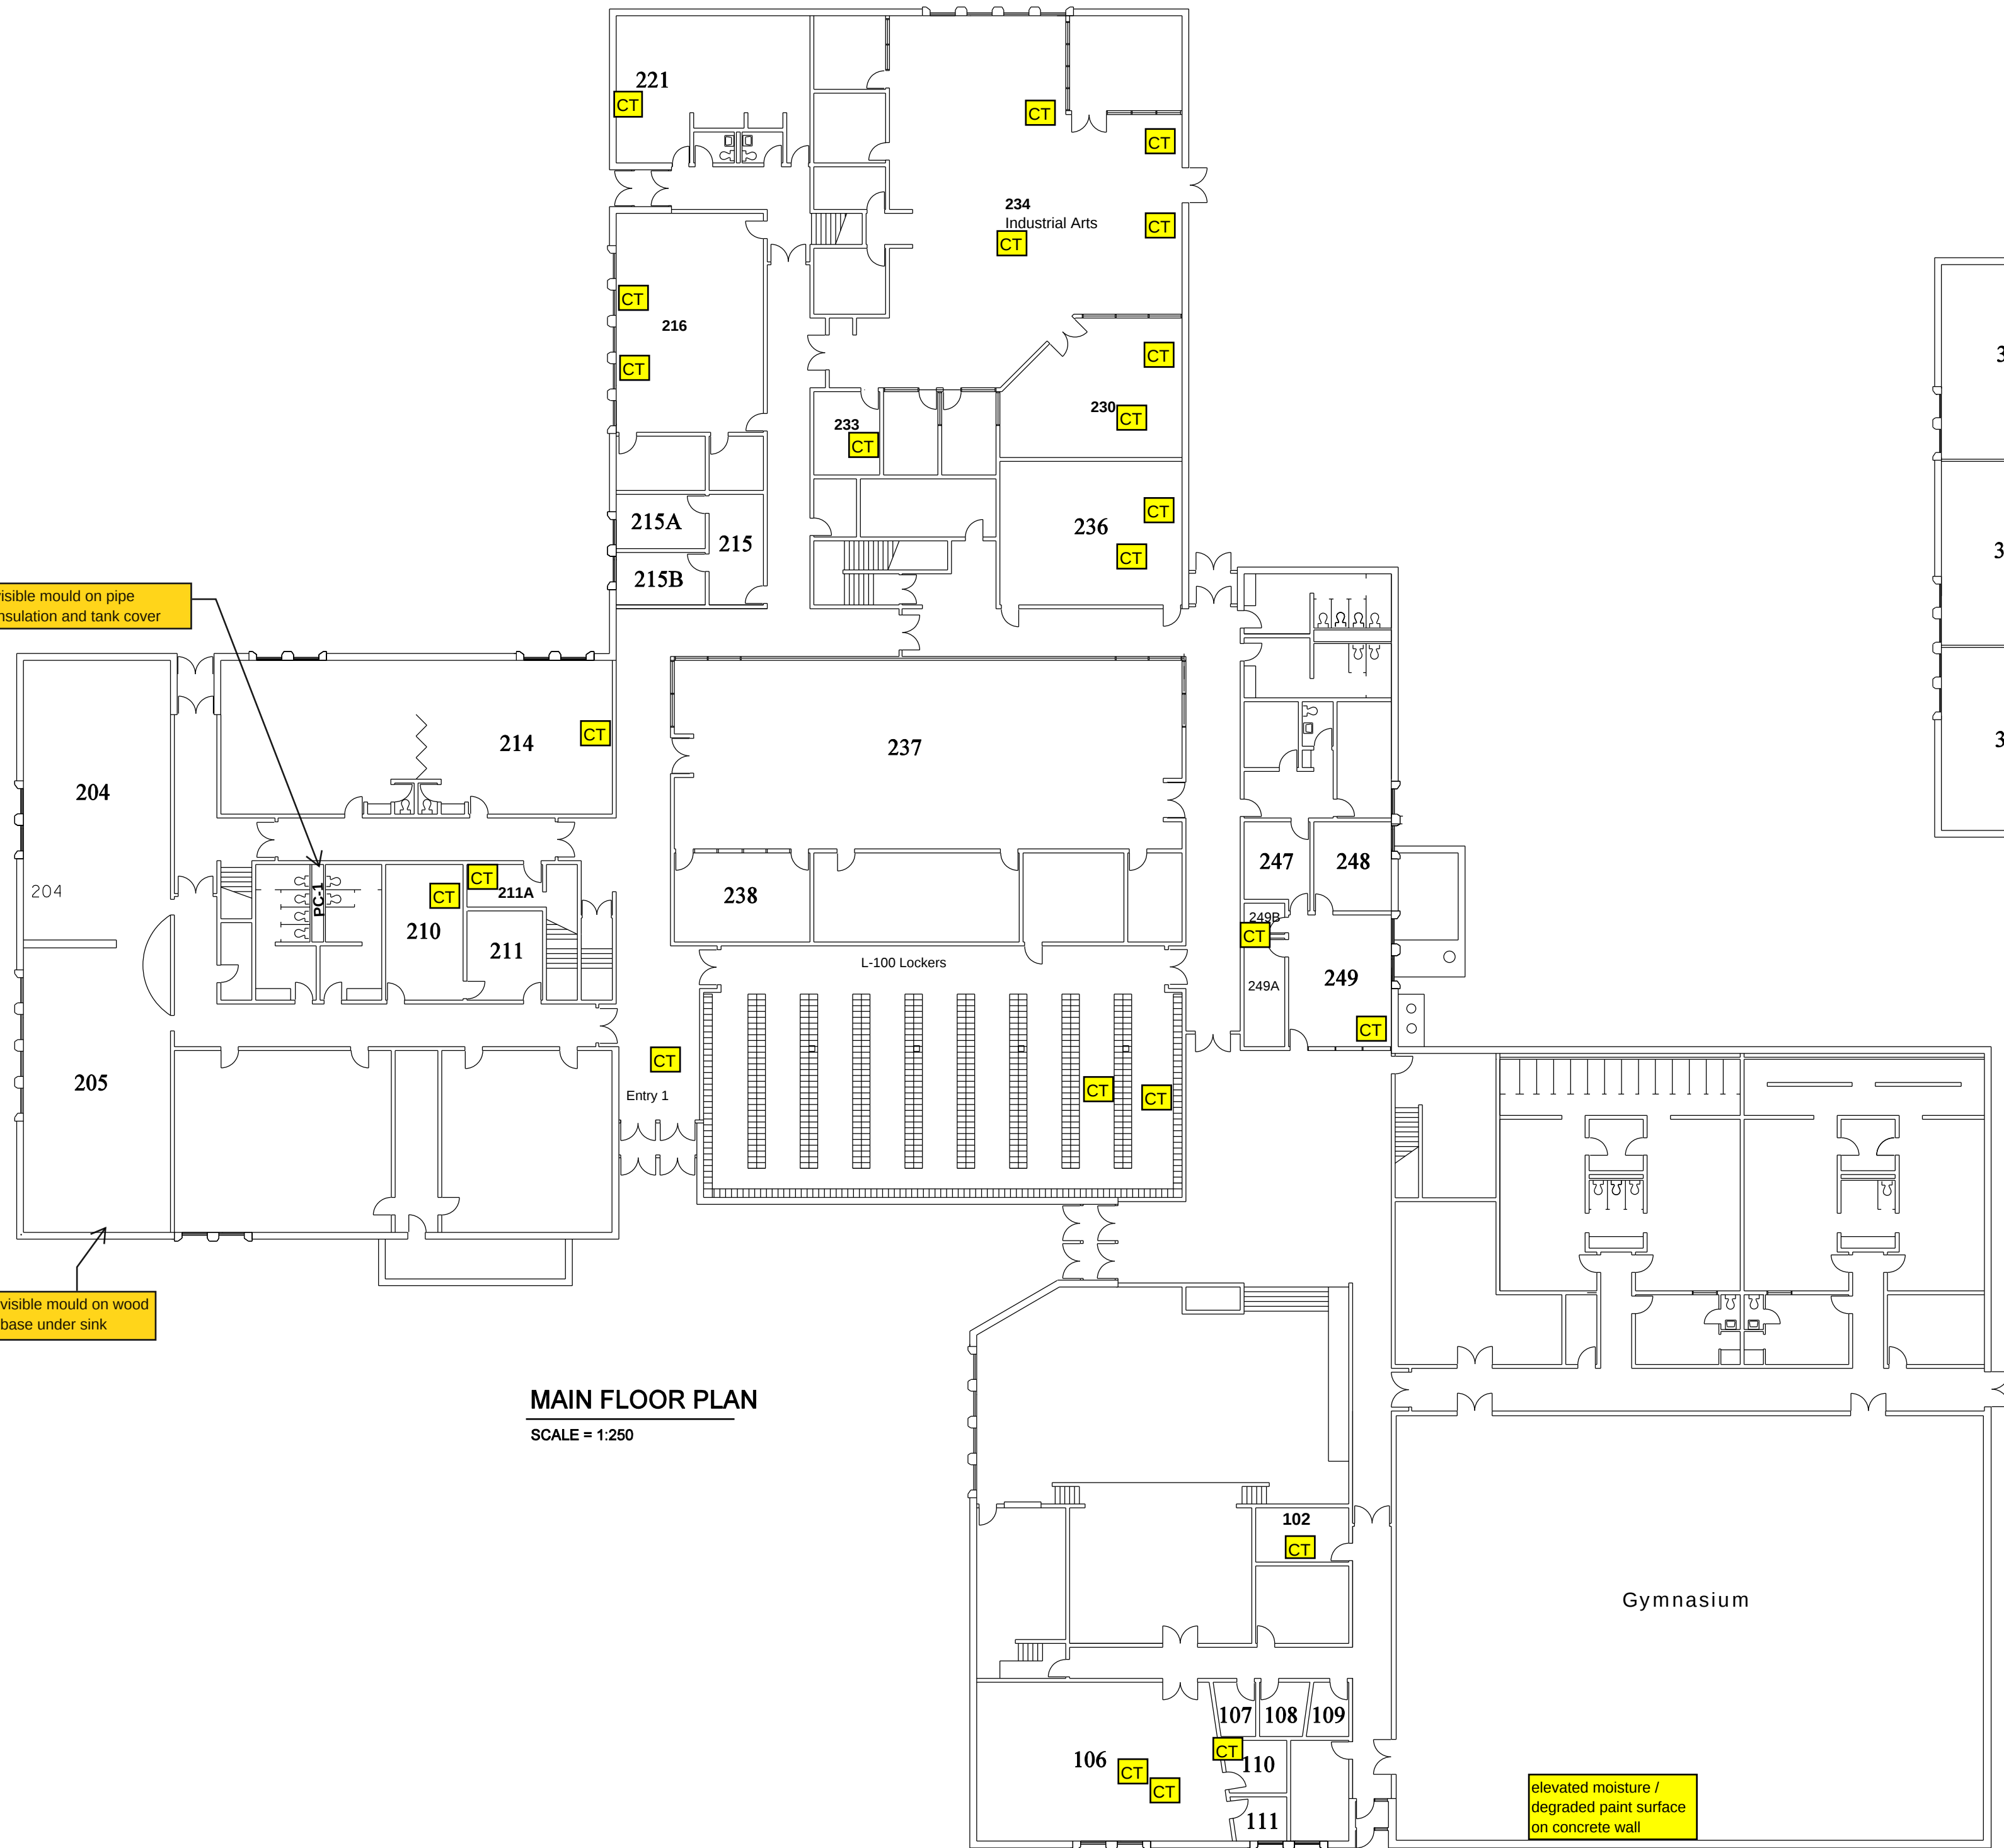
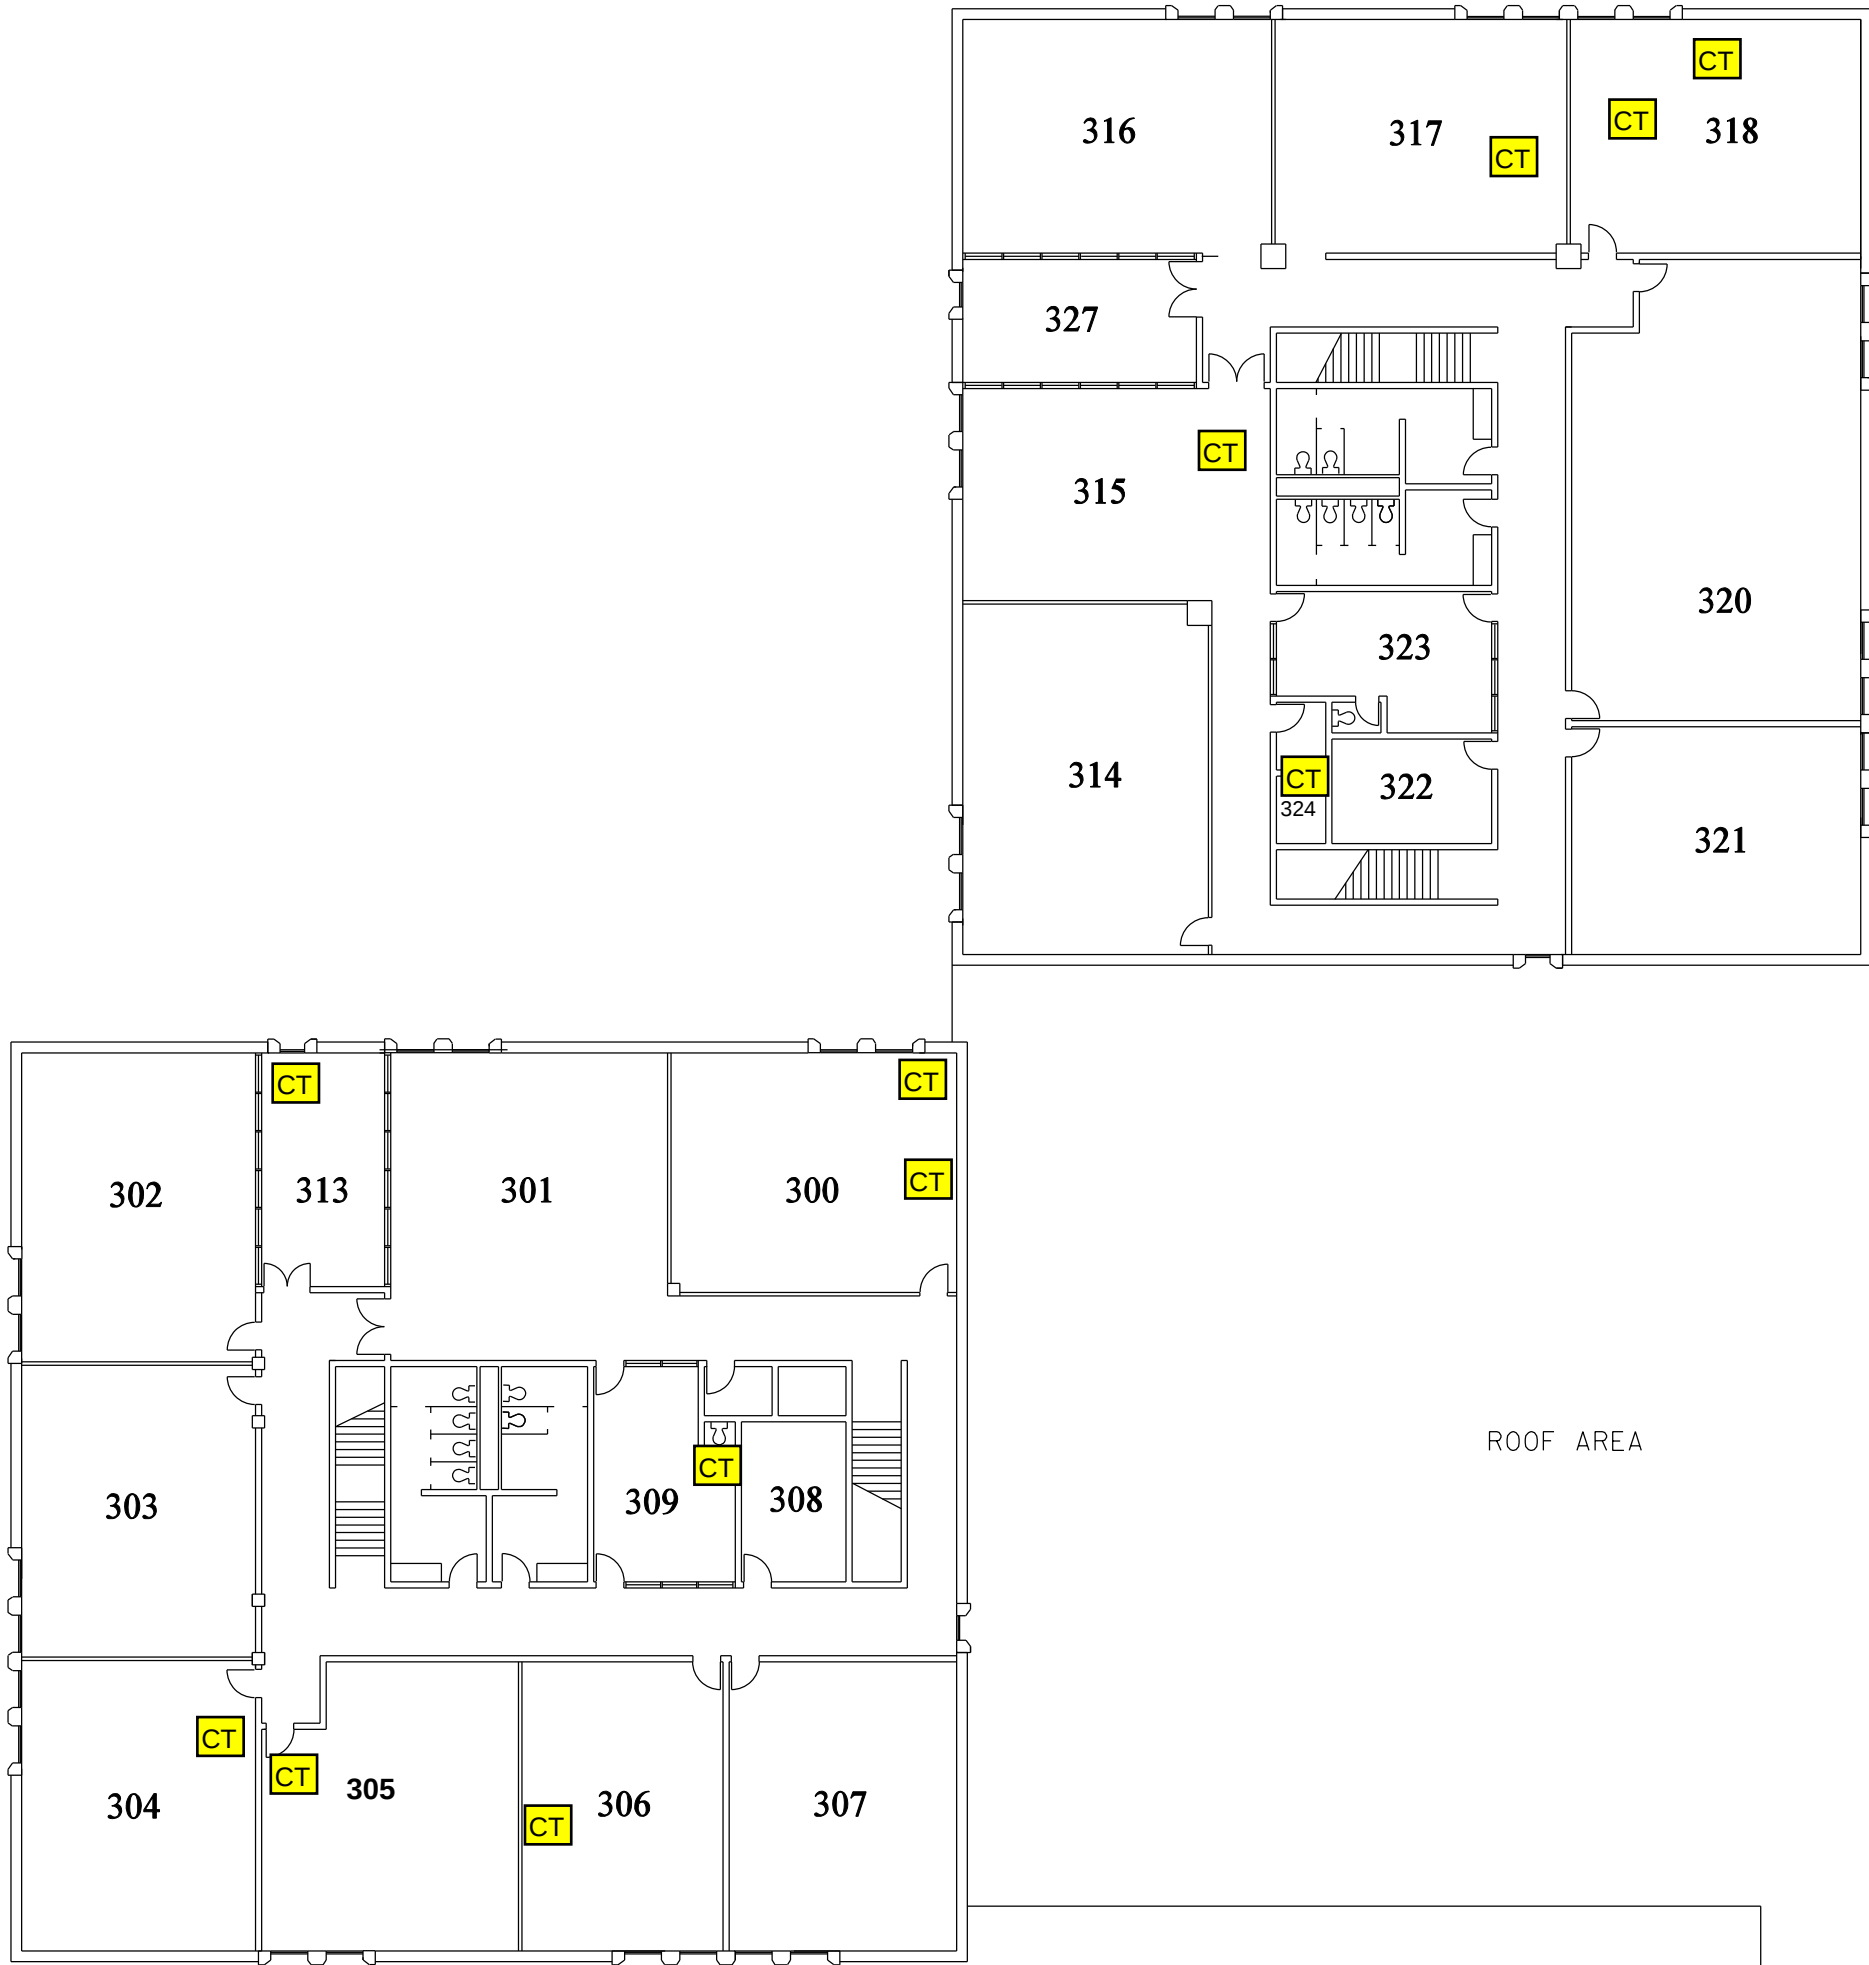
| <b>Table III</b><br><b>Summary of Moisture affected areas</b> | | |
|---|---|---|
| Rms Entry1; L-100 (Lockers); 102; 106; 110; 210; 211A; 214; 216; 221; 230; 233; 234; 236; 249; 249B; 300; 304; 305; 306; 309A; 313; 317; 318; 324 | Stained ceiling tiles observed and reported throughout the building (see site floor plan - Appendix I for location markings). | Replace ceiling tiles as precautionary measure and to assist in detecting further water leaks. Some leaks were reported at the time of assessment. |
