# Mould & Moisture Assessment Morell Regional High School

**Project No. 12620**

**March 9, 2011**

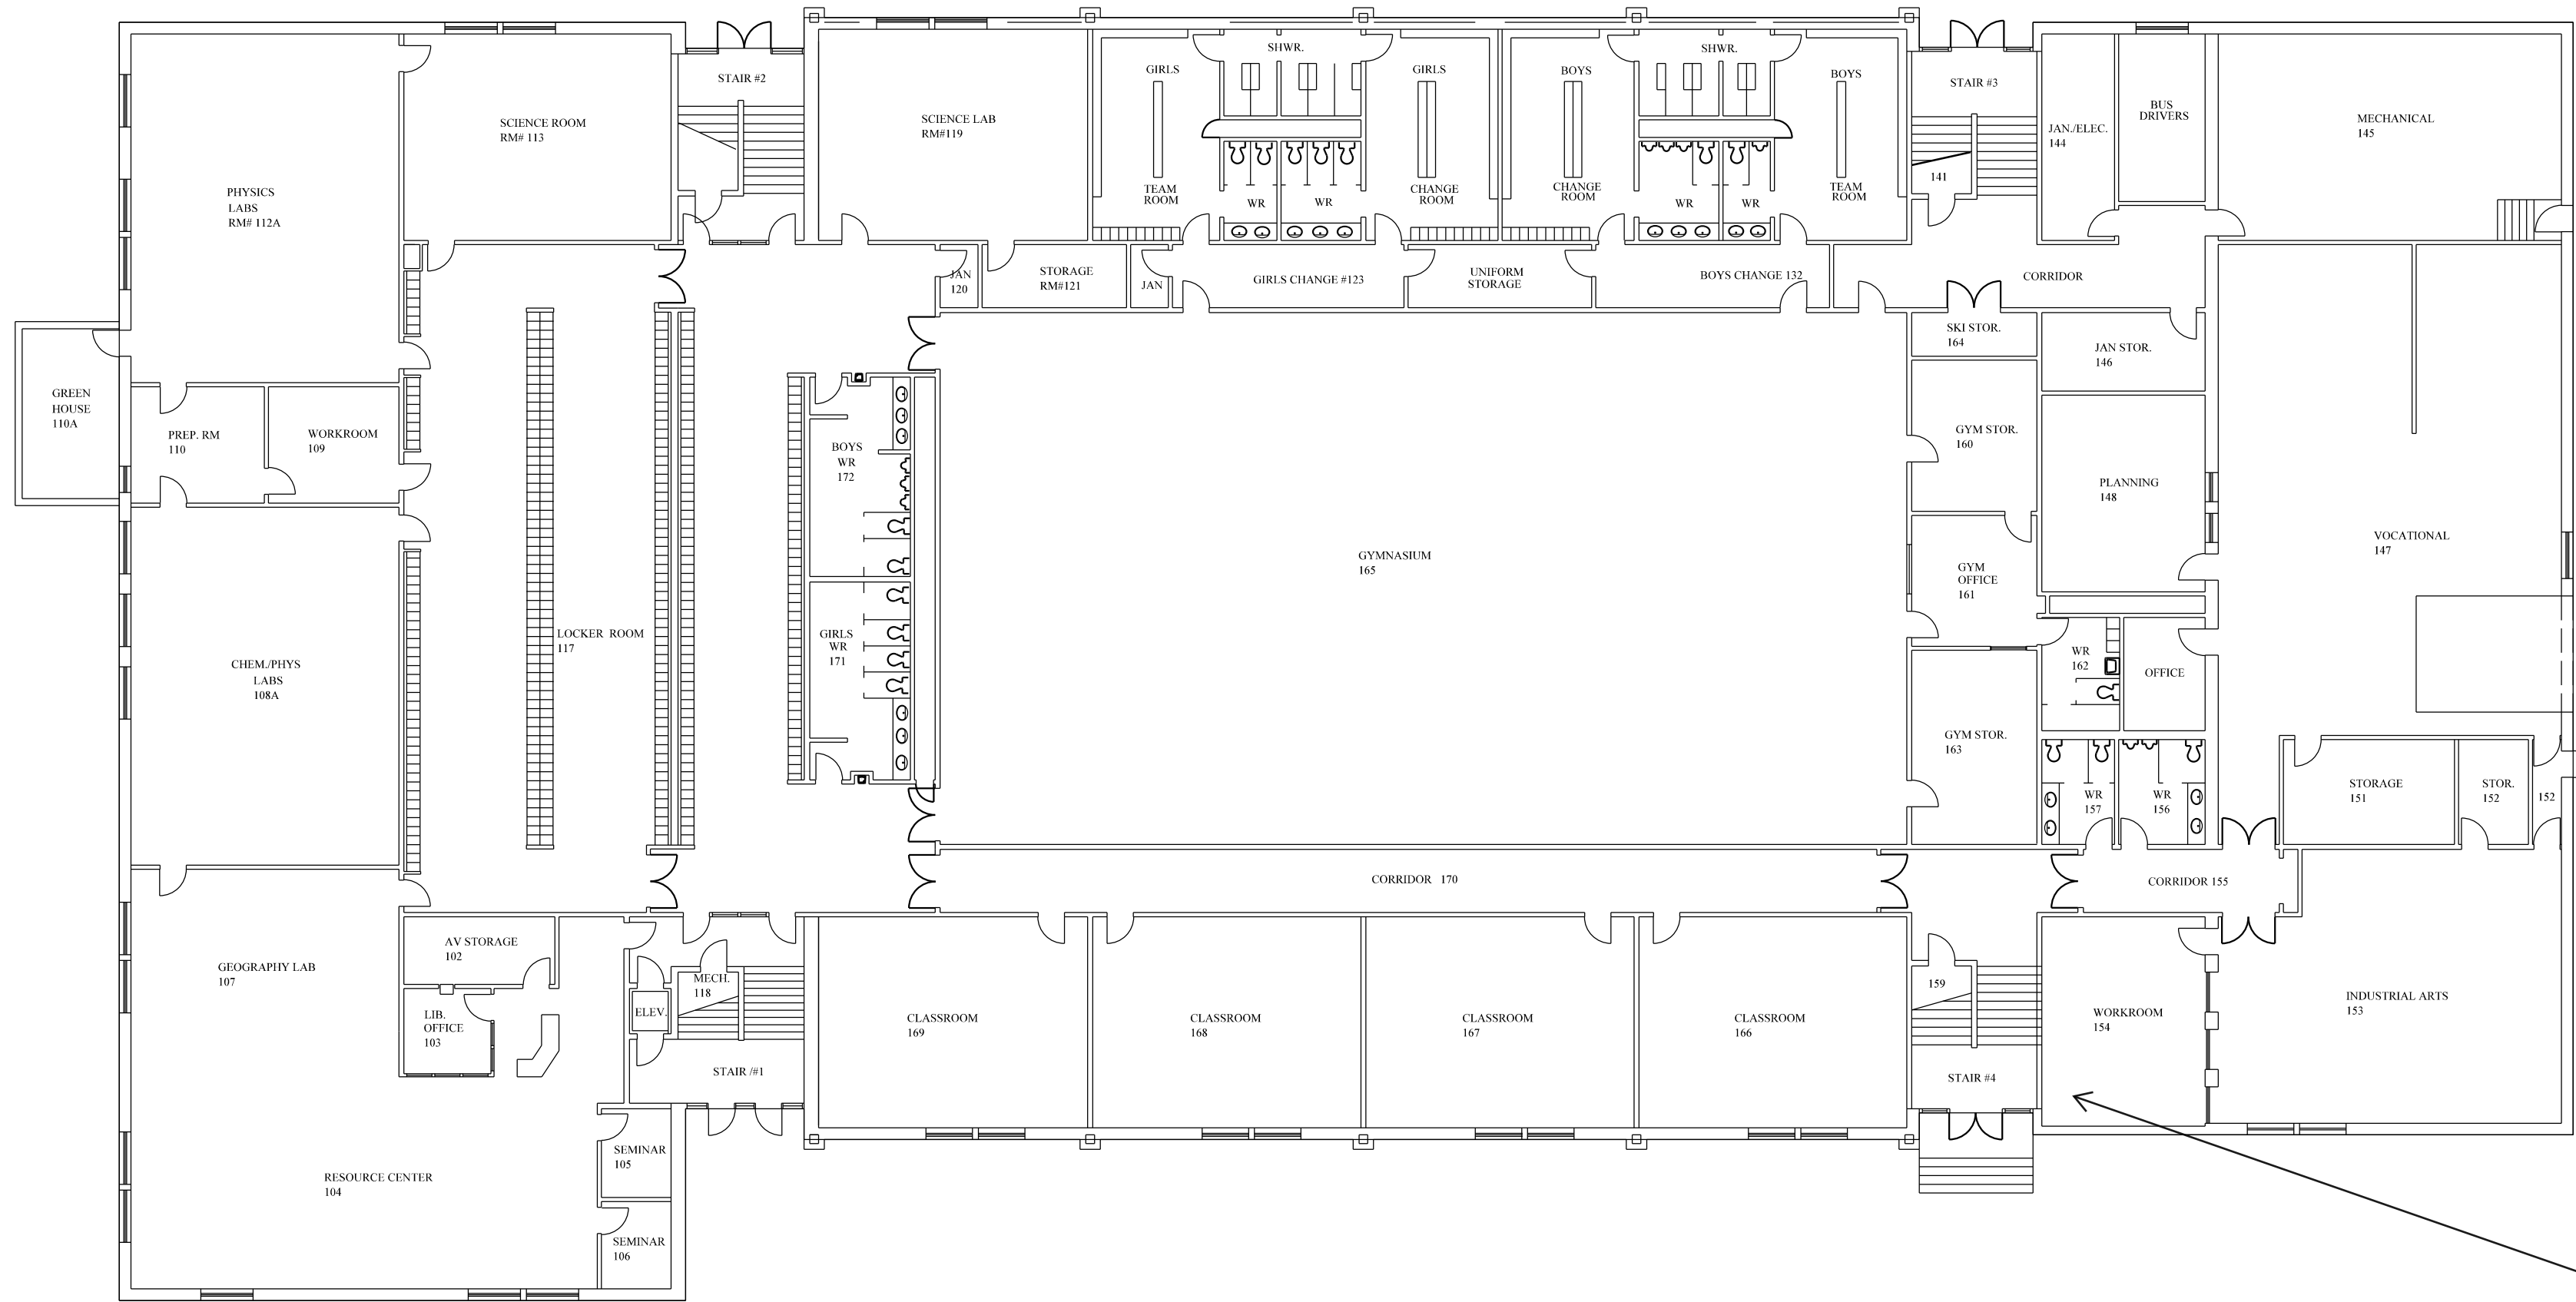
MAIN FLOOR

<b>Table II</b> <b>Summary of Moisture affected areas</b>		
<b>Room No. / Description</b>	<b>Comments / Observations</b>	<b>Action required</b>
Rm 107, 117, 145, 231	Water stained ceiling tile No visible mould or moisture detected at the time of the assessment	Replace ceiling tile as precautionary measure and to assist in detecting further water leaks. Report and repair future leaks promptly to prevent potential mould growth.
Room- 106, 144, 154, 153, 240	Water stains and cracked painted surfaces on wall. No moisture detected. No visible mould.	Report any future leaks and conduct follow up investigation to address if recurring leak and to prevent the potential for mould growth.
Room 154 - Workroom	Surface damaged paint surface on concrete block wall. Surface damage to drywall pipe chase. Rusted surfaces. No moisture detected at the time of assessment. Suspect water leak from pipe into radiator.	Further investigation into pipe chase to assess for the potential of hidden mould. Follow Level 1 remediation guidelines as precautionary measure.

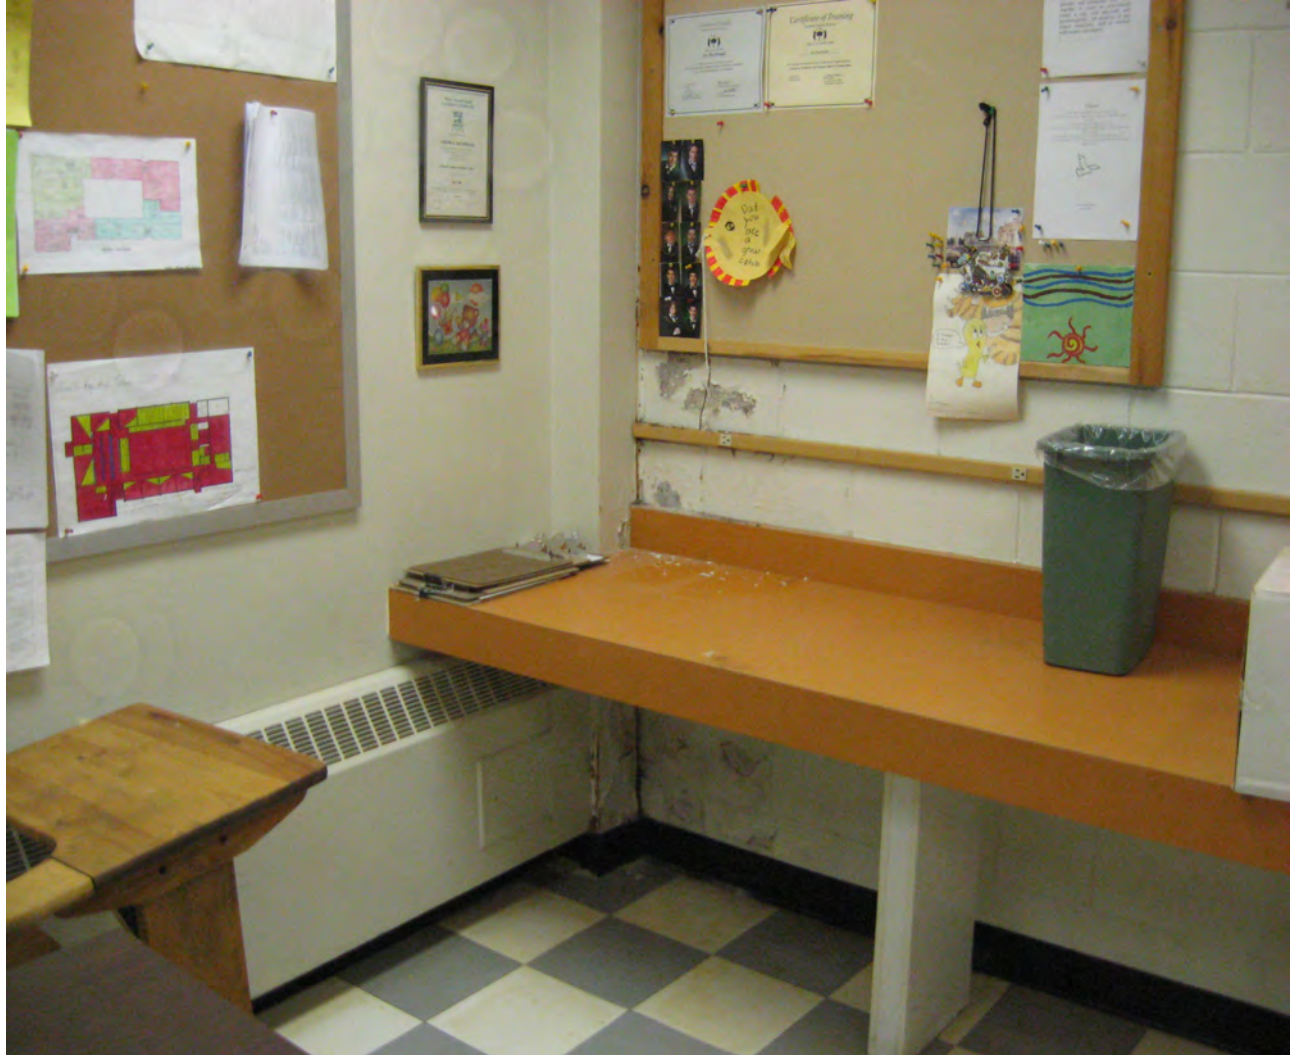
However, Room 154 (Workroom) was reported to have surface damage on painted wall surface around a pipe chase. Although there was no elevated moisture detected at the time of the assessment, further investigation should be carried out to assess materials behind the drywall surface for potential mould growth. Level 1 remediation guidelines should be carried out during

Further investigation into pipe chase

investigation as a precautionary measure.
