Mould & Moisture Assessment Mount Stewart Consolidated School

Project No. 12620

March 9, 2011

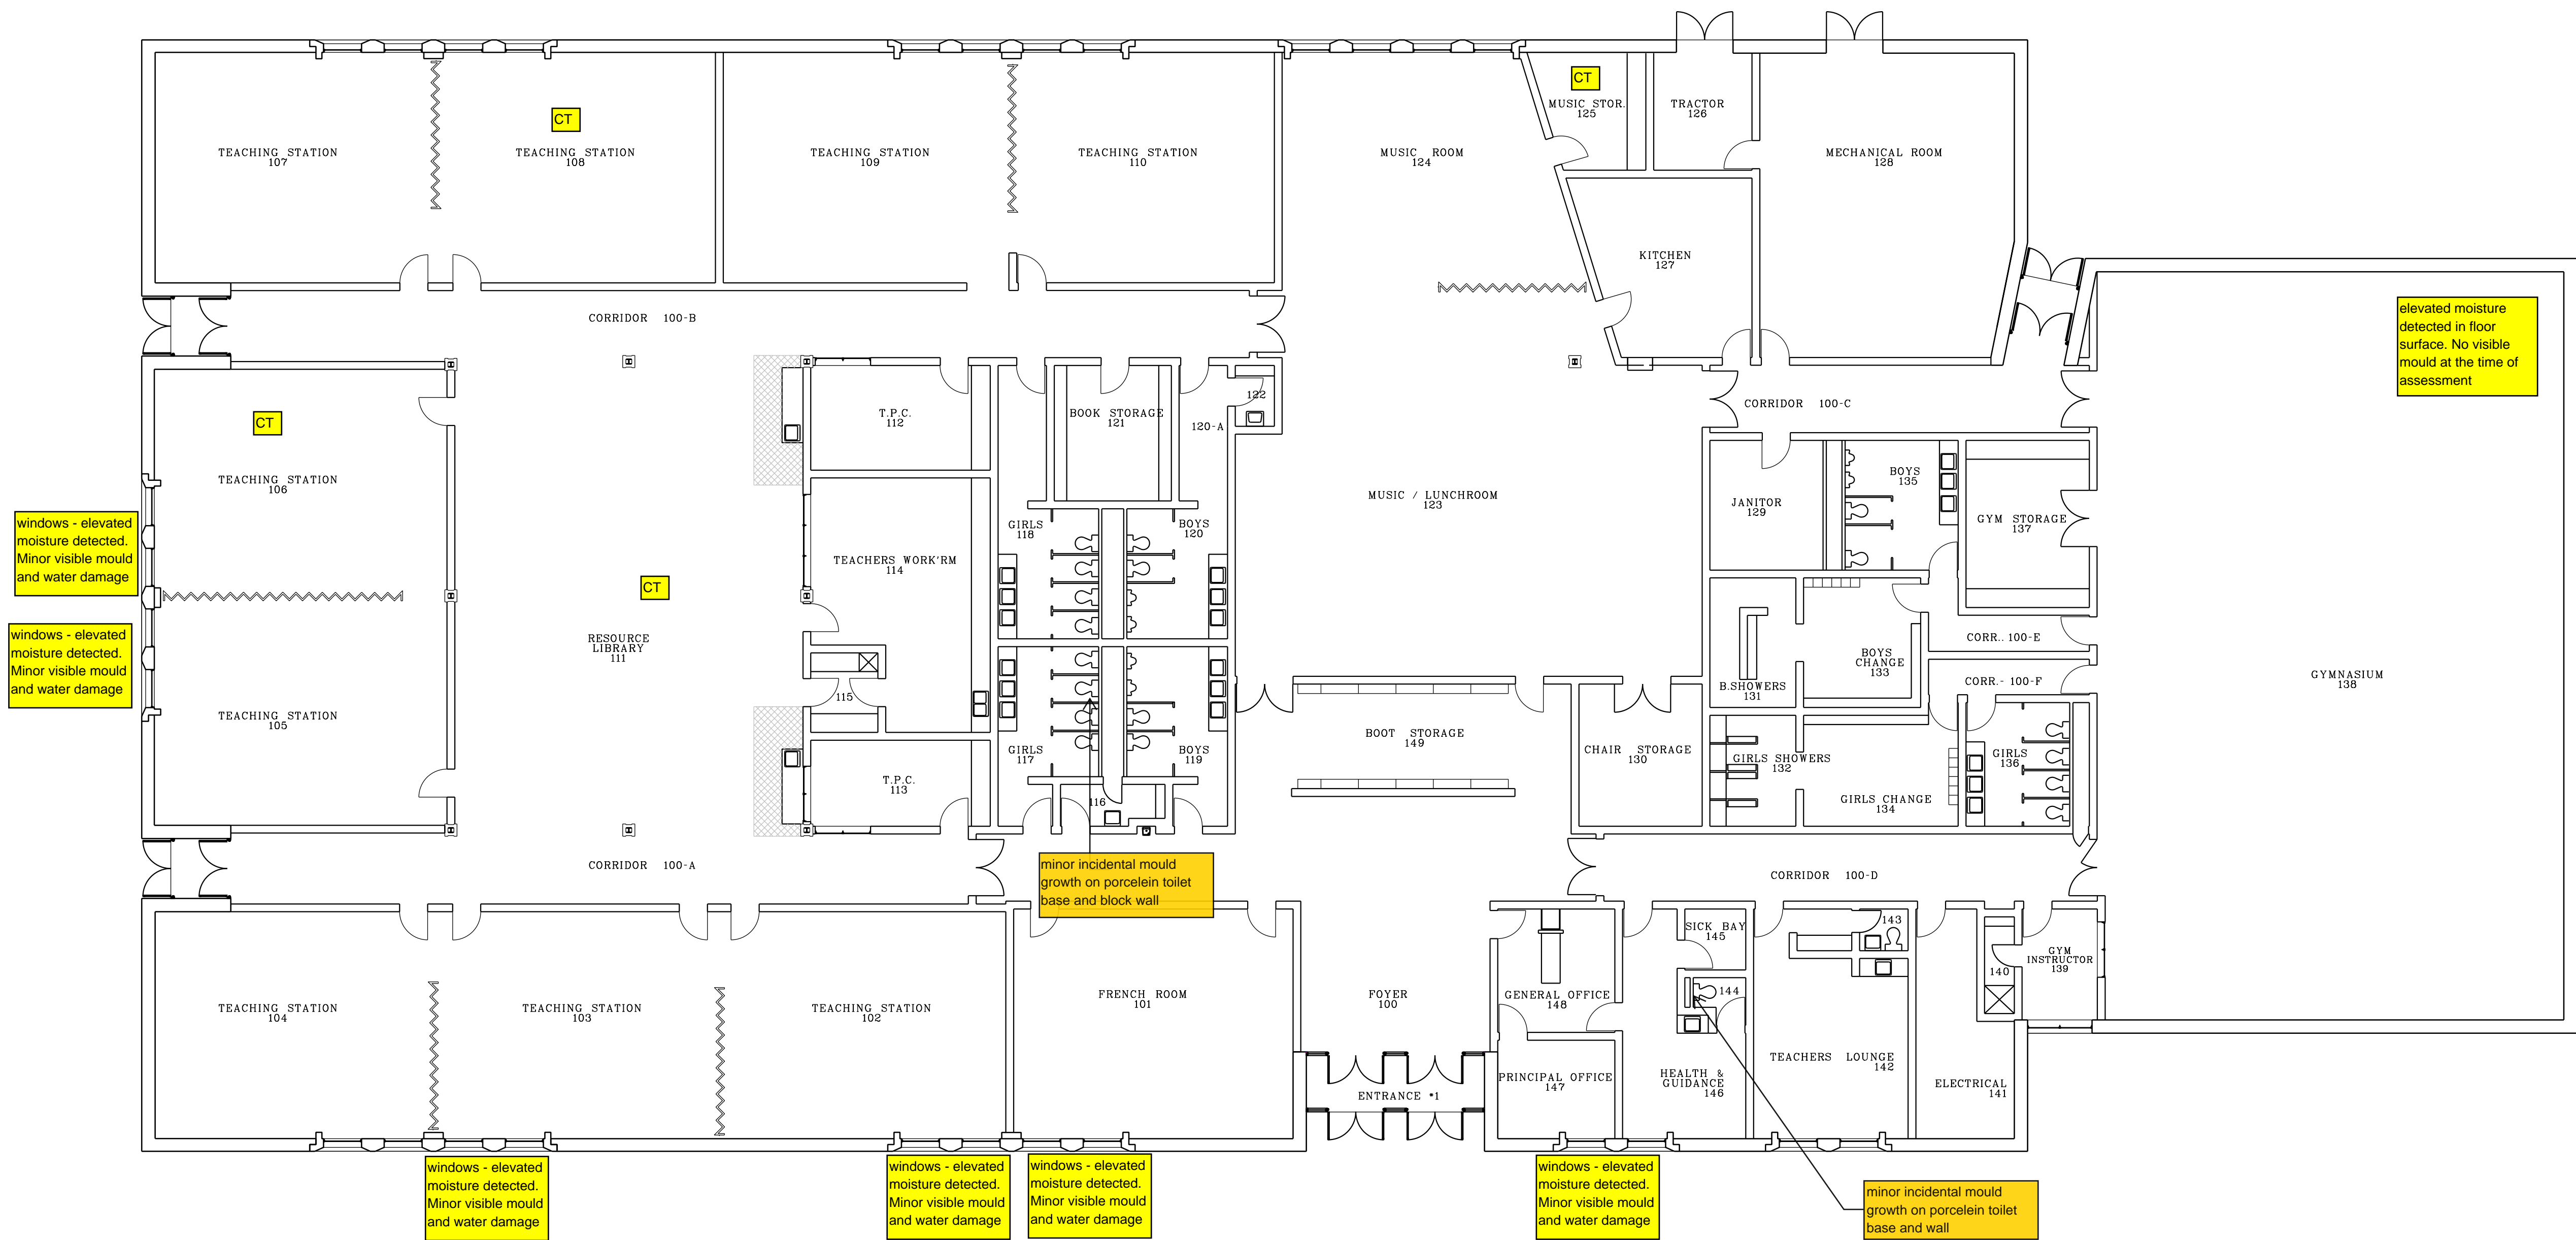
APPENDIX I
Site Floor Plans

Room numbers identified correspond to Site Floor Plans (Appendix 1) and not necessarily on site room numbers.

CT - affected ceiling tile area
