# Mould & Moisture Assessment O'Leary Elementary School

**Project No. 12620**

**March 28, 2011**

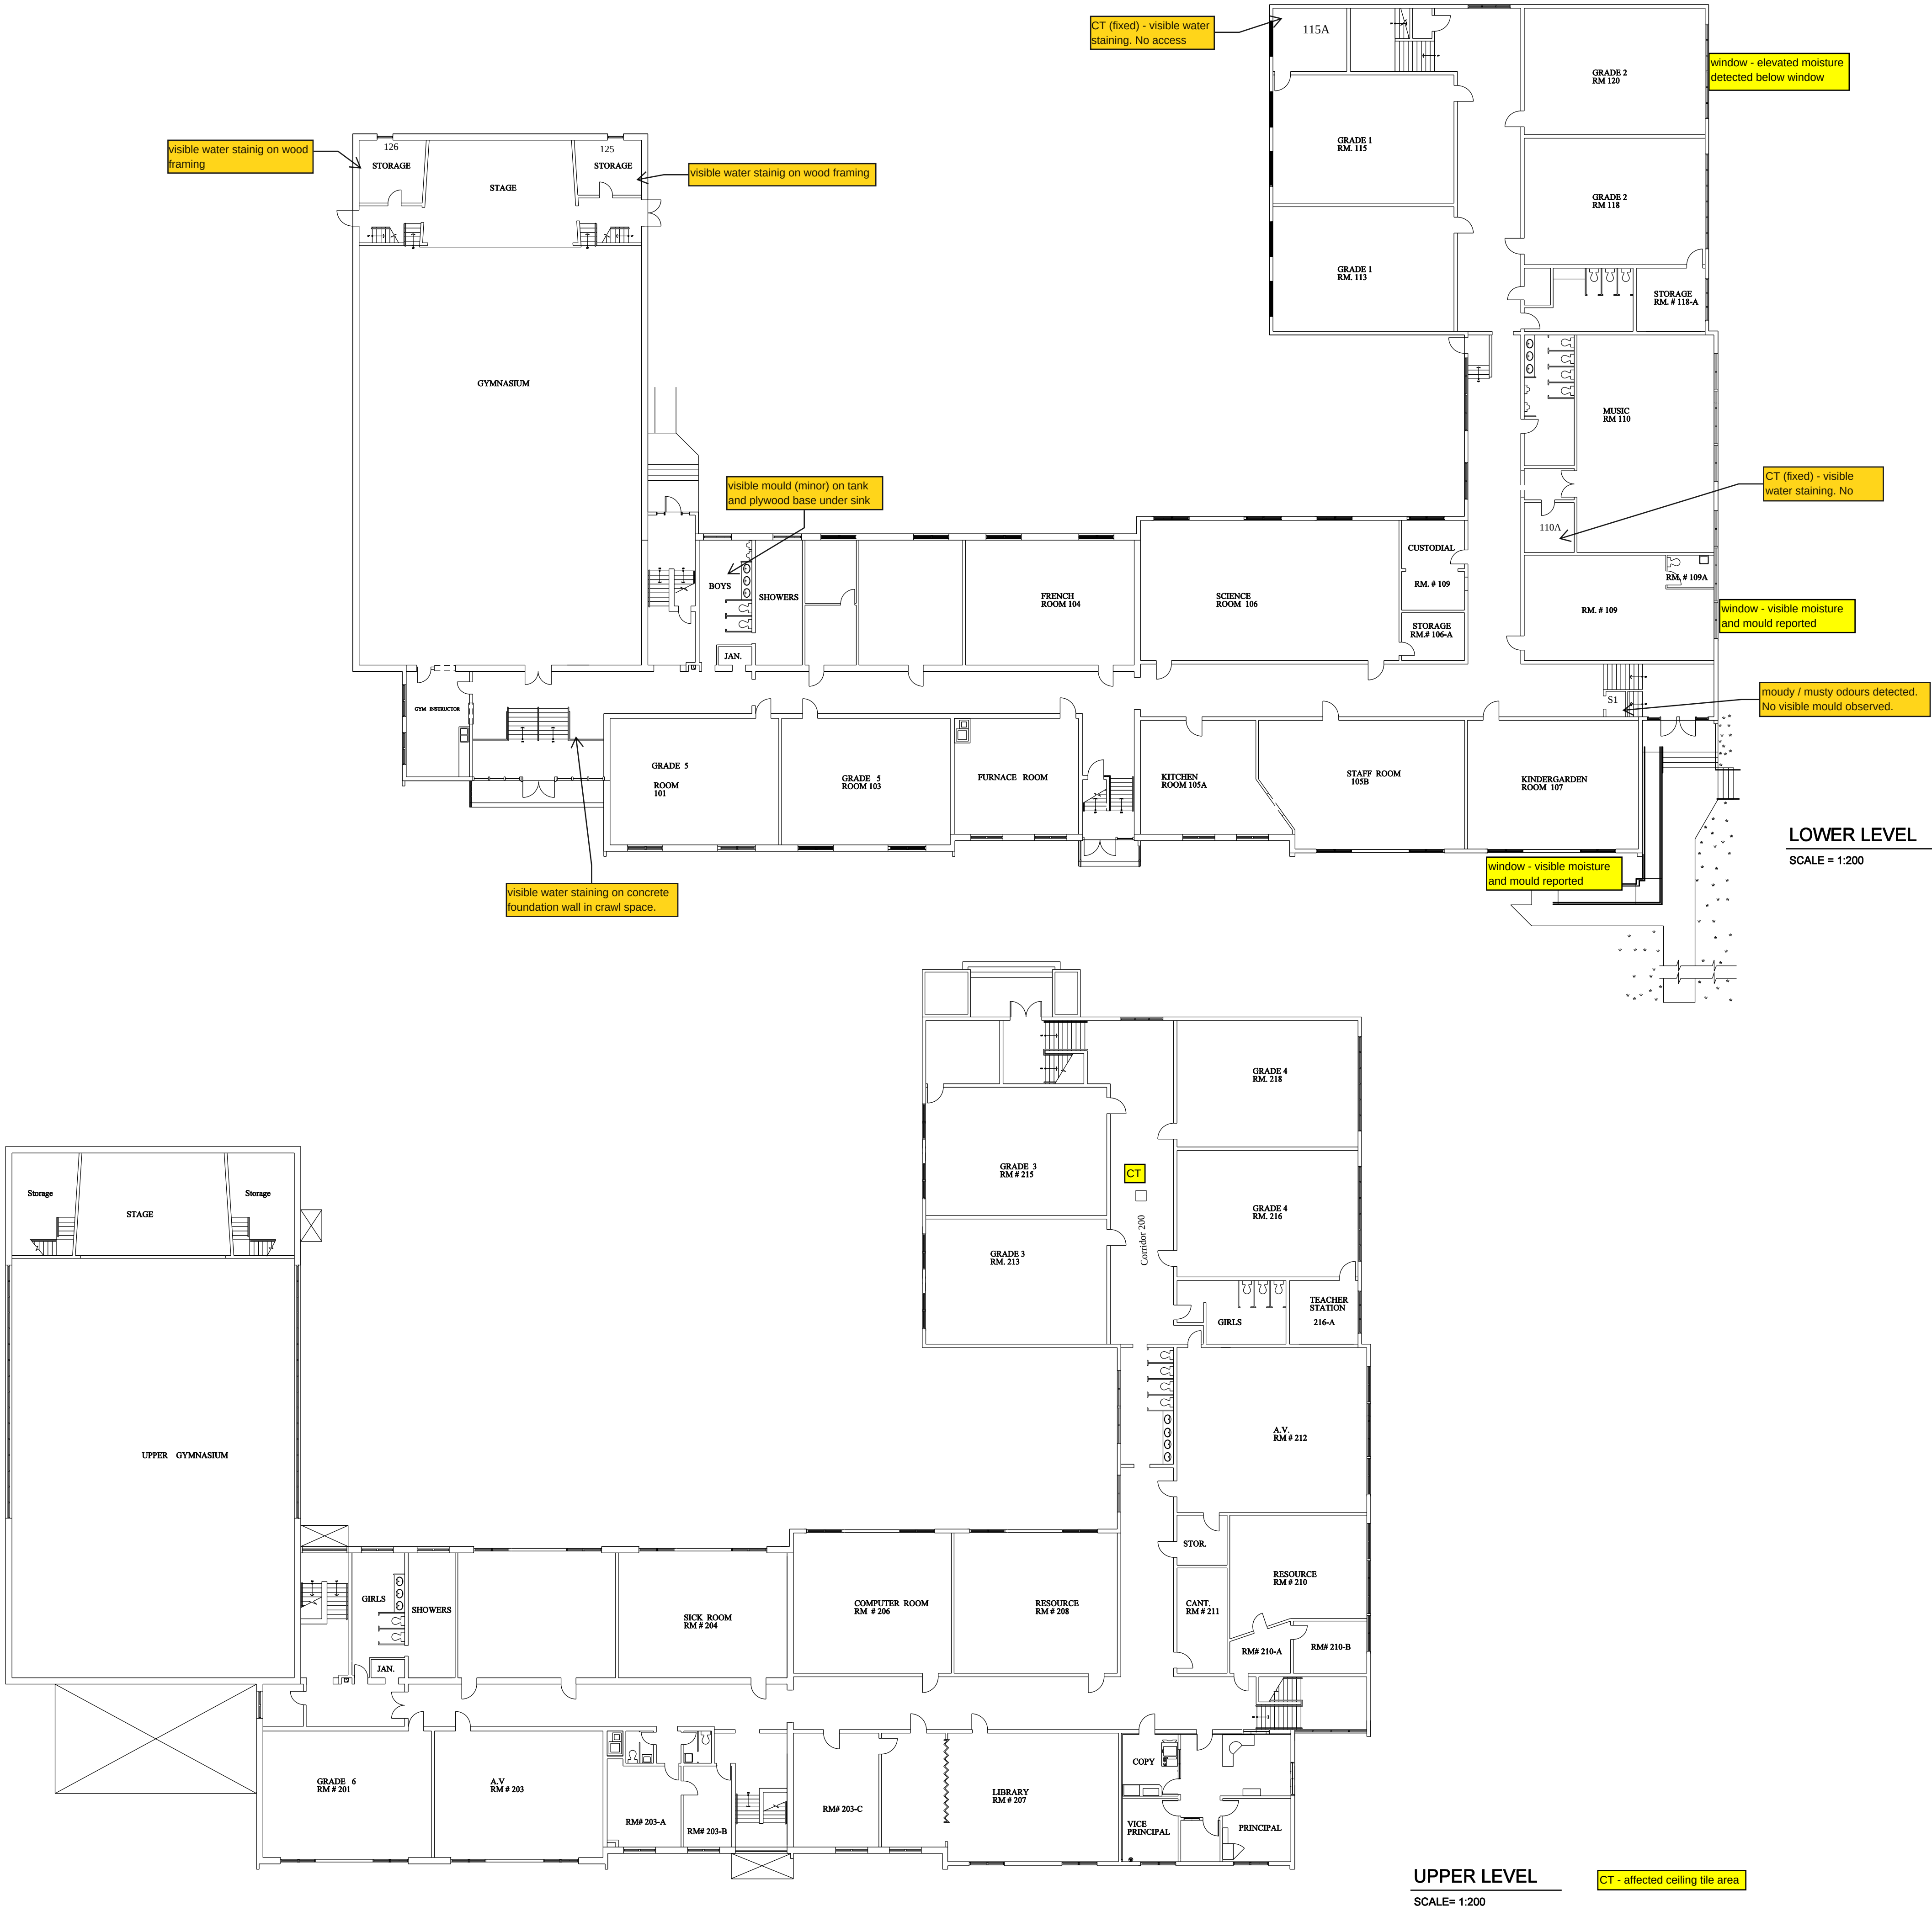
**APPENDIX I**  
**Site Floor Plans**

Water staining on fixed ceiling tiles was noted in two areas. These areas are noted in Table III and are identified on the site floor plan (Appendix I). Although there was no evidence of moisture or visible mould in these areas, it is recommended to remove the affected areas to further assess conditions above these areas for potential hidden mould.

| <b>Table III</b><br><b>Summary of Moisture affected areas</b> | | |
|---|---|---|
| Rm 120 | Elevated moisture detected on plaster below windows. | Further investigation required into addressing water infiltration and potential hidden mould |
| Rms 110A; 115A | Visible water damaged ceiling tiles.<br>No elevated moisture at the time of the assessment. | Removal of affected fixed ceiling tiles to further investigate for potential hidden mould above ceiling. |
