Mould & Moisture Assessment Parkside Elementary School

Project No. 12620

March 9, 2011

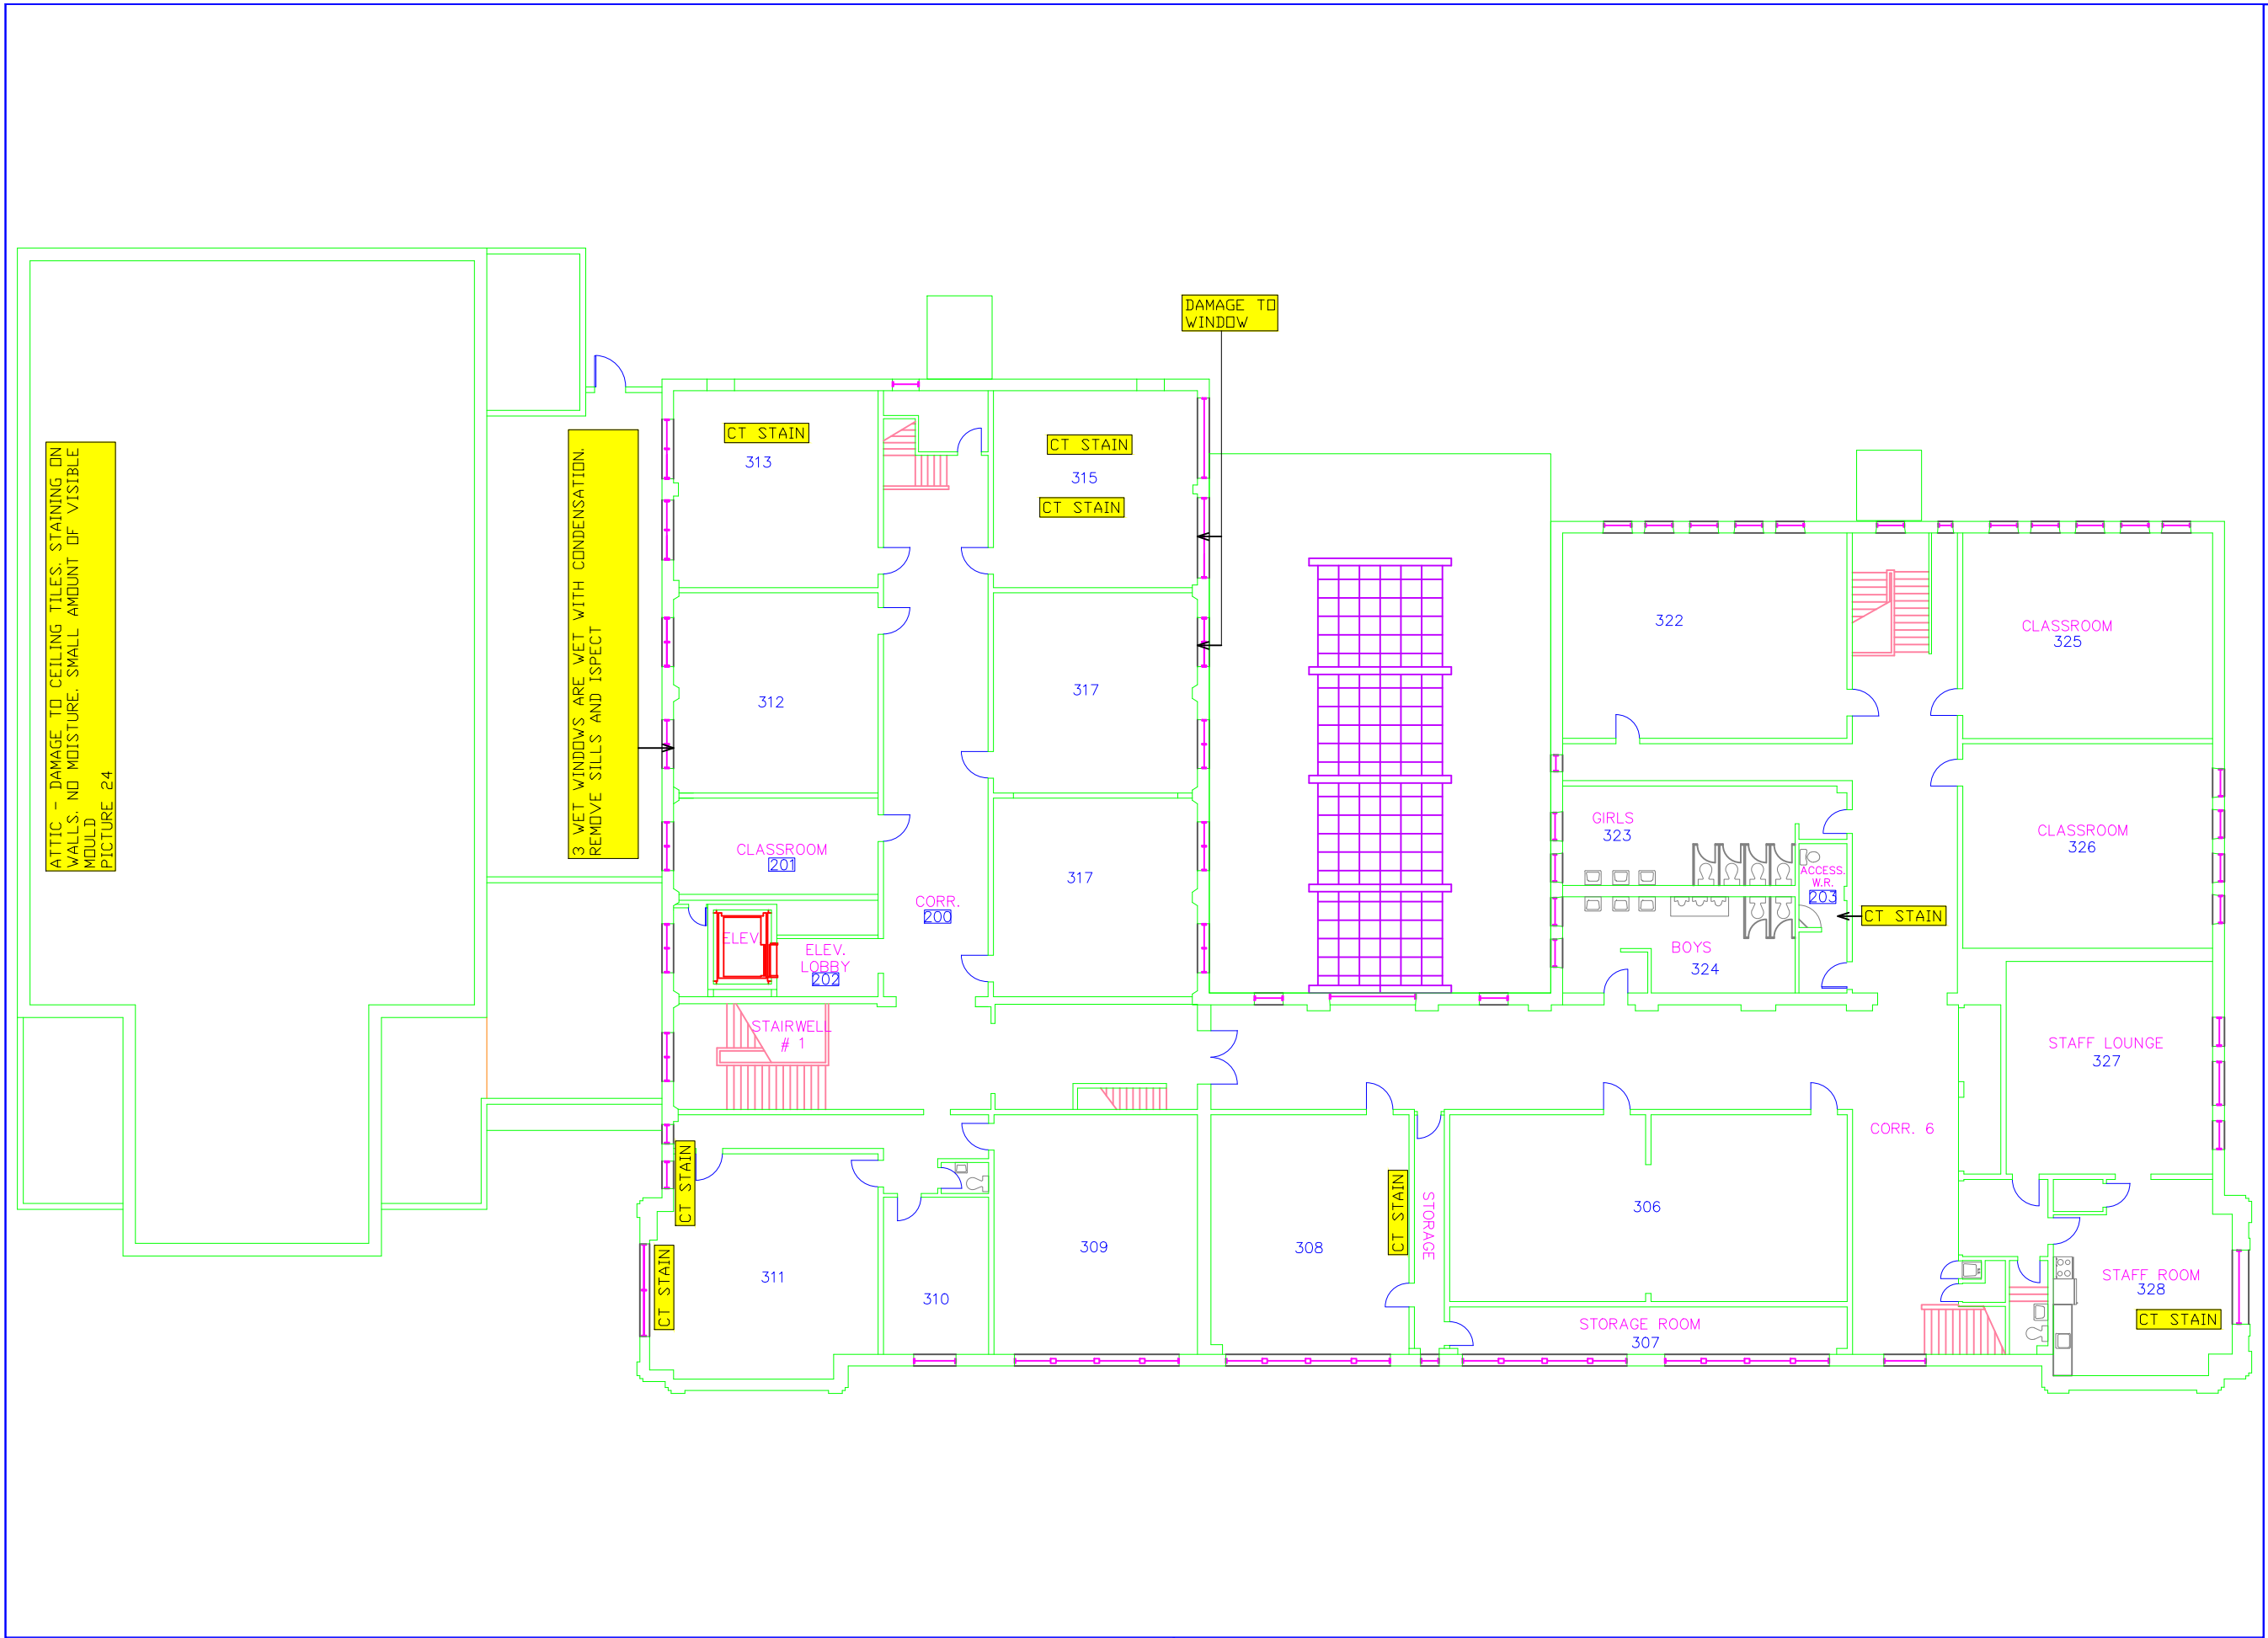
DRAWING TITLE
UPPER LEVEL

ATTIC - DAMAGE TO CEILING TILES, STAINING ON WALLS, NO MOISTURE. SMALL AMOUNT OF VISIBLE MOULD.
PICTURE 24

3 WET WINDOWS ARE WET WITH CONDENSATION. REMOVE SILLS AND INSPECT

DAMAGE TO WINDOW
