Mould & Moisture Assessment École Pierre Chiasson

Project No. 12620

May 9, 2011

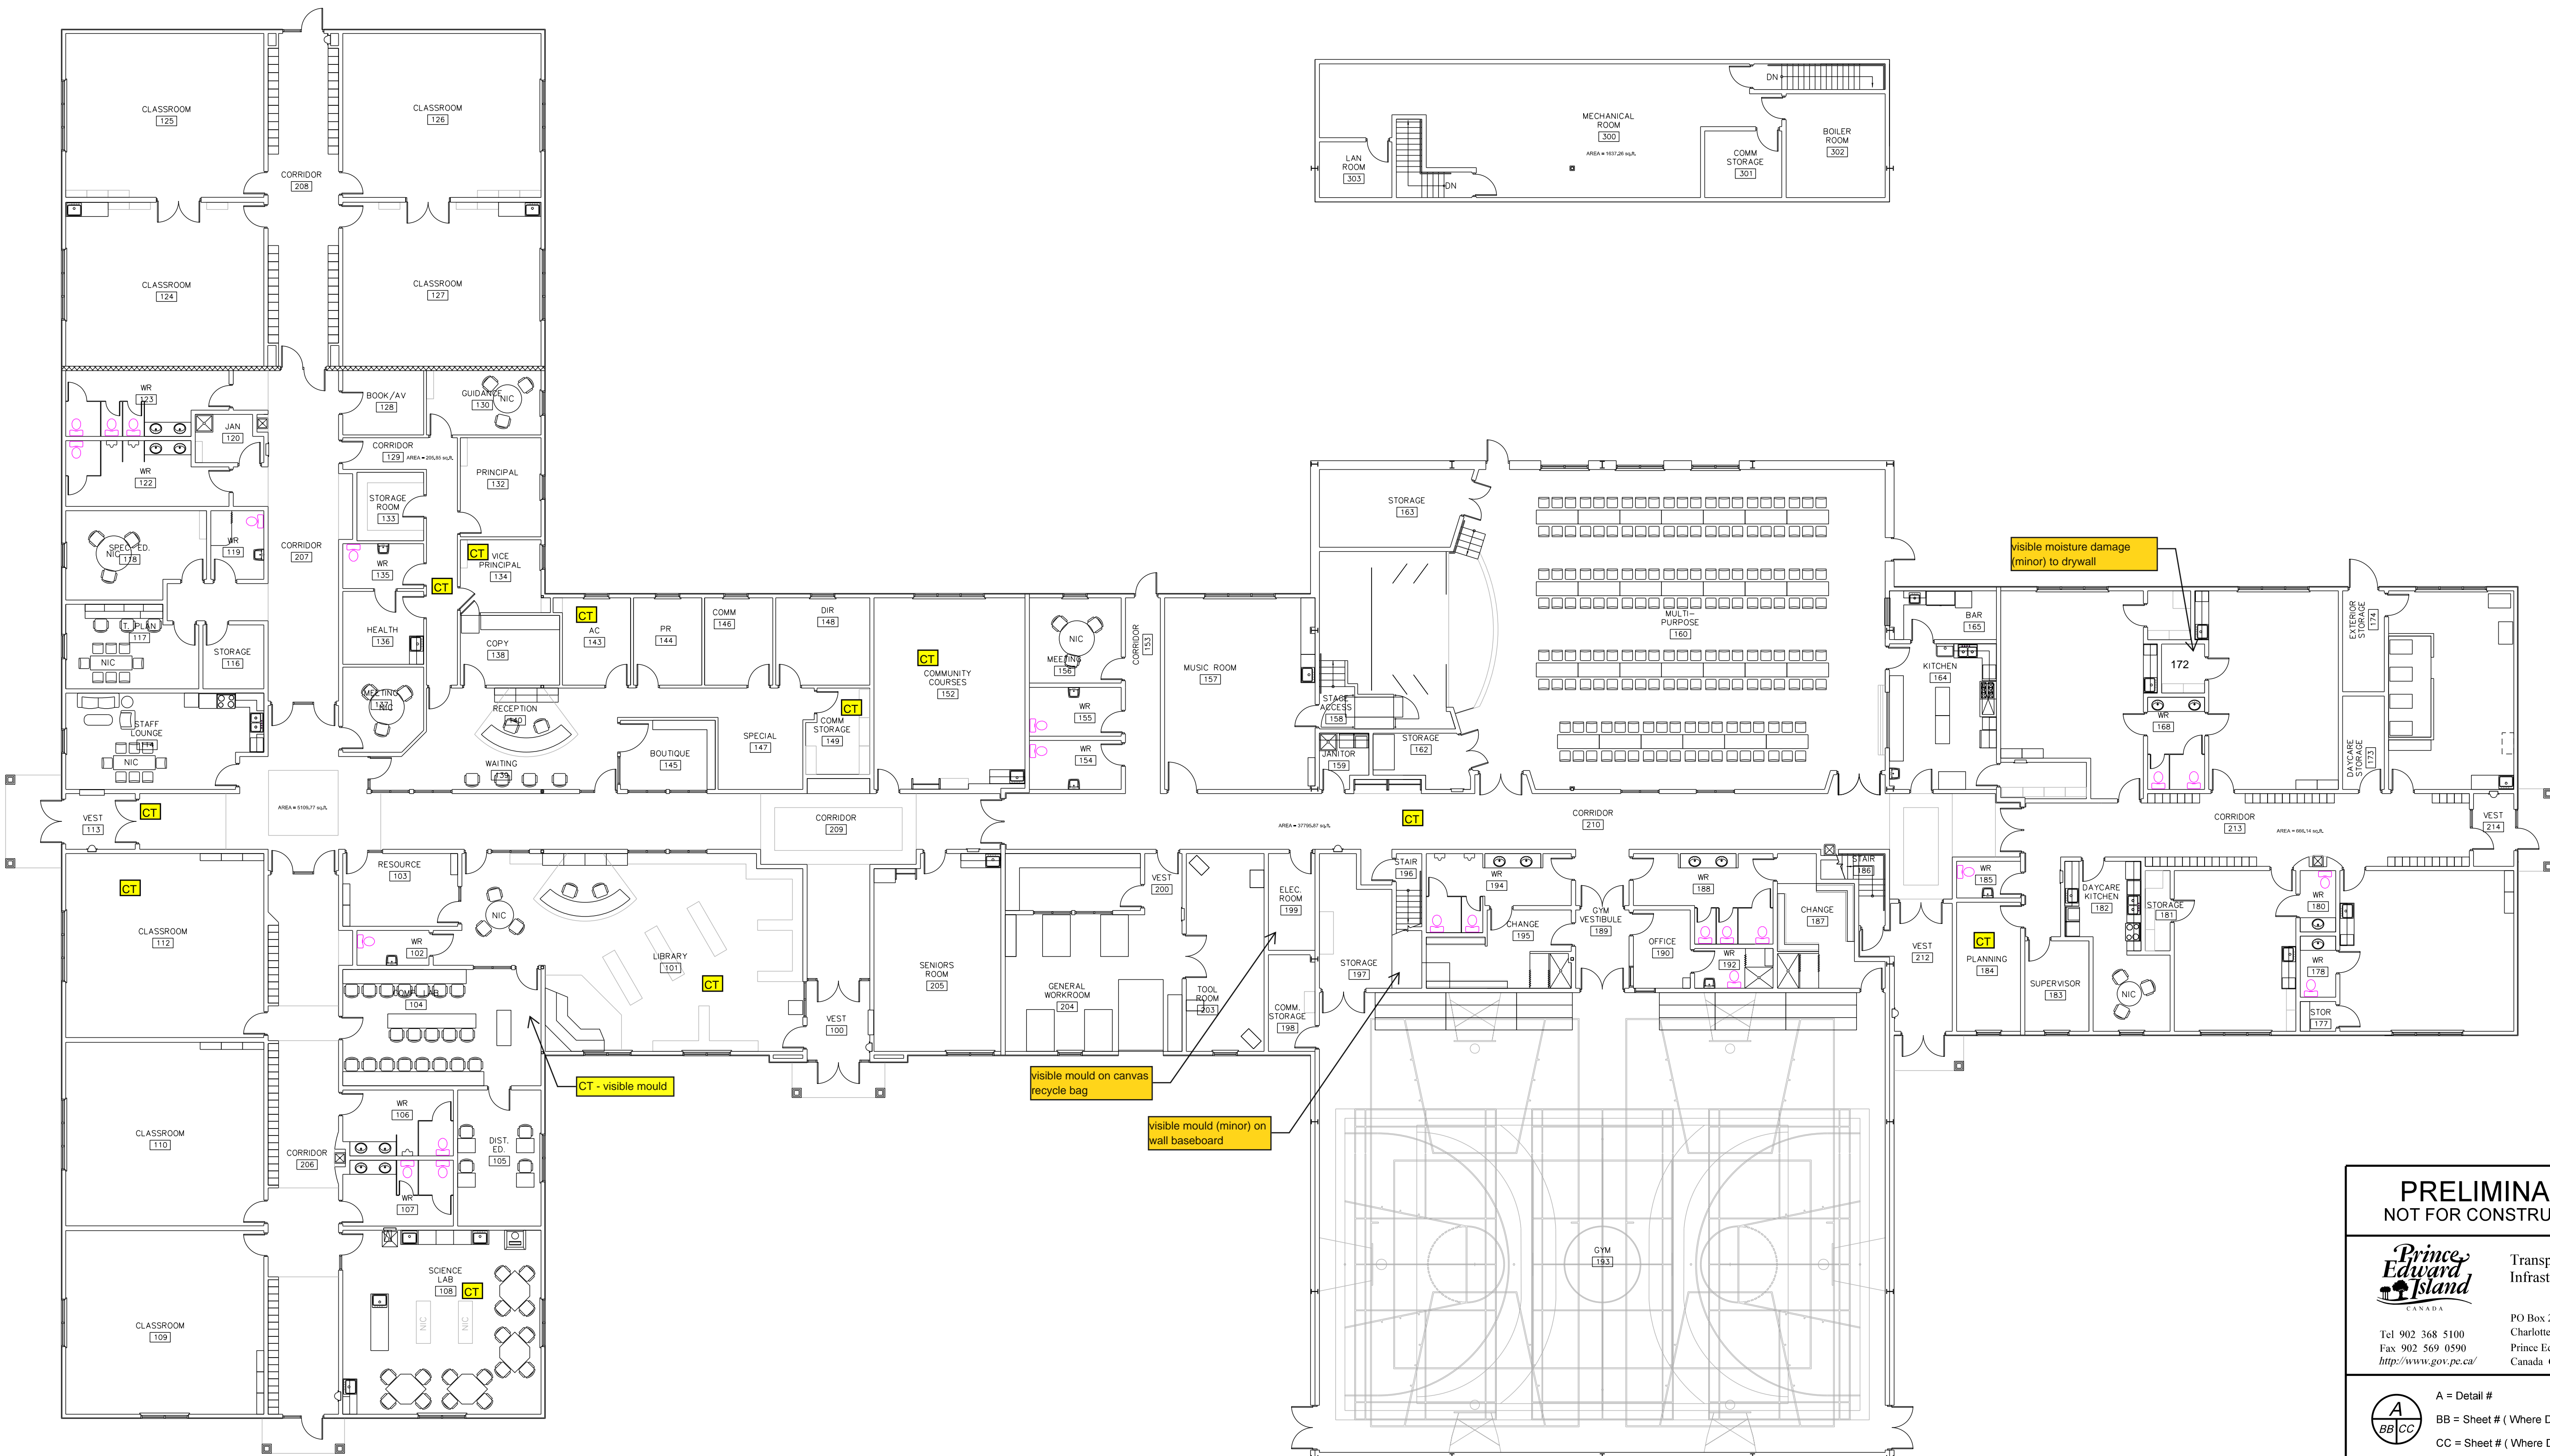
FLOOR PLAN

Room No. / Description	Comments / Observations	Action required
Rms 101; 104; 108; 112; Corridor 113; 126; 127; Corridor 129; 134; 143; 149; 152; 184; Corridor 210	Stained ceiling tiles observed and reported throughout the building (see site floor plan - Appendix I for location markings). Reported roof leaks.	Replace ceiling tiles as precautionary measure and to assist in detecting further water leaks. Further investigation required into addressing roof leaks.
Rm-172	Visible moisture damage to wall and painted surface. No visible signs of mould or moisture. Appears to isolated incident. Reported hot water heater vented steam/water.	Repair surfaces and report any further occurrences to detect problems related to moisture and potential mould growth.
Corridor # 209	Visible water damage on drywall ceiling. Reported as an occurrence when the school was built.	Report any further water / moisture issues promptly to address potential infiltration issues.

CT - affected ceiling tile area

visible moisture damage (minor) to drywall

CT - visible mould

visible mould on canvas recycle bag

visible mould (minor) on wall baseboard

There were evident signs of water stains on in lay ceiling tiles throughout the school where only one area was noted with visible mould (Rm 104). Other areas assessed had no visual signs of mould above the ceiling where accessible. All ceiling tiles exhibiting evidence of water damage are recommended to be removed and replaced as a precautionary measure and also to detect any further leaks which may re-occur. These areas are noted in Table III and are identified on the site floor plan (Appendix 1).
