Mould & Moisture Assessment Queen Charlotte Intermediate School

Project No. 12620

April 20, 2011

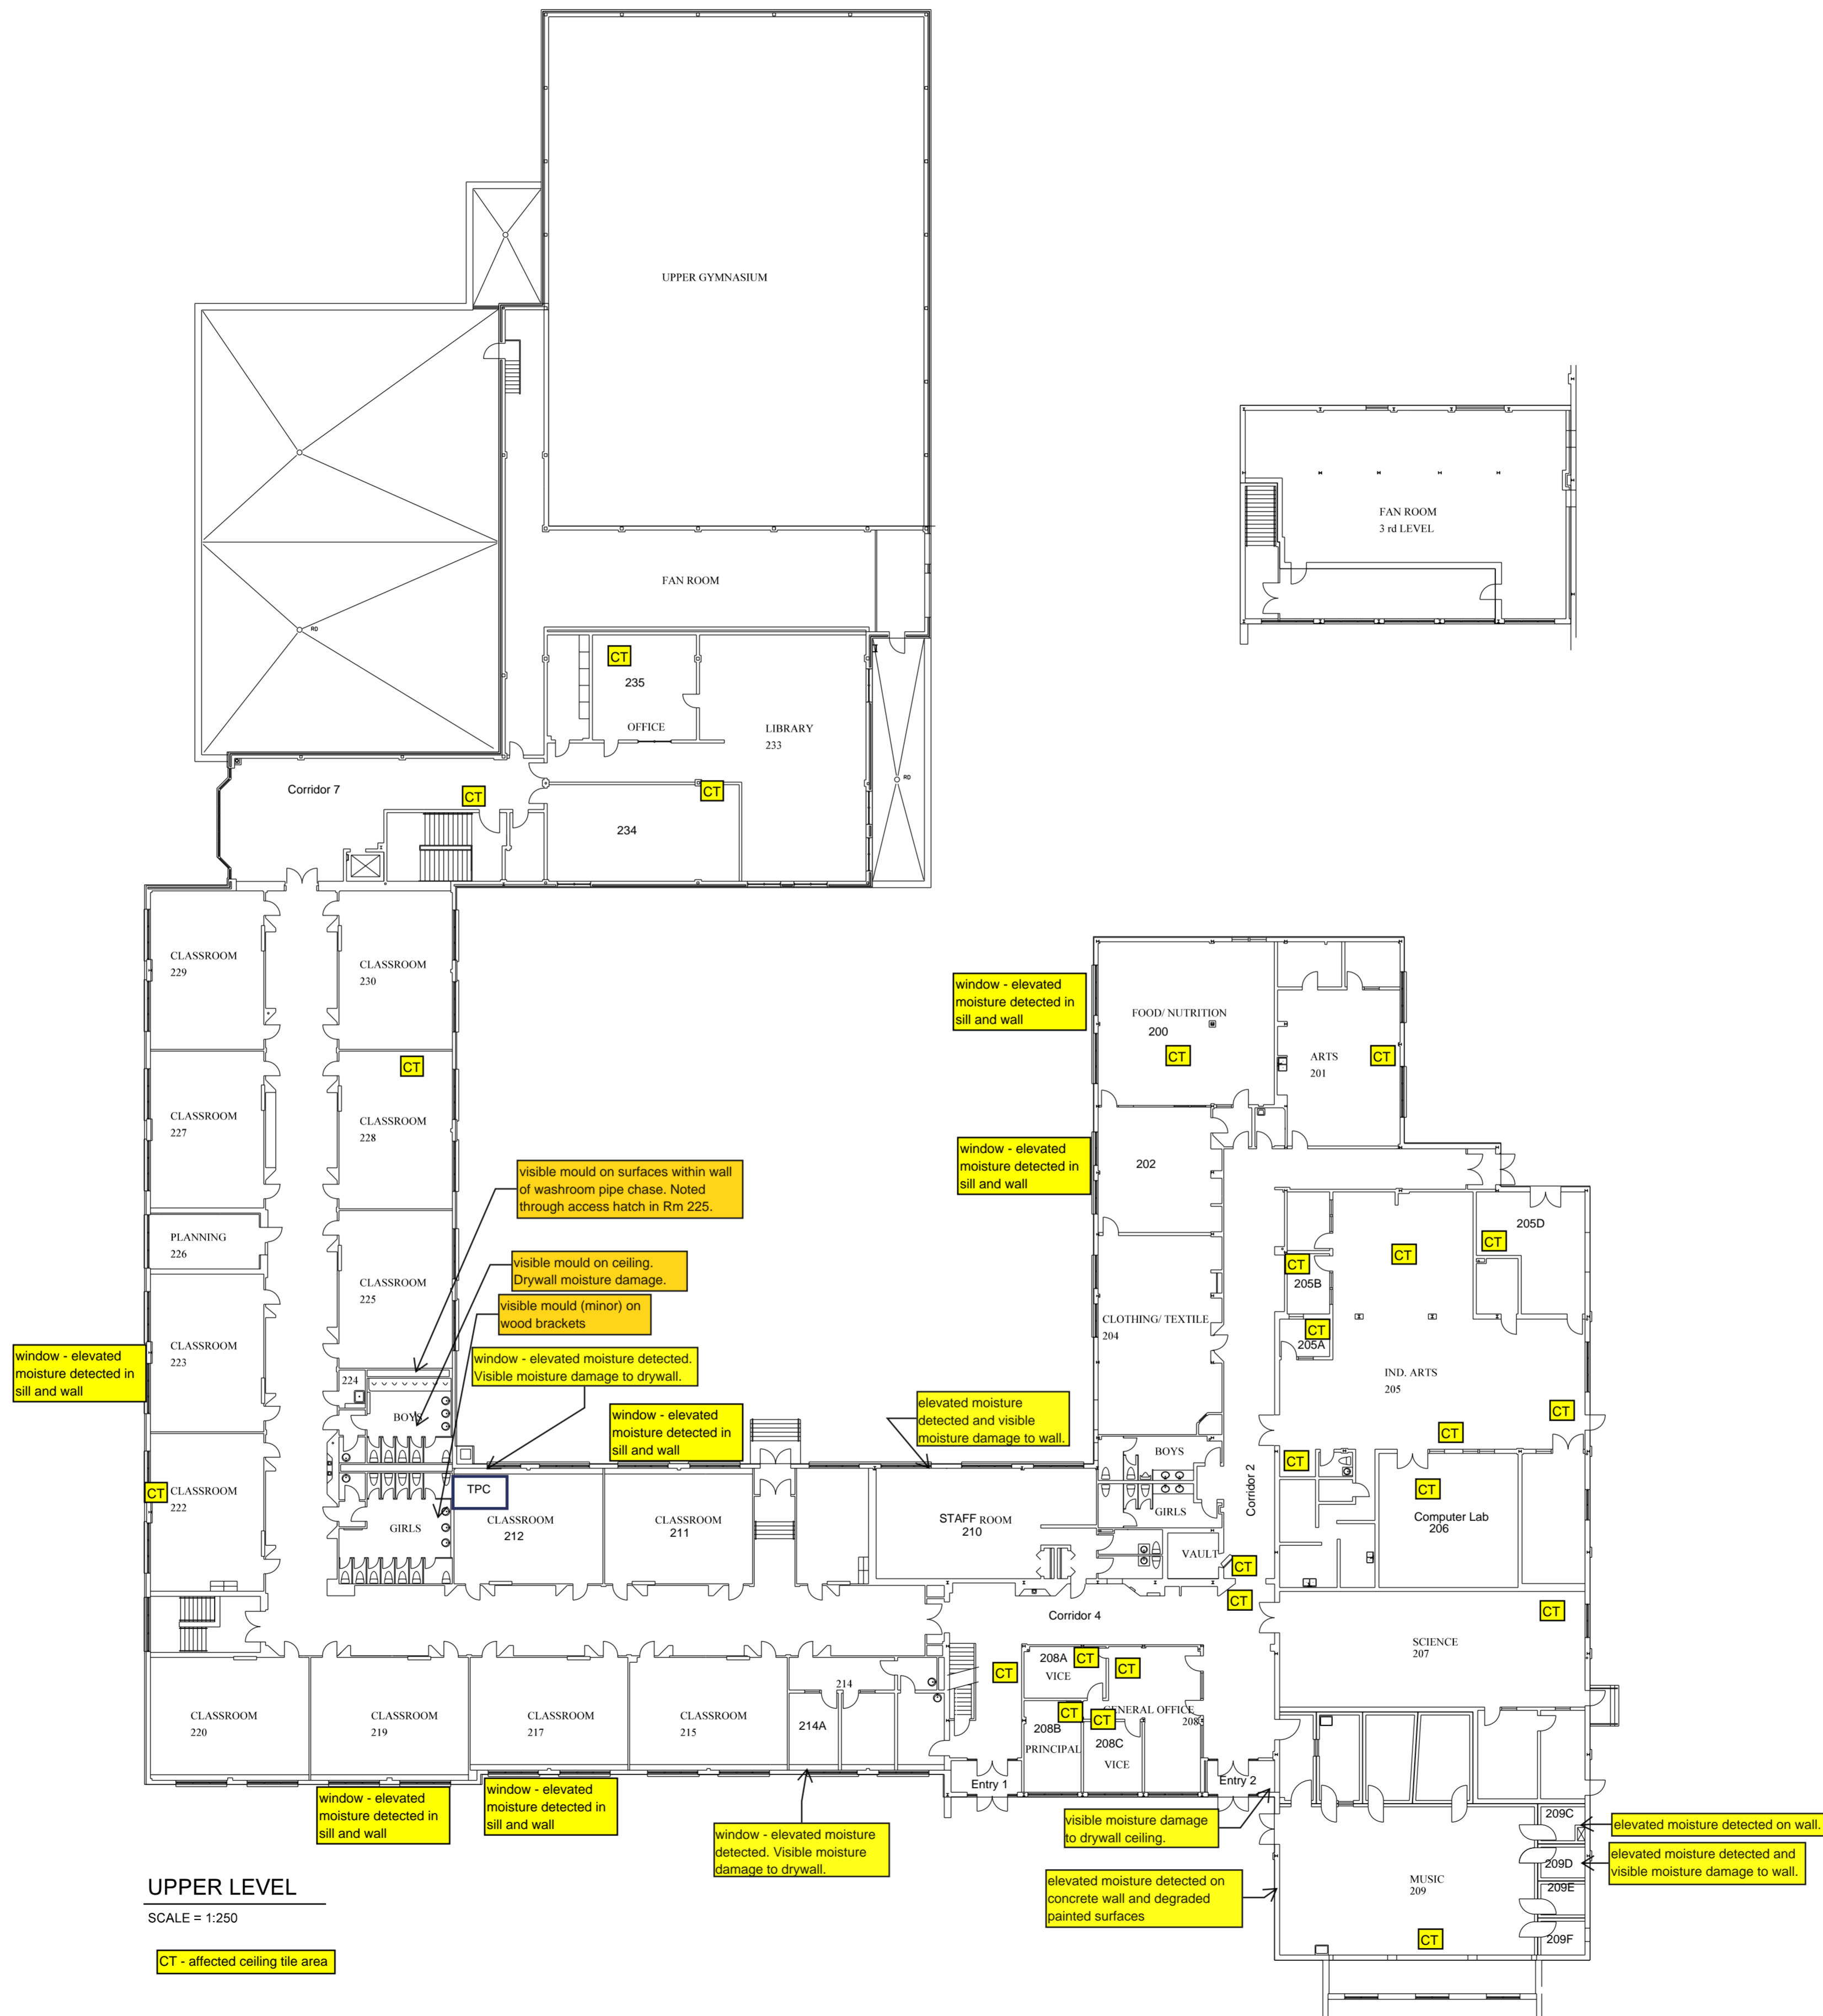
Scale:	1:250	Design By:	-
Drawn By:	-	Date:	January 2011
Project No.:	460 0000	Drawing #:	A2 of 2

CT - affected ceiling tile area
