# Mould & Moisture Assessment Sherwood Elementary School

**Project No. 12620**

**March 9, 2011**

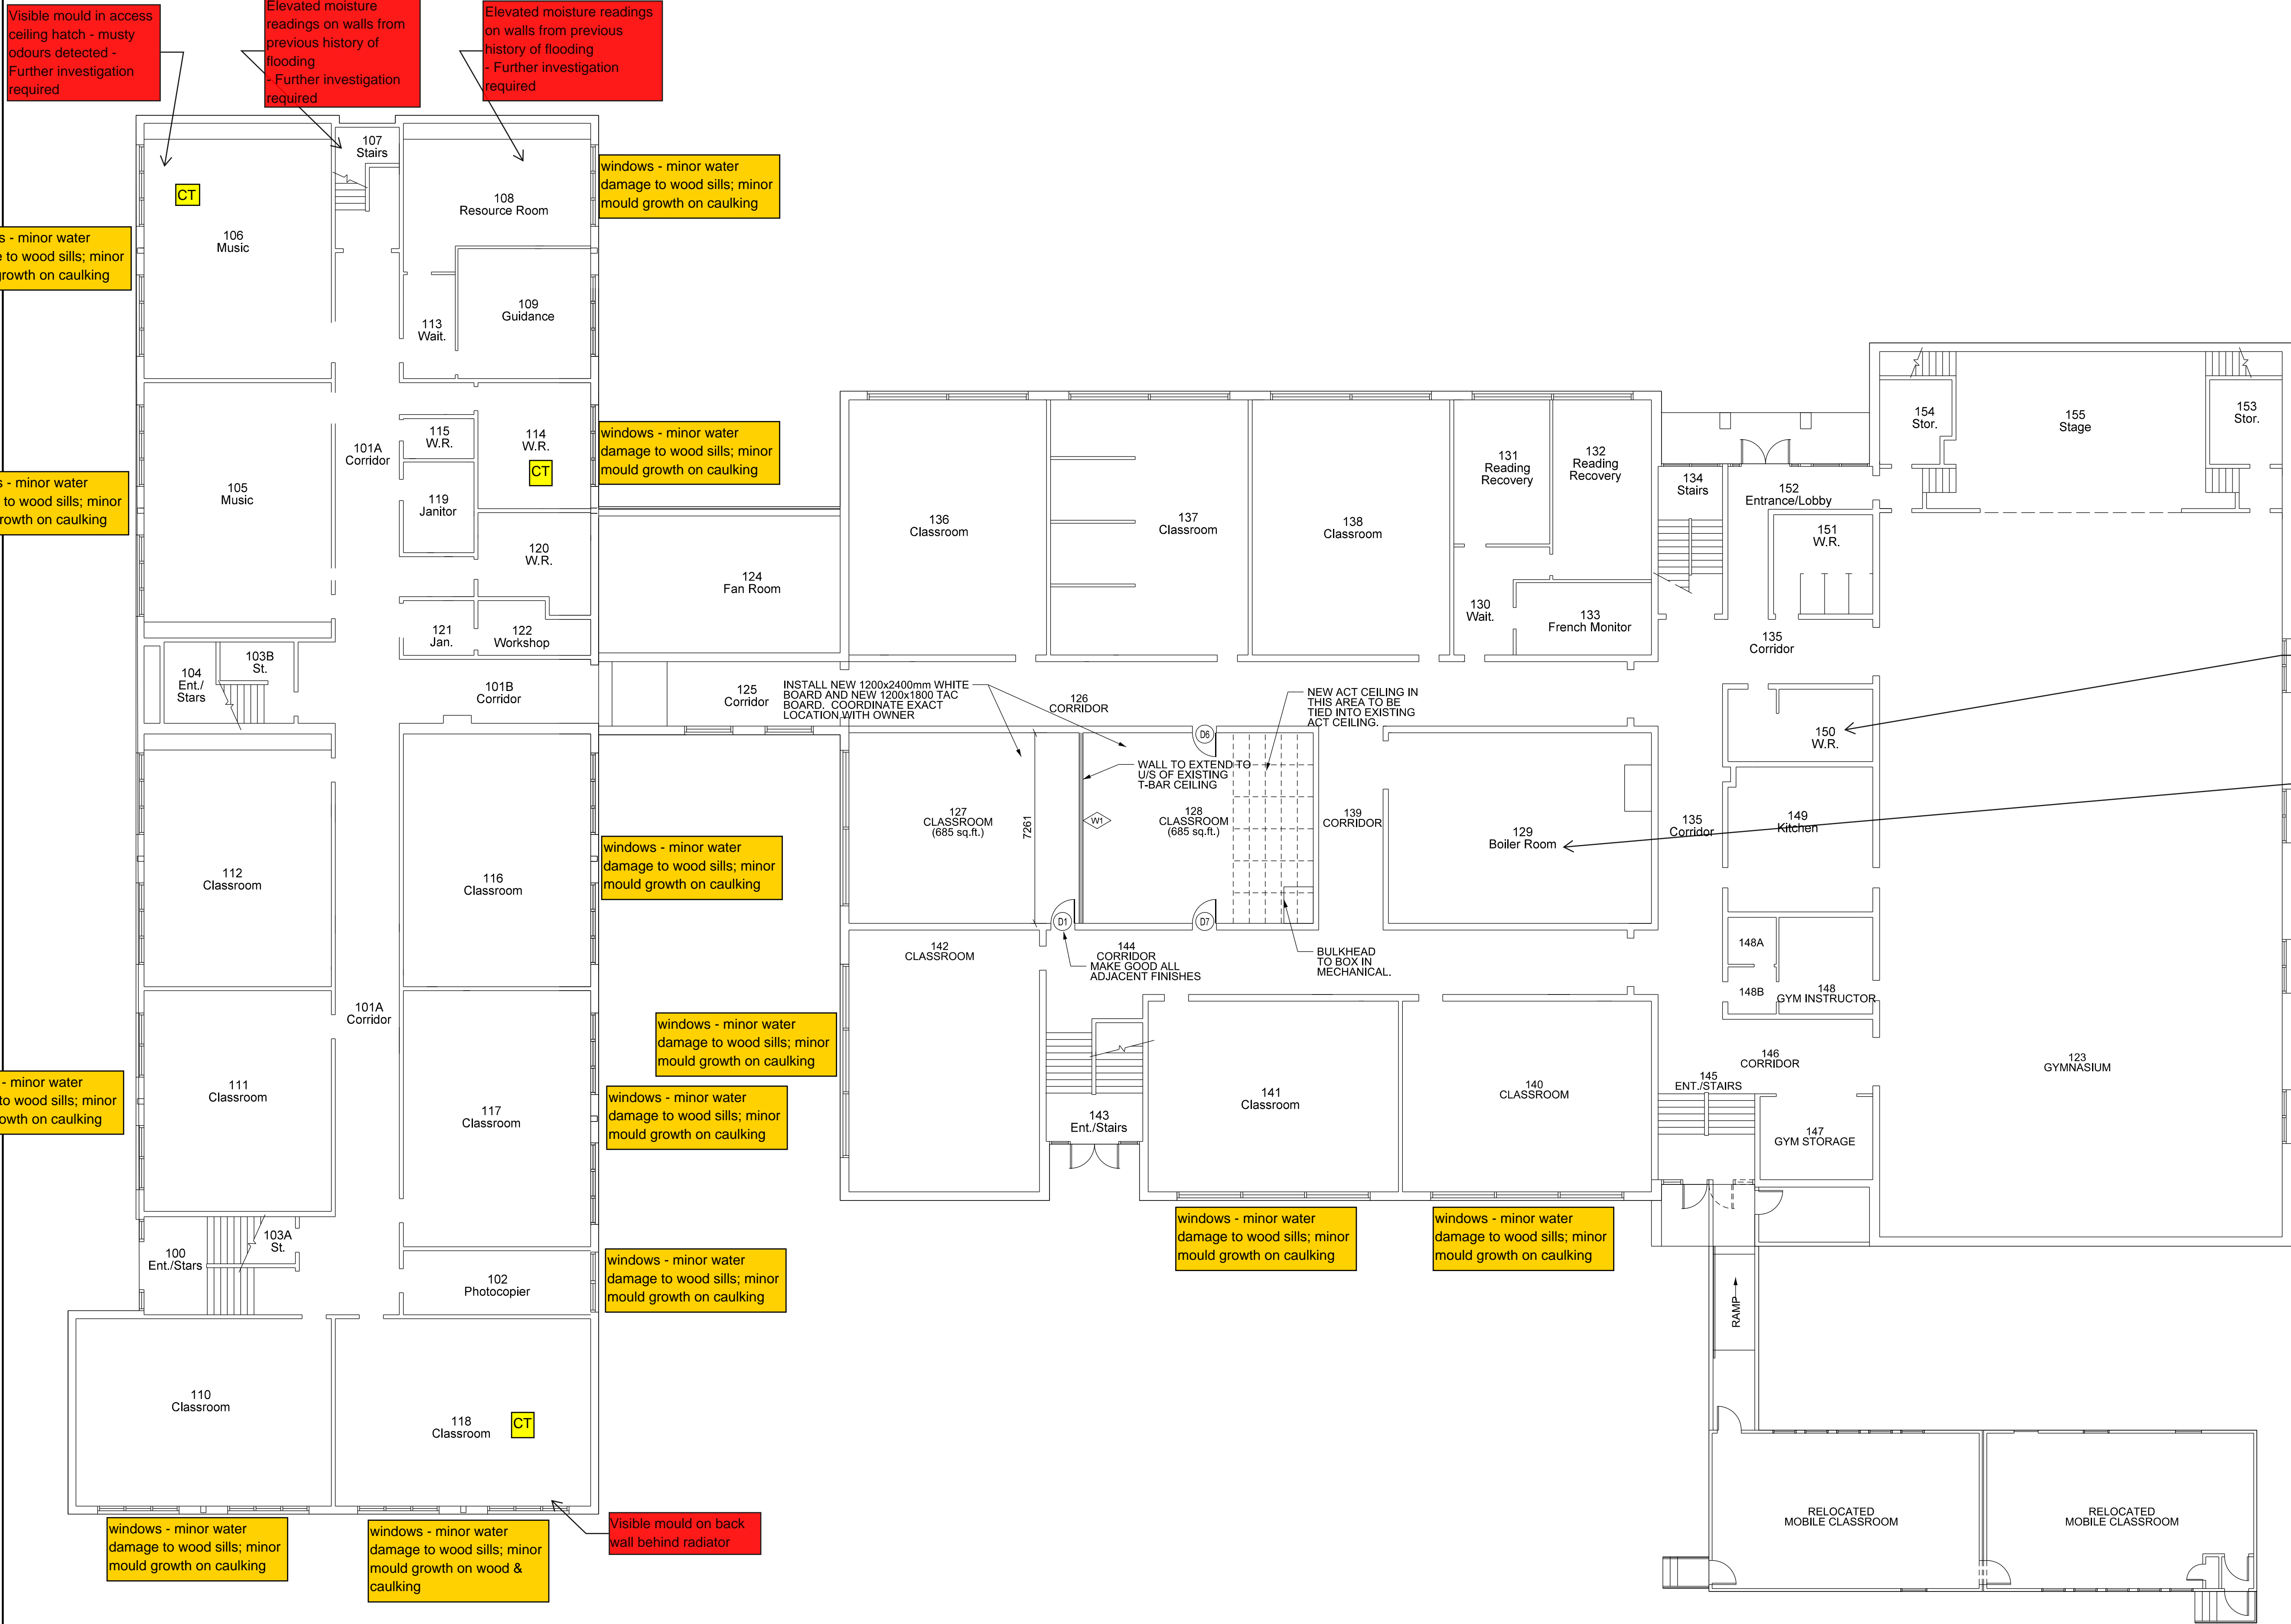
Drawing Title :  
**Lower Level Floor Plan**

Minor visible mould on wood water tank cover and on wood bracket on wall

Visible mould on mechanical pipes

CT - stained ceiling tile
