# Mould & Moisture Assessment Somerset Elementary School

**Project No. 12620**

**May 4, 2011**

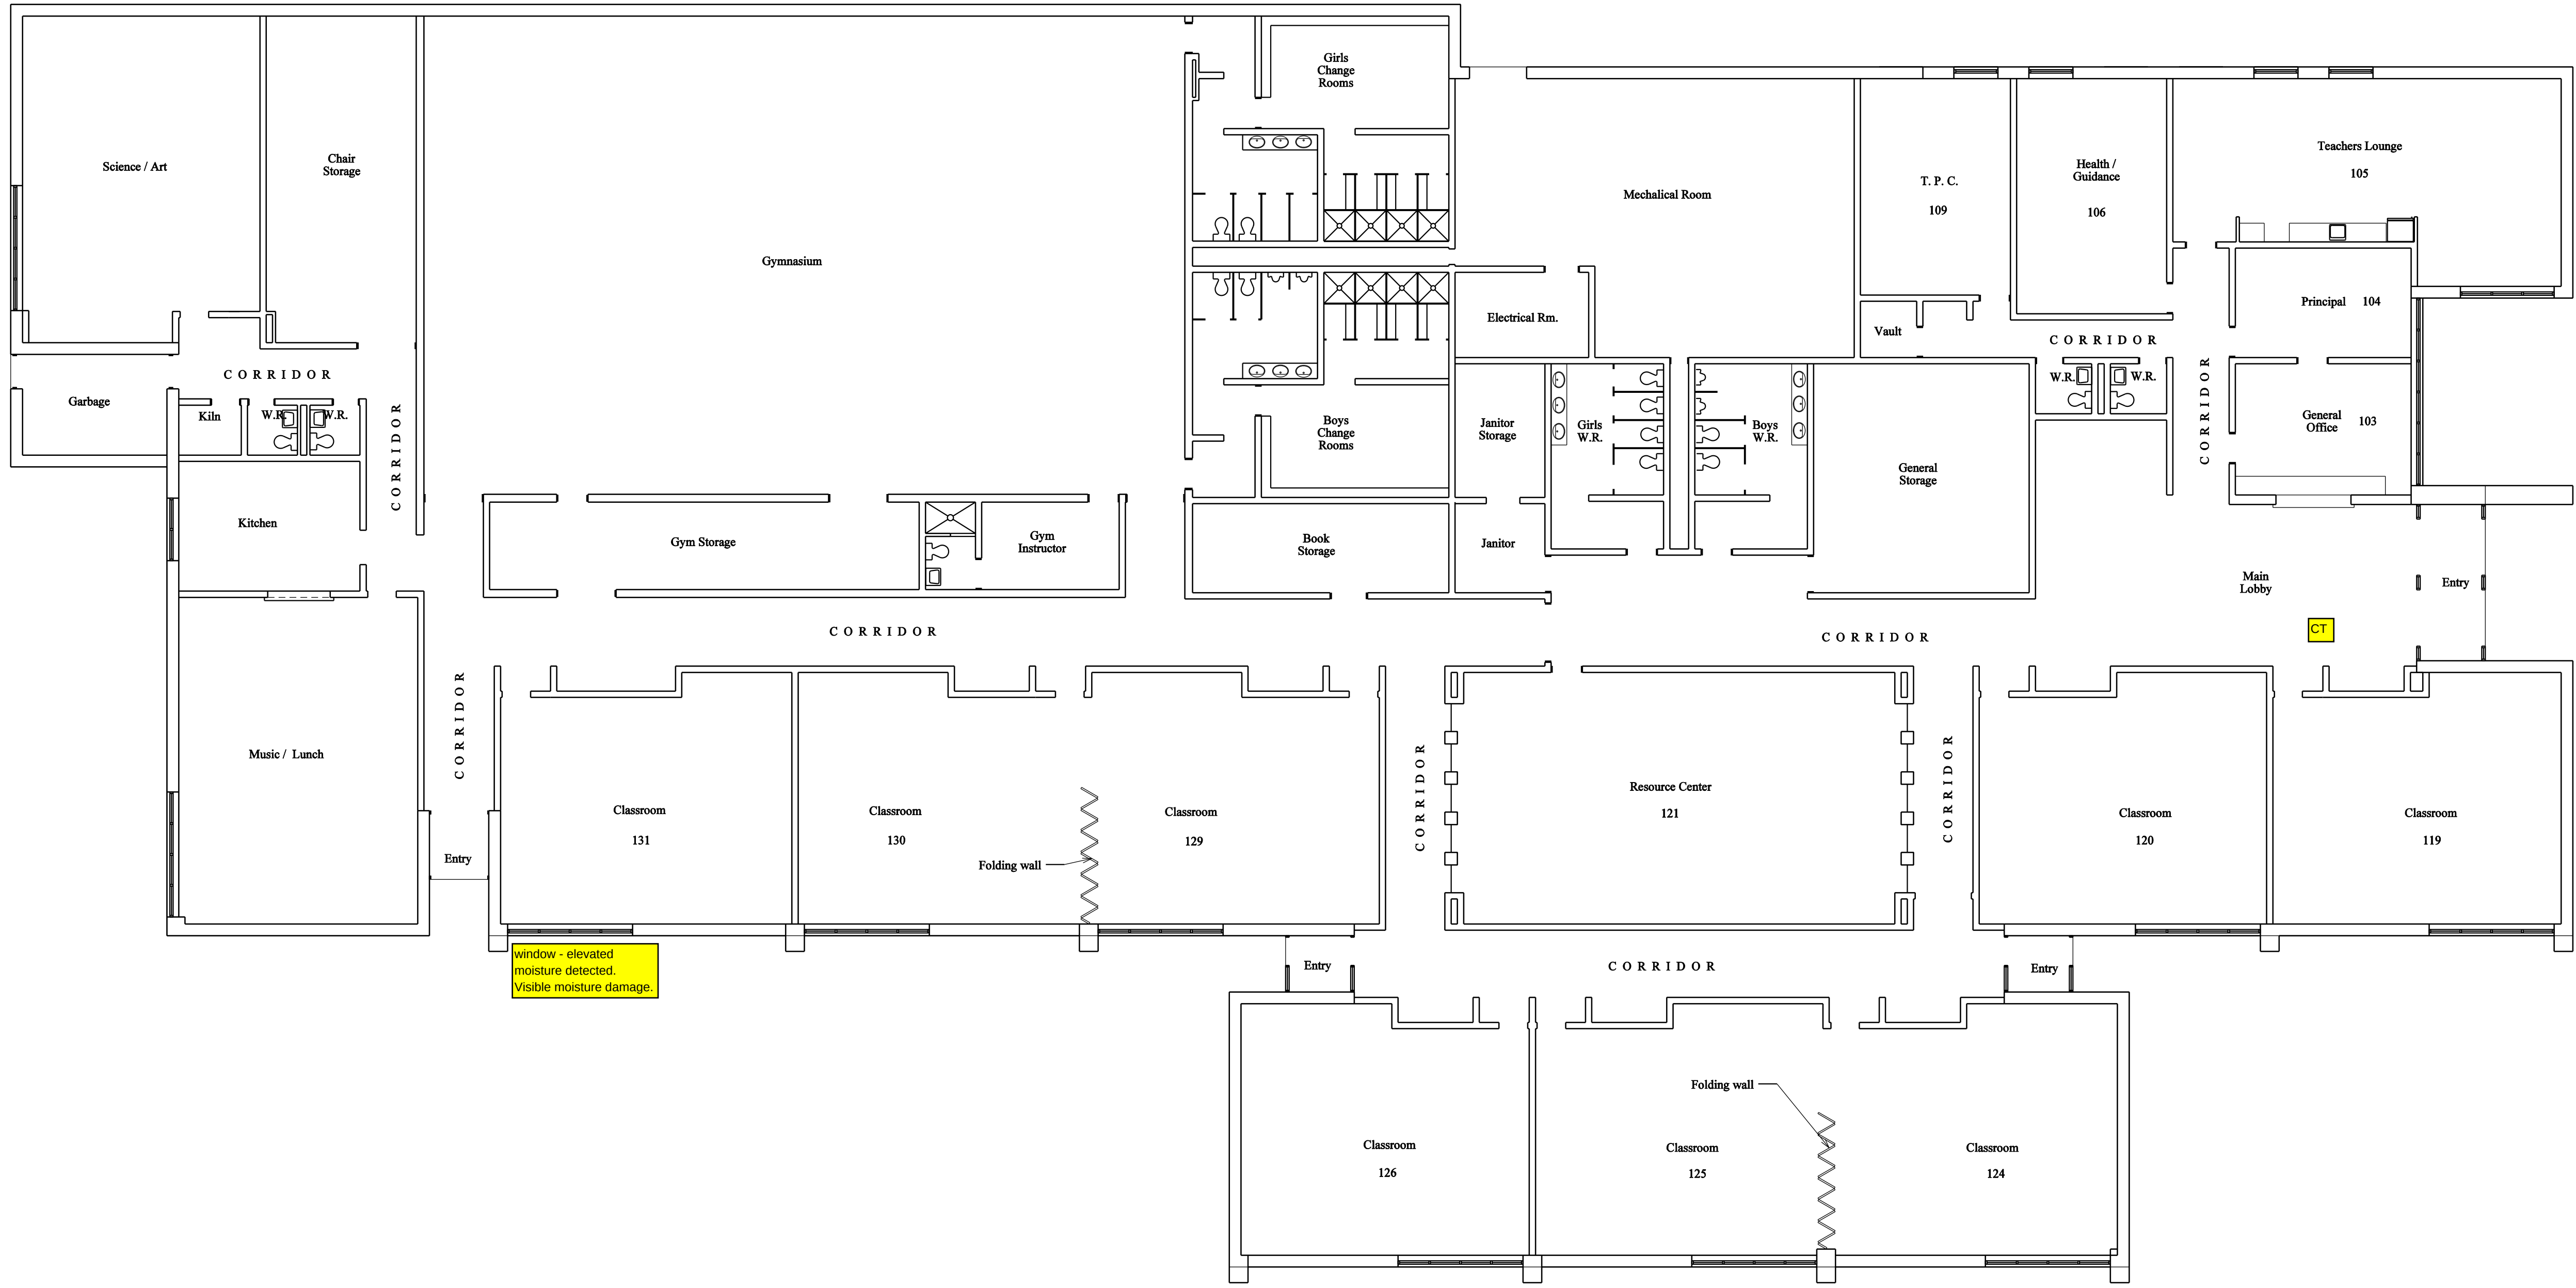
MAIN FLOOR PLAN

| Table II<br>Summary of Moisture affected areas | | |
|---|---|---|
| Main Lobby | Stained ceiling tile observed.<br>Mechanical duct work non-insulated above. | Replace ceiling tile as precautionary measure. Address mechanical system condensation issue to avoid further recurrence and subsequent mould growth conditions. |
| Rm 131 | Visible moisture damage to window sill.<br>Elevated moisture detected. | Further investigation required into addressing water infiltration / condensation and potential hidden mould. |

CT - affected ceiling tile area
