Mould & Moisture Assessment Souris Consolidated School

Project No. 12620

March 25, 2011

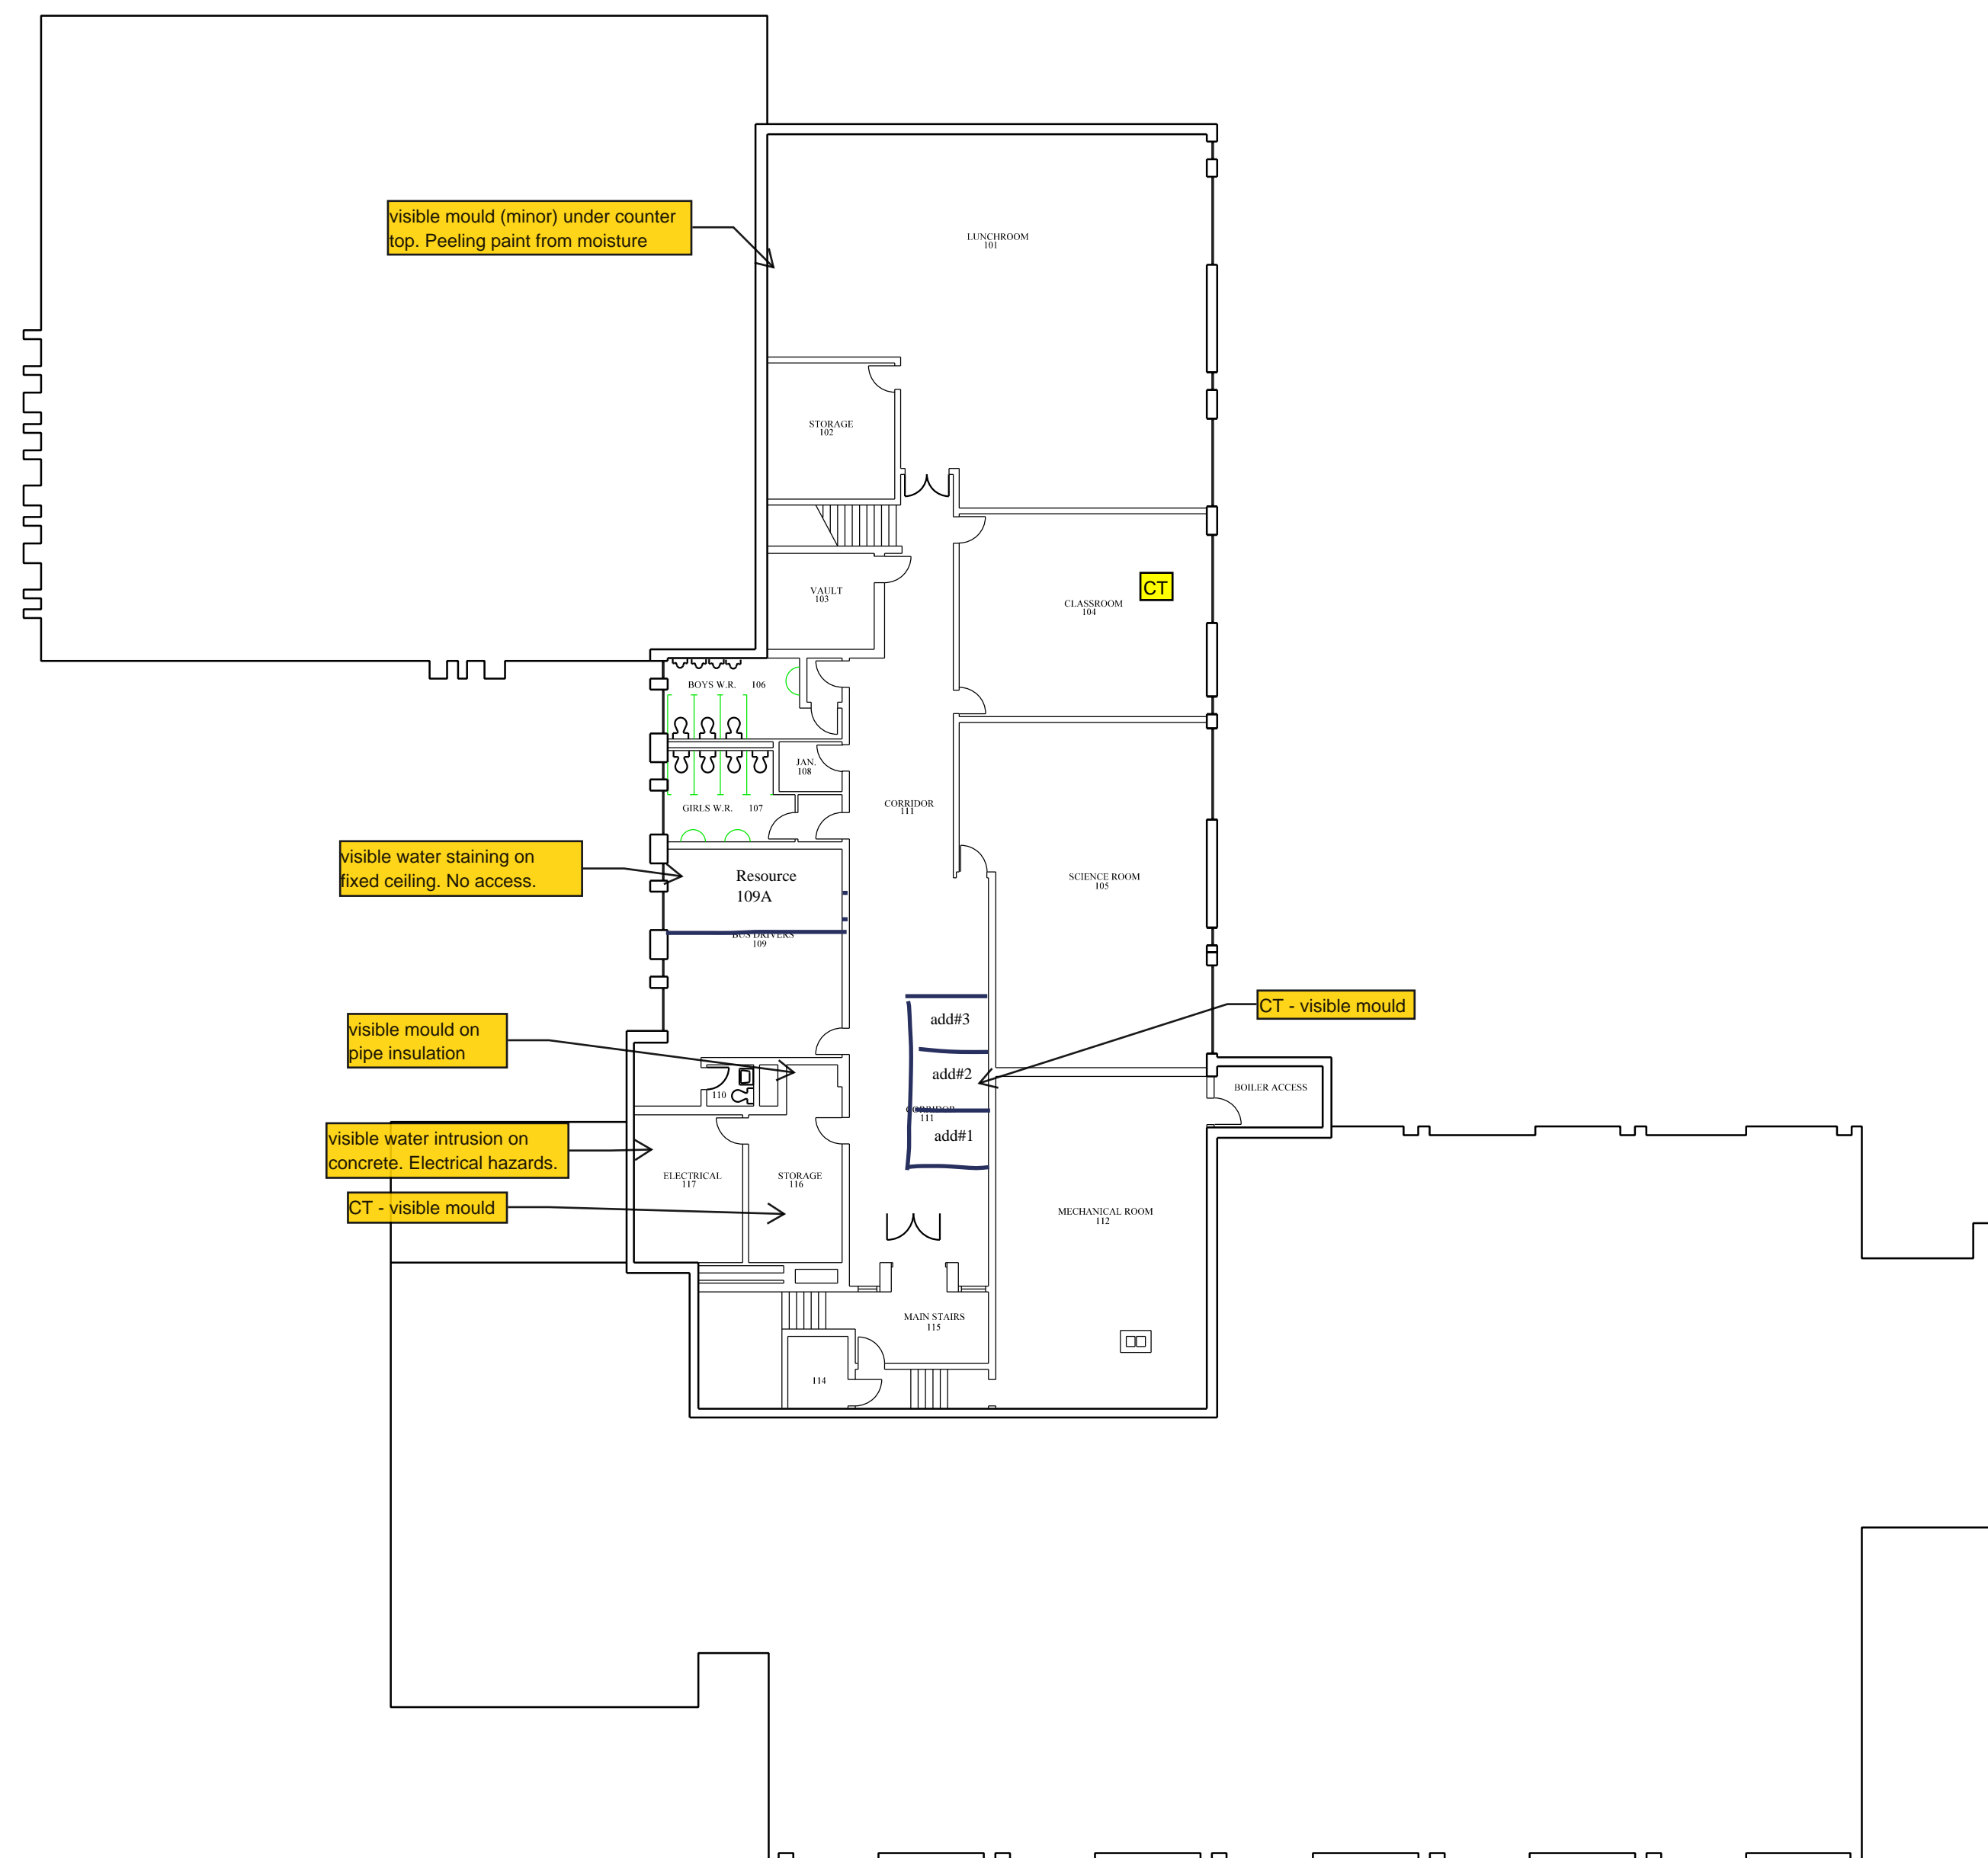
LOWER FLOOR

Table III Summary of Moisture affected areas		
Room No. / Description	Comments / Observations	Action required
add#2 (lower level); 116; 206; 224; 242; 305; 308; 311; 314; 315	Stained ceiling tiles observed and reported throughout the building on all levels (see site floor plan - Appendix I for location markings).	Replace ceiling tiles as precautionary measure and to assist in detecting further water leaks. Some leaks were reported at the time of assessment.
Rm 104; 109A; 242	Visible water damage on fixed ceiling.	Further investigation required into addressing water infiltration and potential hidden mould

CT - affected ceiling tile area
