# Mould & Moisture Assessment Southern Kings Consolidated School

**Project No. 12620**

**April 20, 2011**

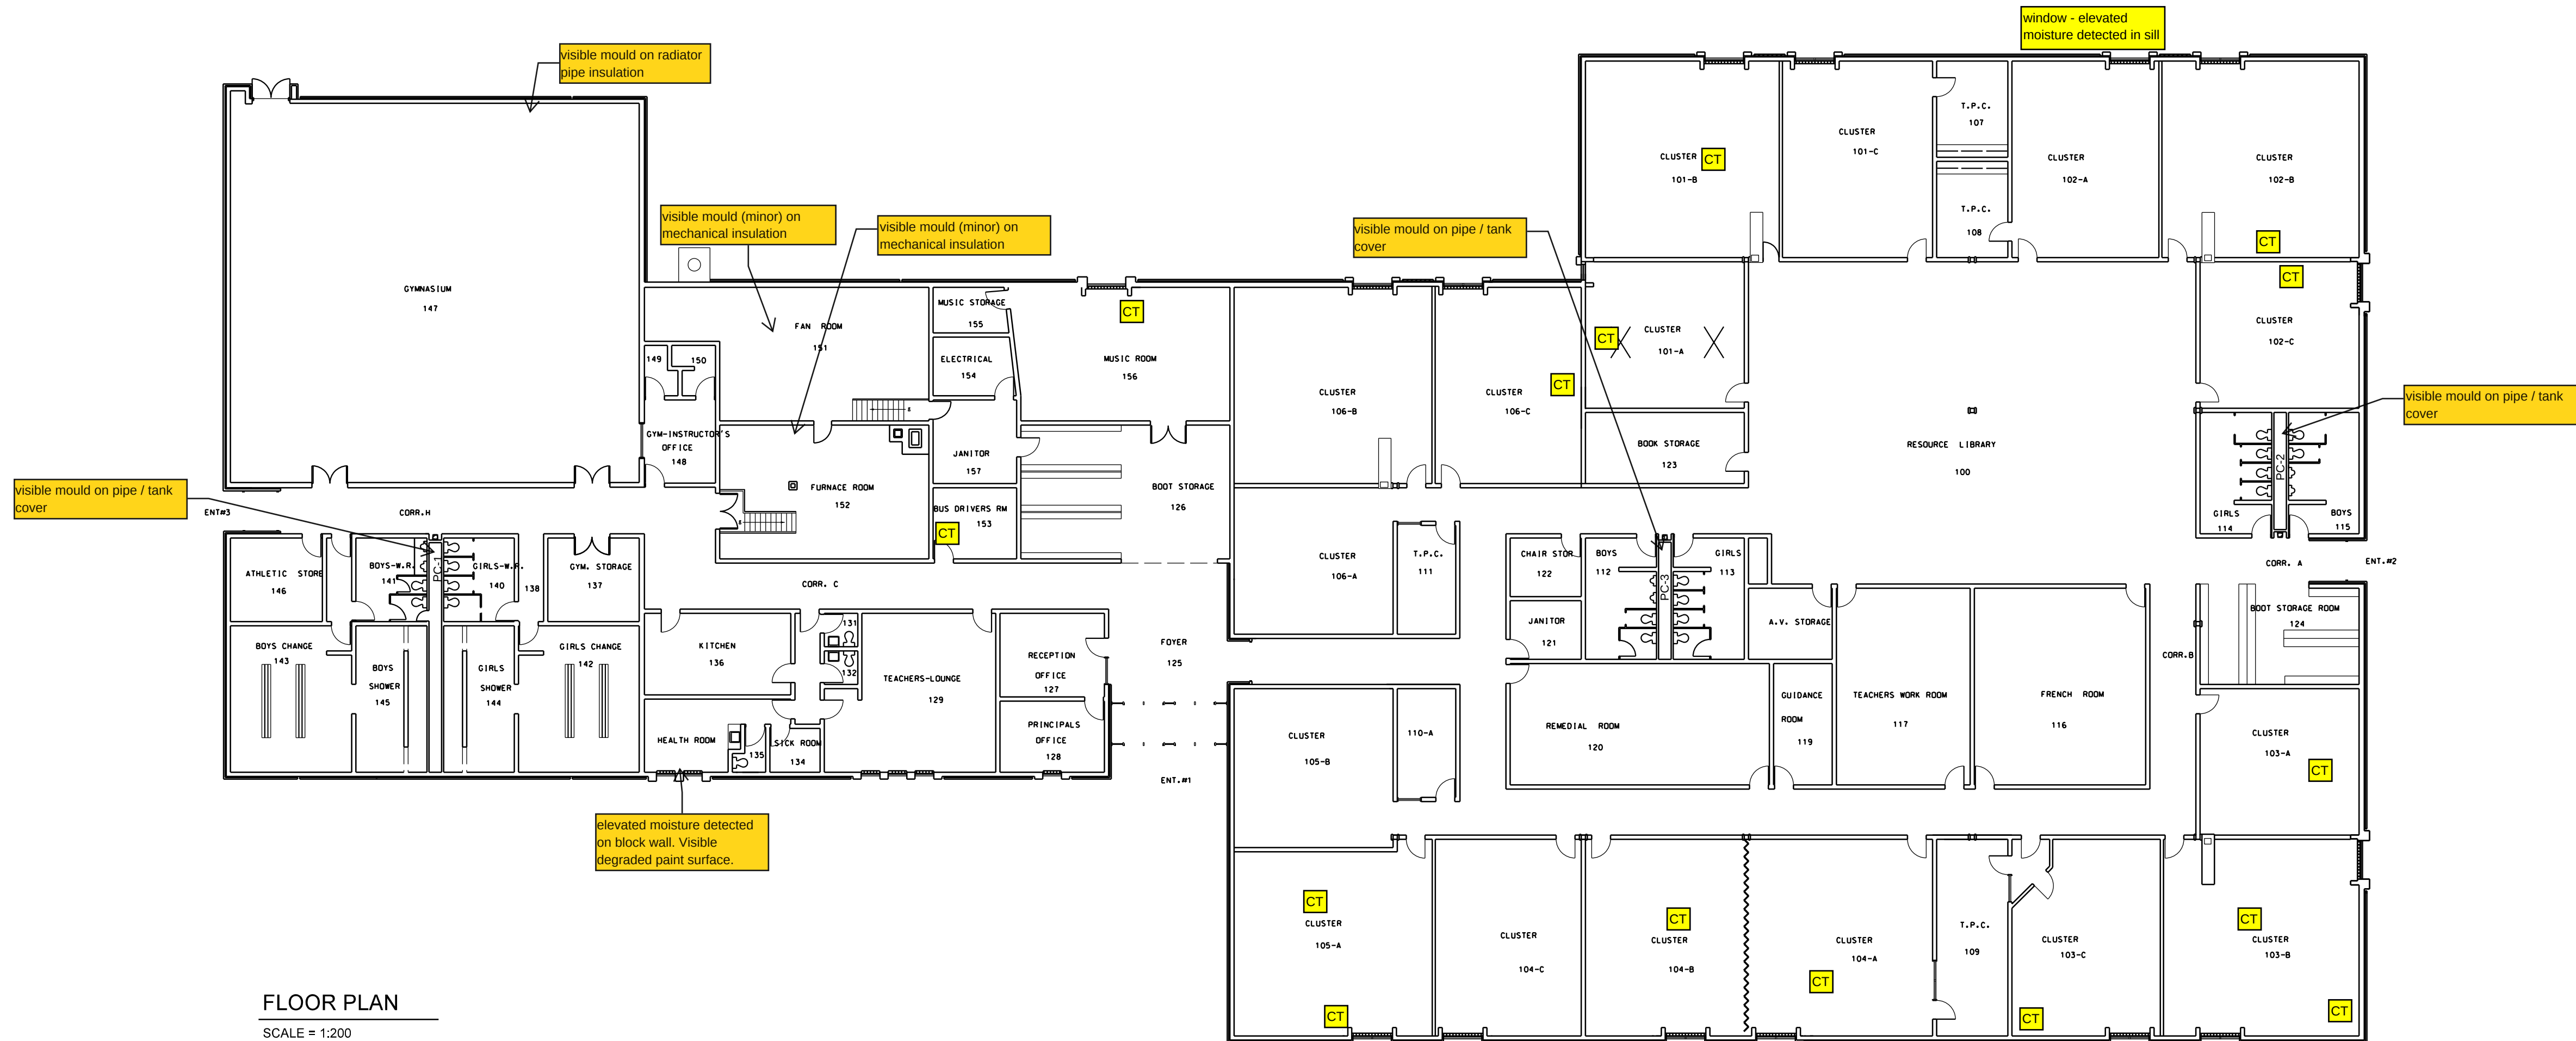
FLOOR PLAN

| <b>Table III</b><br><b>Summary of Moisture affected areas</b> | | |
|---|---|---|
| Rm 101A; 101B;<br>102B; 102C; 103A;<br>103B; 103C; 104A;<br>104B; 105A; 106C;<br>153; 156 | Stained ceiling tiles observed and reported throughout the building (see site floor plan - Appendix I for location markings). | Replace ceiling tiles as precautionary measure and to assist in detecting further water leaks. Some leaks were reported at the time of assessment. |

Leaks on ceilings have been identified in several areas throughout the school. These areas are noted in Table III and are identified on the site floor plan (Appendix I). No visible mould growth was identified in these areas at the time of the assessment. All ceiling tiles exhibiting evidence of water damage are recommended to be removed and replaced as a precautionary measure while those ceiling tiles identified and/or exhibiting evidence of suspect mould contamination are recommended to be removed following Level 1 mould remediation protocols.

CT - affected ceiling tile area
