Mould & Moisture Assessment St. Jean Elementary School

Project No. 12620

March 9, 2011

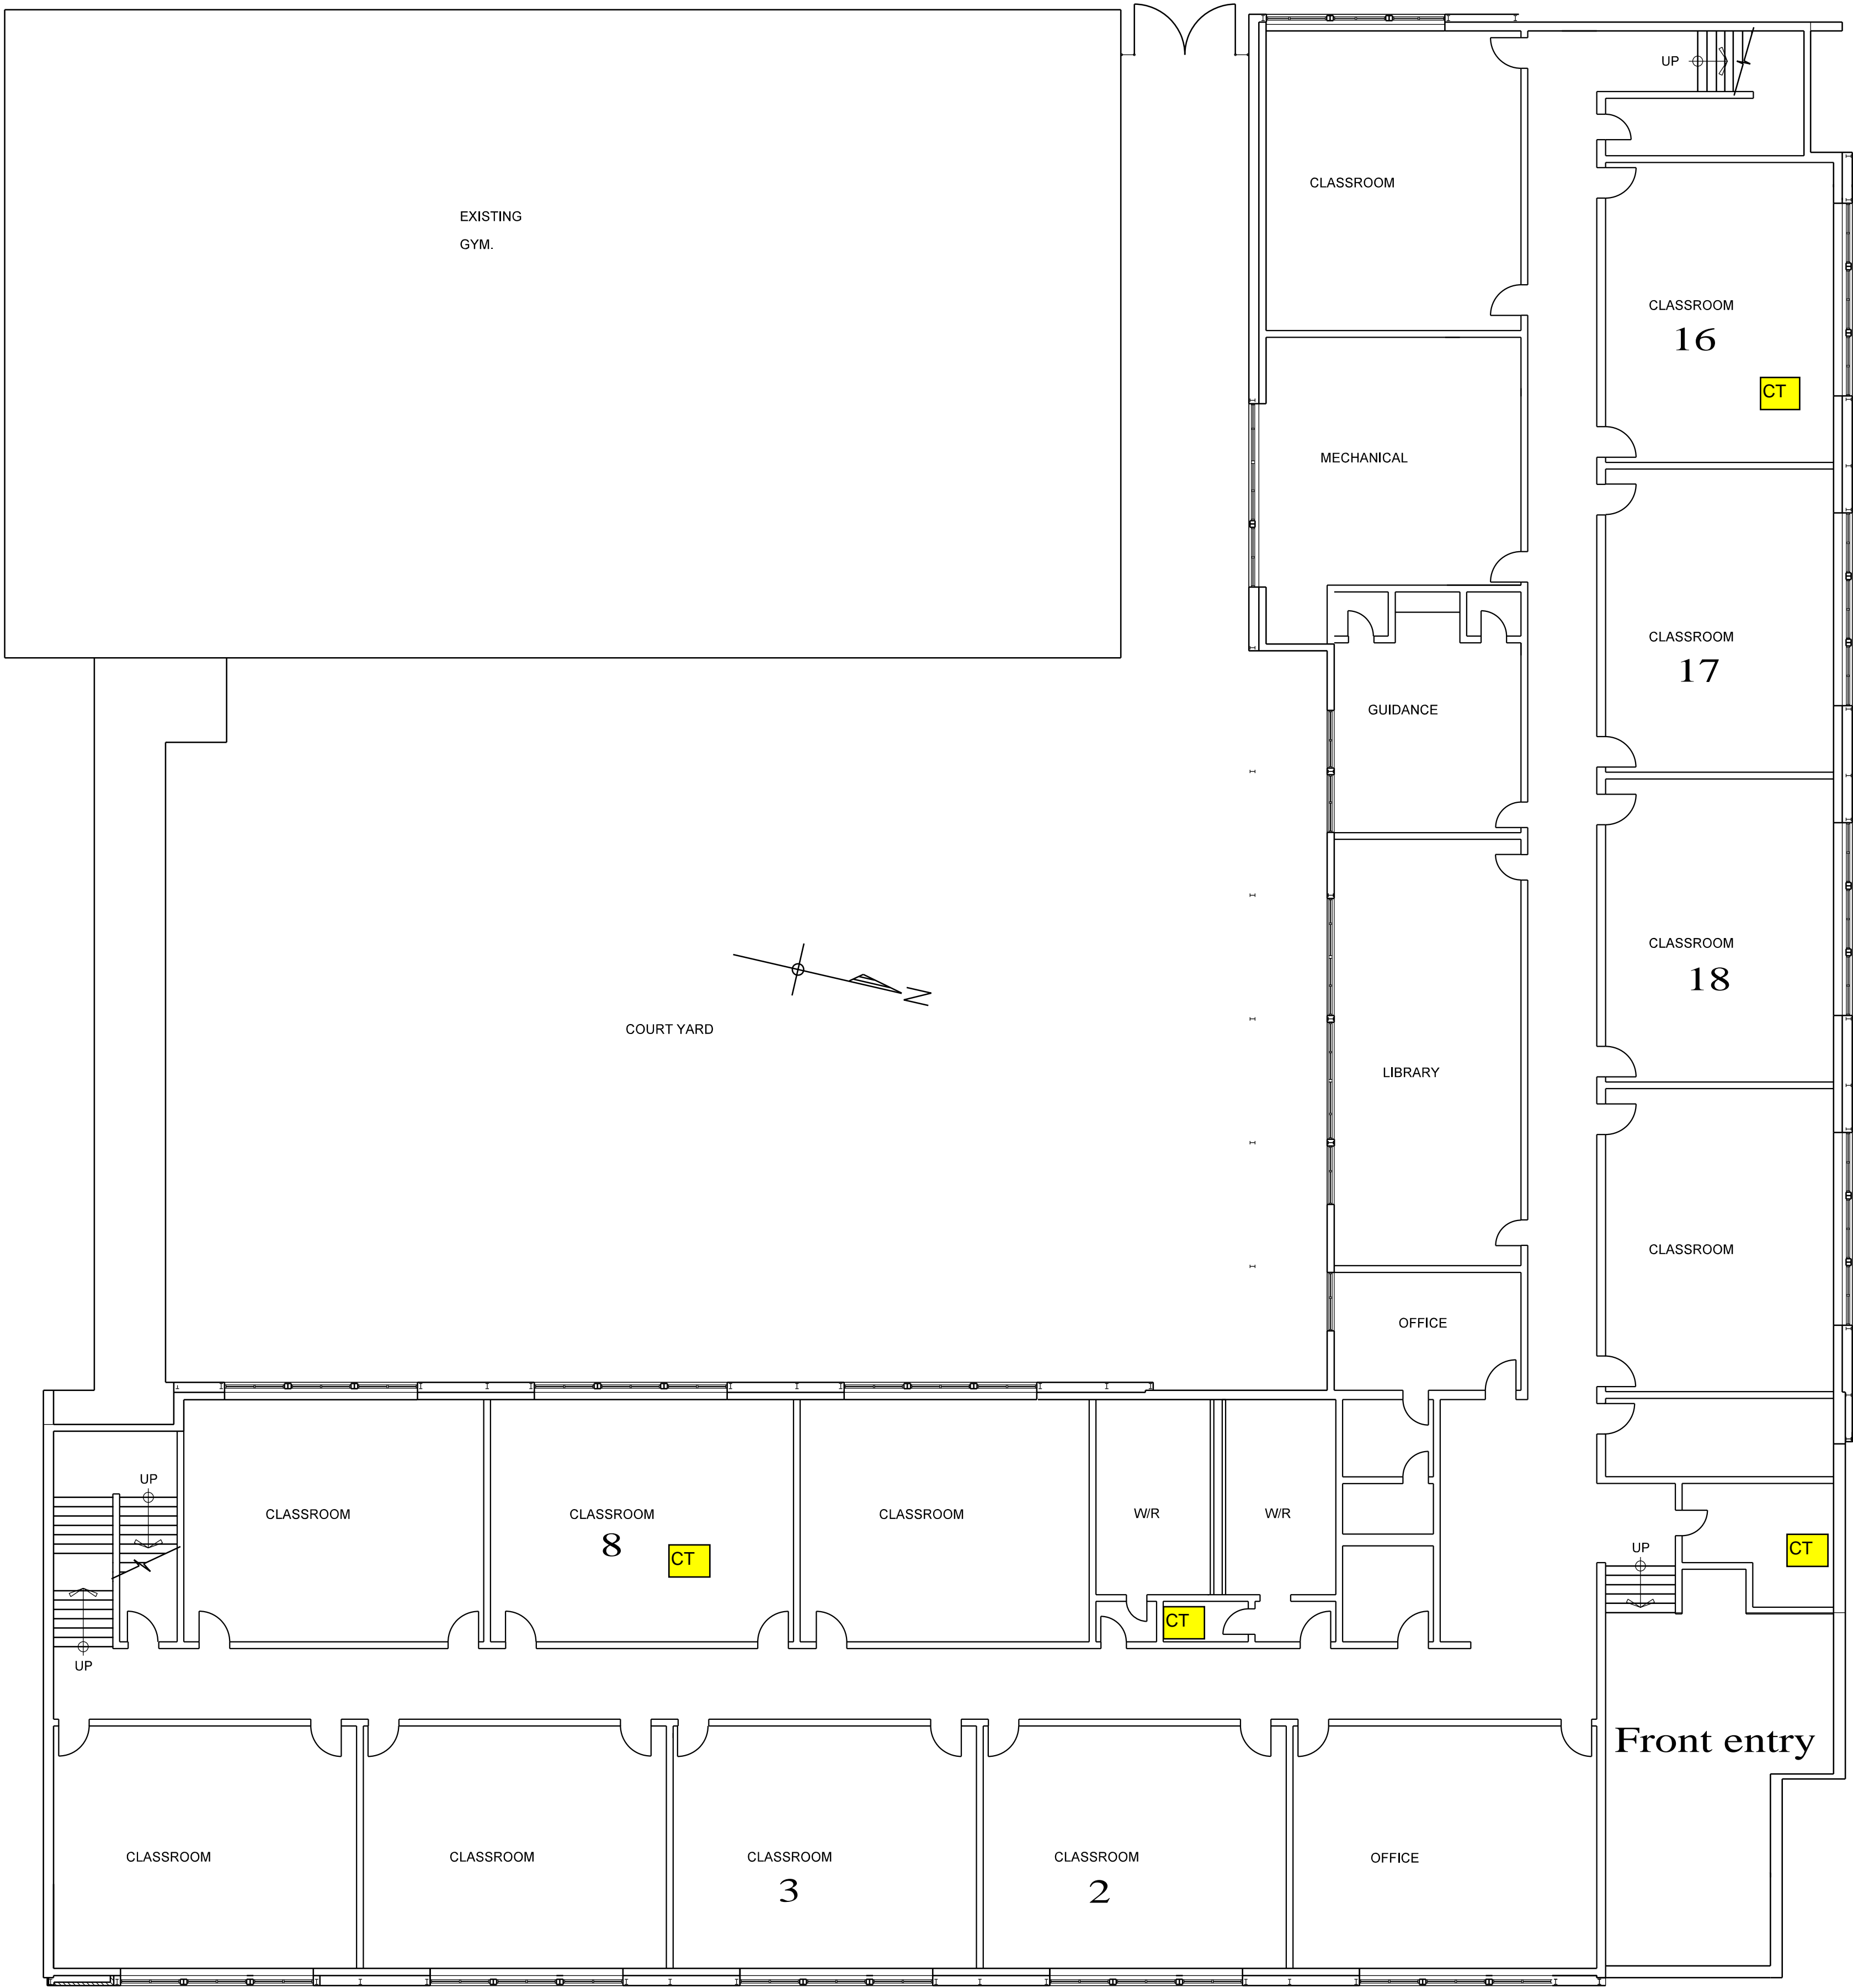
Drawing Title :
Lower Floor Plan

Table III Summary of Moisture affected areas		
Room No. / Description	Comments / Observations	Action required
Room 8; 16; VP office; Janitor Rm (lower level)	Water stained ceiling tiles. No visible mould or moisture detected at the time of the assessment.	Replace ceiling tile as precautionary measure and to assist in detecting further water leaks.
Corridor outside Gymnasium / ceiling space	Reported water infiltration and repairs completed. (no elevated moisture detected)	Jan 12, 2011 inspection of space through access hole and boroscope. No mould or moisture observed. No further action required at this time. If future leaks occur, report promptly and re assess area.
Gymnasium mezzanine / Cadet office 2; 5	Water damage to ceiling fibreboard reported as old and non recurring	Jan 12, 2011 inspection of space through access hole and boroscope. No mould or moisture observed. No further action required at this time. If future leaks occur, report promptly and re assess area.

CT - water stained ceiling tile

Minor water leaks were identified with stained ceiling tiles. These areas have been summarized in Table III. These ceiling tiles exhibiting evidence of water damage are recommended to be removed and replaced as a precautionary measure and to assist in detecting further water leaks.
