ST. LOUIS
ELEMENTARY SCHOOL

Mould & Moisture Assessment St. Louis Elementary School

Project No. 12620

April 13, 2011

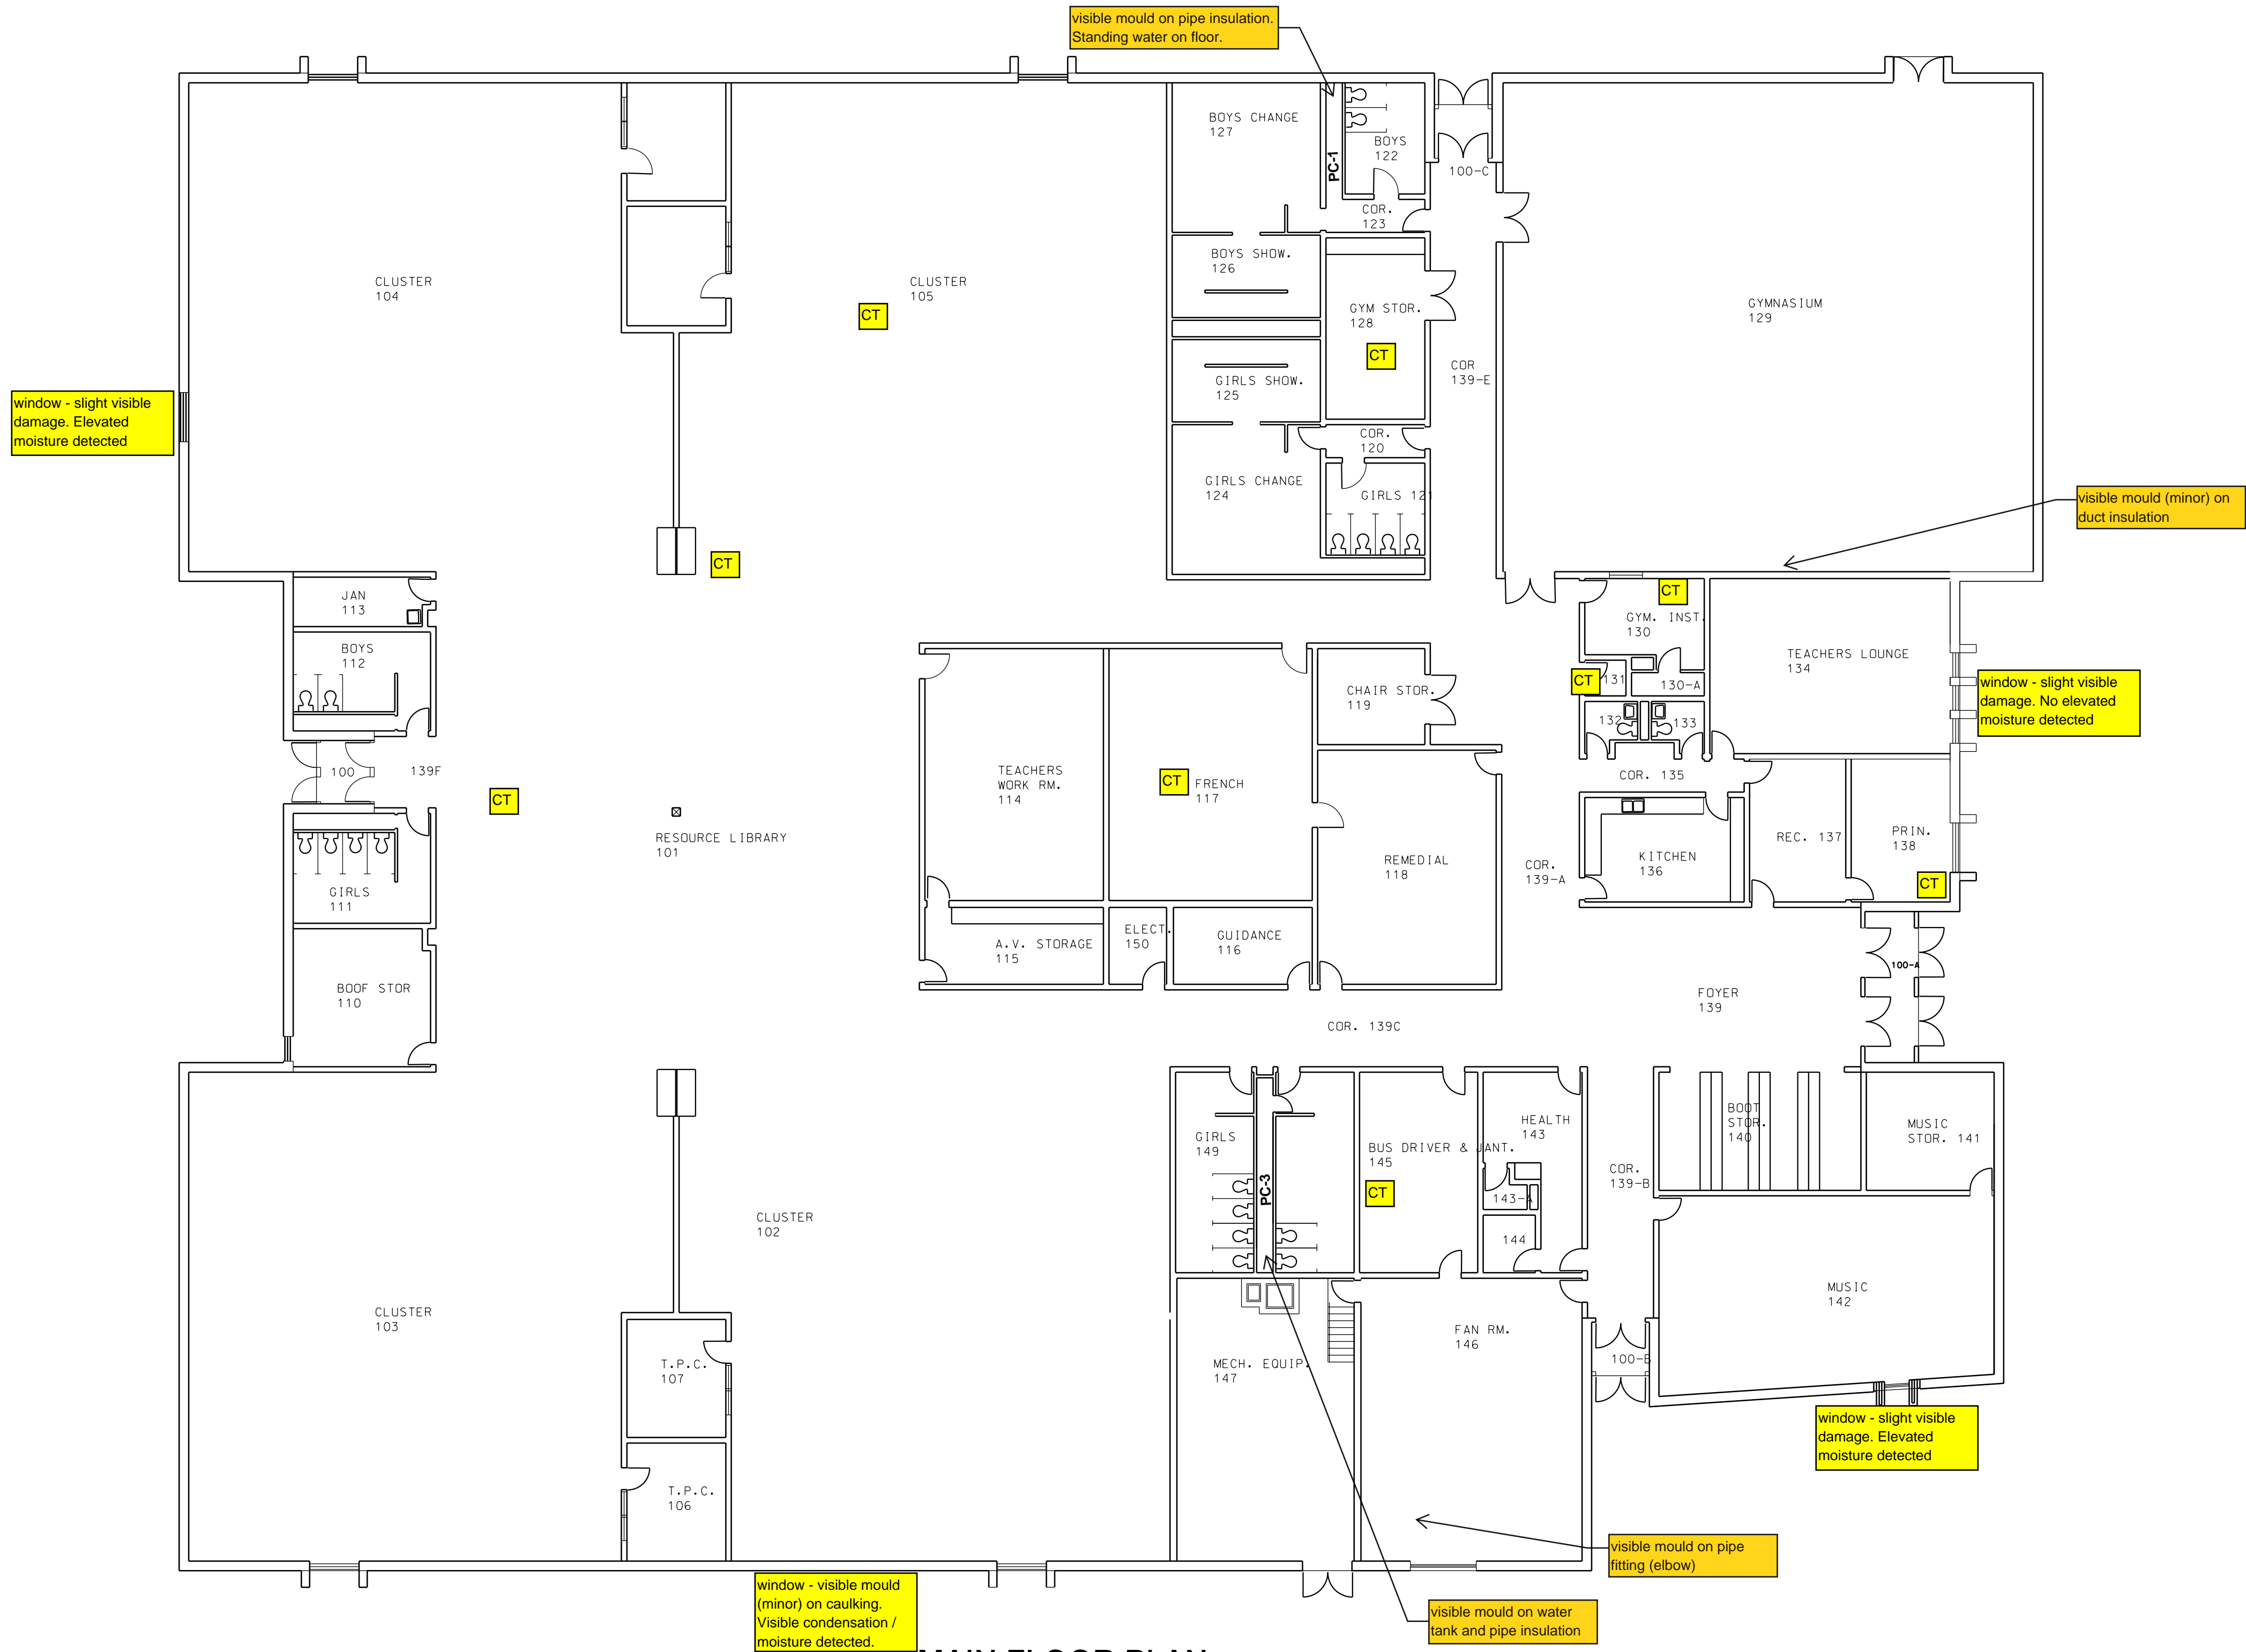
MAIN FLOOR PLAN

Table III Summary of Moisture affected areas		
Room No. / Description	Comments / Observations	Action required
Rm 101; 105; 117; 128; 130; 131; 138; 145	Stained ceiling tiles observed and reported throughout various locations (see site floor plan - Appendix I for location markings).	Replace ceiling tiles as precautionary measure and to assist in detecting further water leaks.
