Mould & Moisture Assessment Stonepark Intermediate School

Project No. 12620

April 21, 2011

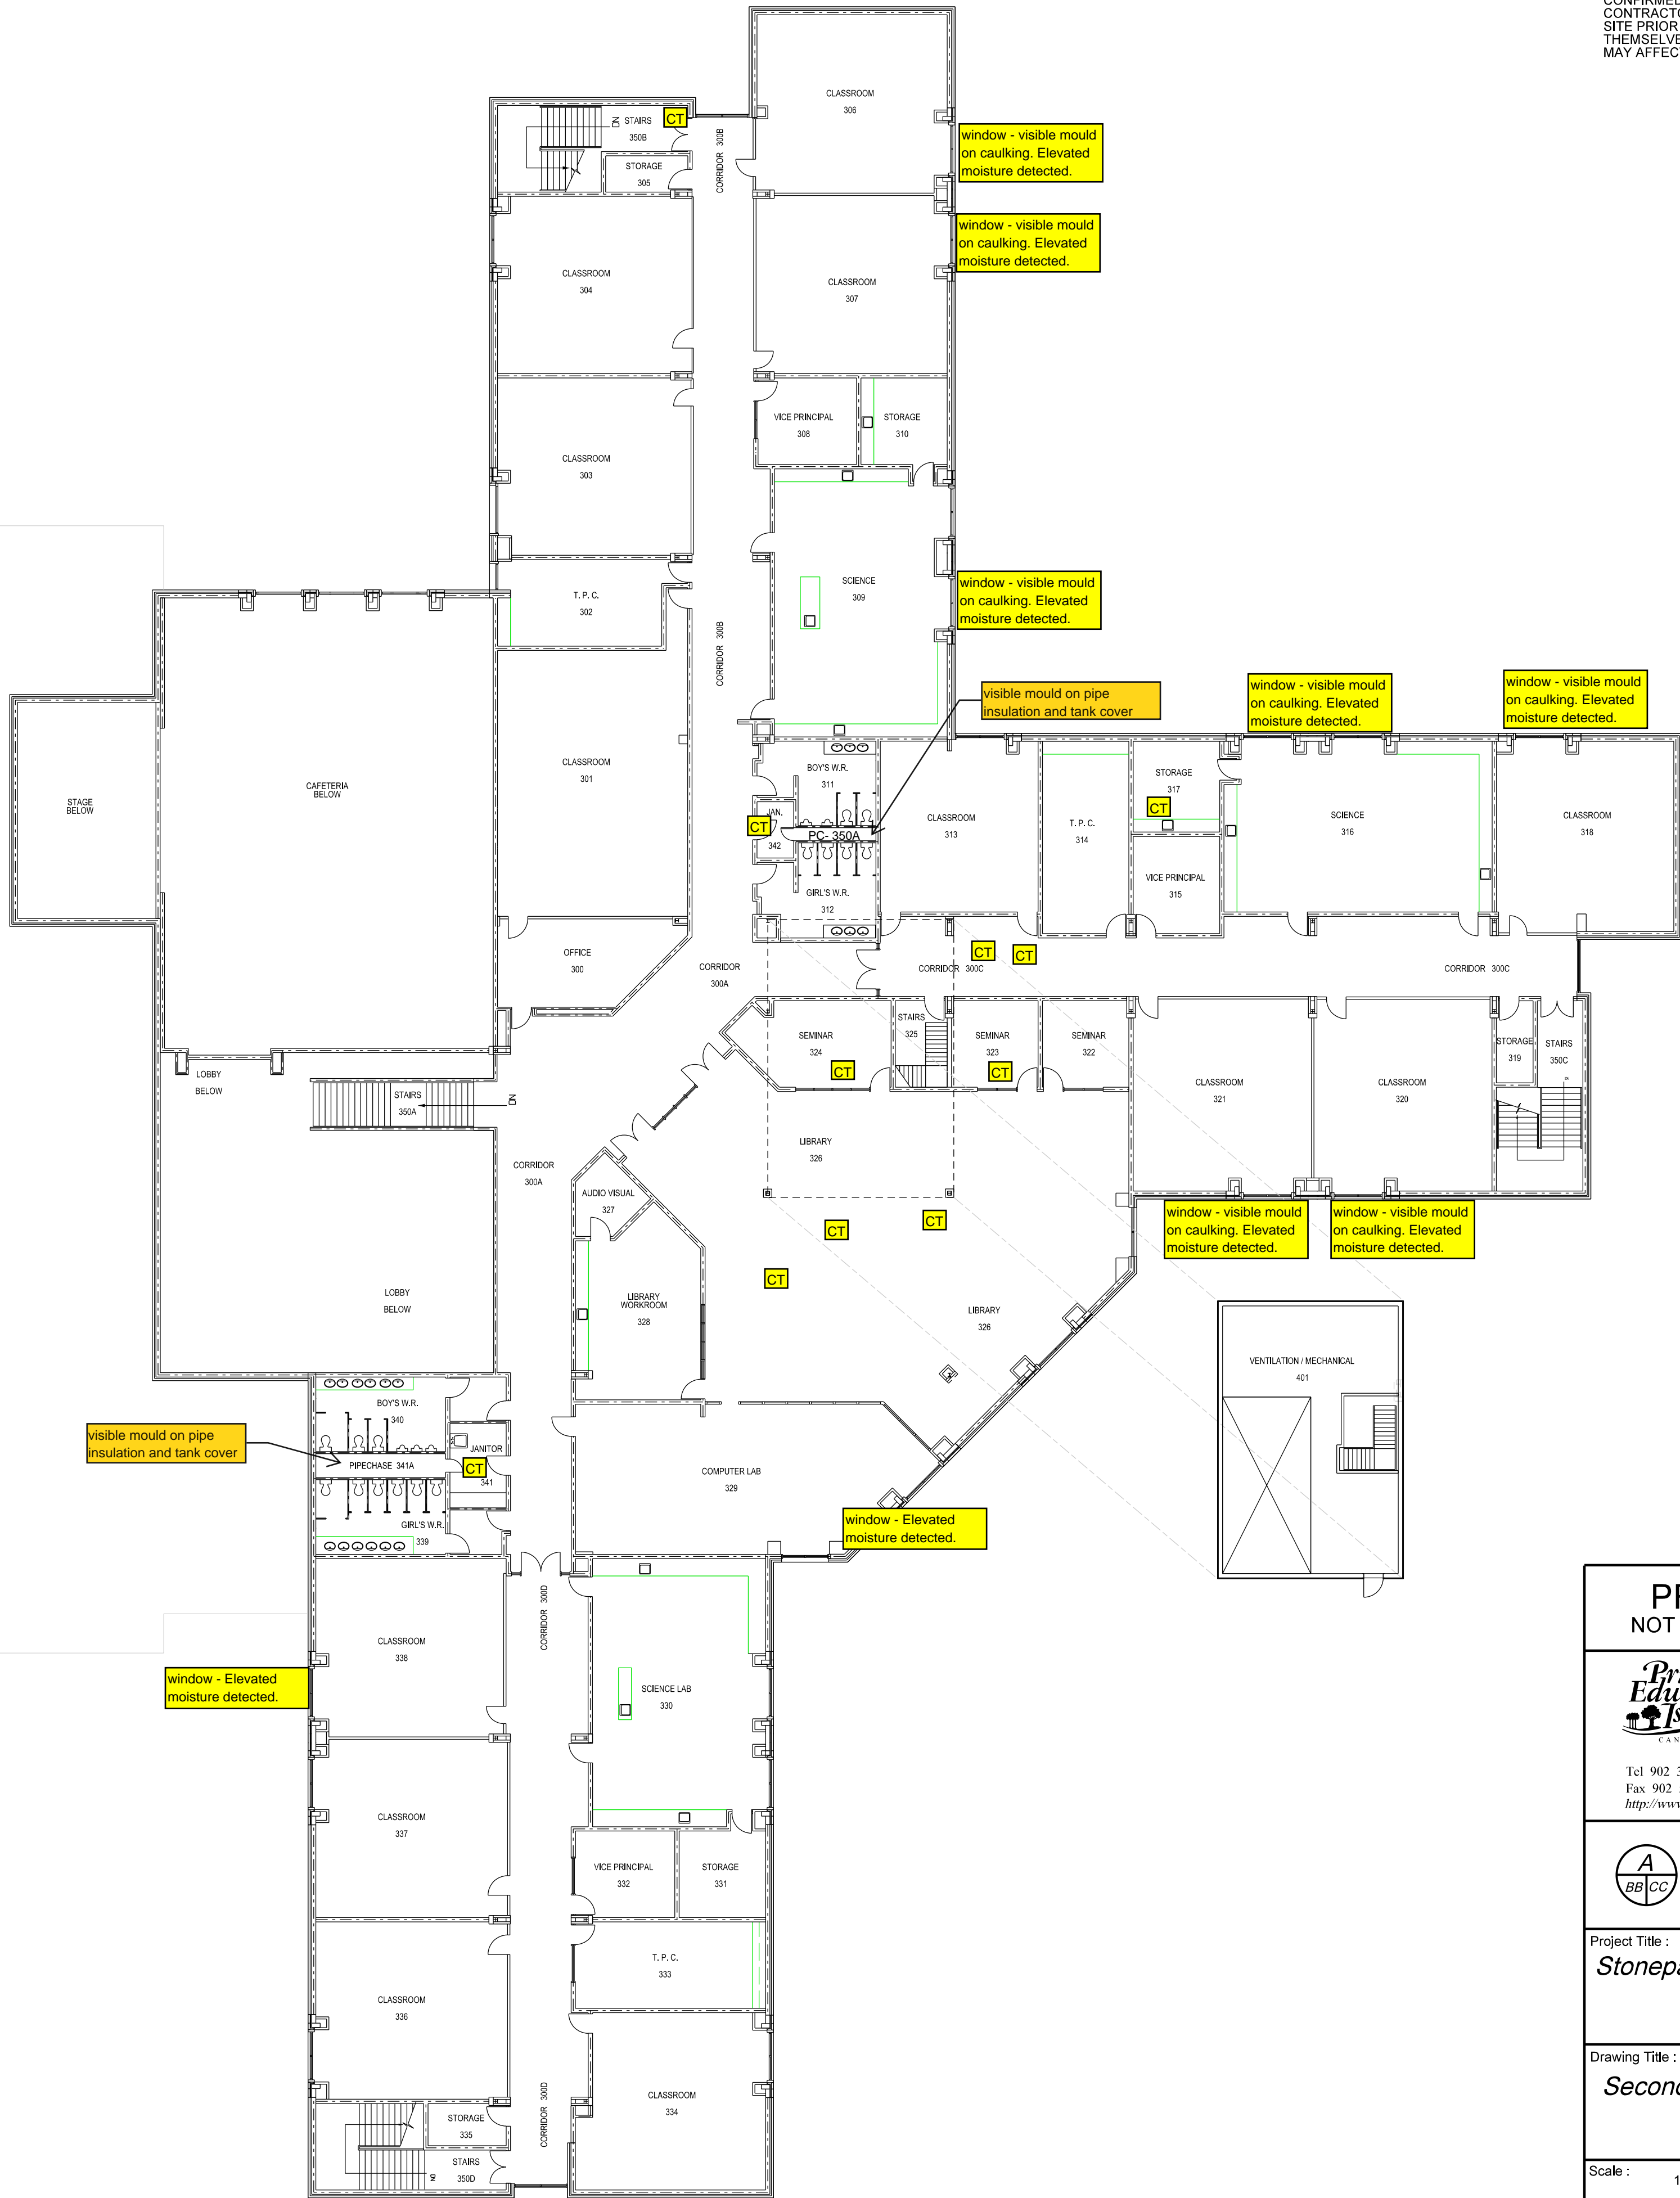
Drawing Title :
Second Floor Plan

Leaks on ceiling tiles have been identified in several areas throughout the school. These areas are noted in Table III and are identified on the site floor plan (Appendix I). Only a couple of areas were reported as having visible signs of mould growth on them as noted in Table II. These areas (Games Room; Industrial Arts) both revealed a number of stained tiles as well as evidence of active leaks through deck structure at the time of the inspection.

A number of classrooms exhibited consistent water stained ceiling tiles above window areas especially in the north-east wing. These areas were consistent with windows that had elevated moisture and visible mould and / or minor structural damage.

CT - affected ceiling tile area

It is recommended that all ceiling tiles exhibiting evidence of water damage are removed and replaced as a precautionary measure and to assist in detecting further water leaks.
